# Abbey Ridge Local Area Plan Stormwater Servicing Strategy Final Report – 8 December 2016

**RE: Abbey Ridge Local Area Plan Stormwater Servicing Strategy**

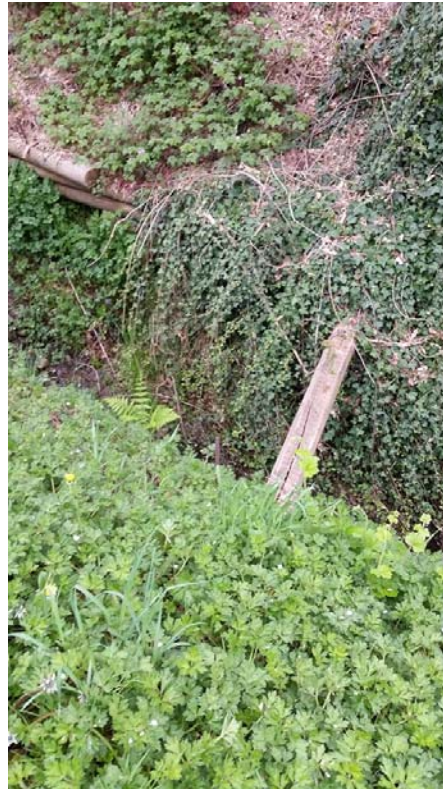
Location	Site ID <sup>1</sup>	Existing Conditions	Recommendations	Risk	Considerations during Future Development
182A Street	182A St. Ditch	Ongoing erosion of the left bank of ditch along property west of 182A Street. The short timber wall retaining the landscaped private property is in an undermined state.	Extend existing driveway culvert northward and/or provide rip-rap protection.	Low	This existing ditch would eventually be replaced with a closed drainage system as development occurs within the area. In the interim, provide rock rip-rap protection to mitigate against any increase in flows from upstream development.
	20-1	Minor erosion downstream of new culvert beneath Highway 1.	The banks should be reviewed periodically for potential changes in erosion rates.	Low	None
Leoran Brook	20-6	Left bank erosion in reach southeast of 9820 181 Street.	The banks should be reviewed periodically for potential changes in erosion rates.	Low	None

**Photo 1. (WP-182A ST DITCH)** 182A Street Ditch. View of left bank decaying and toppling landscape tie retaining walls and wall debris.

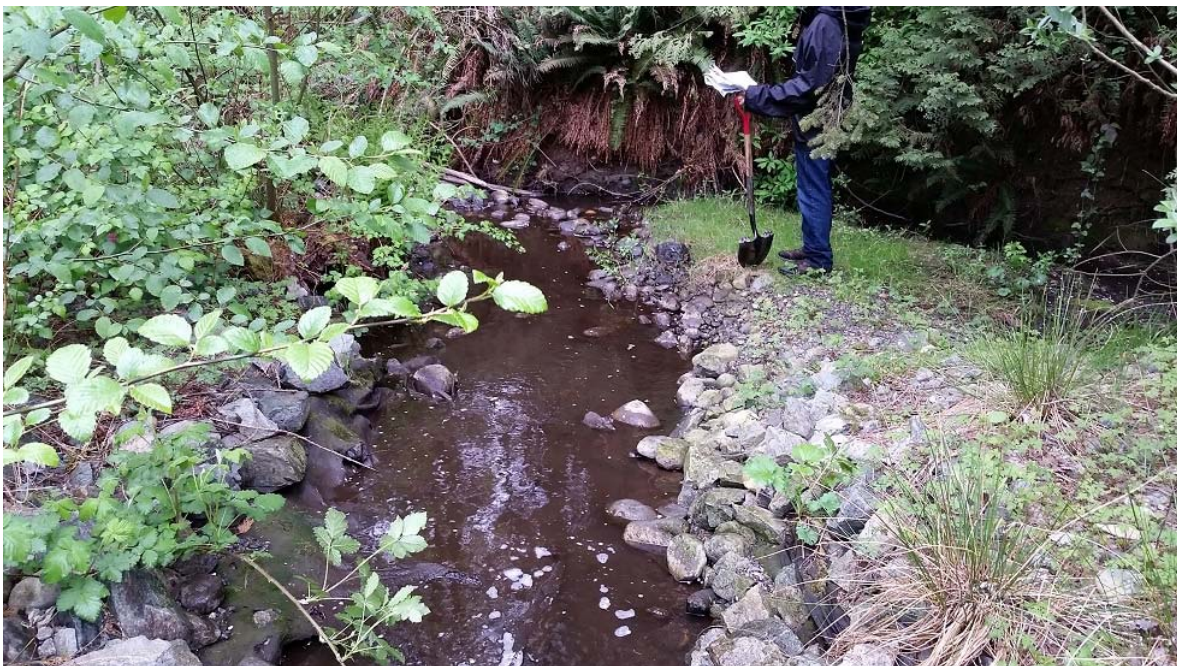
**Photo 2. (WP20-1)** Leoran Brook (upper section at Hwy 1). View of right bank erosion and recent instream works (~5 yrs old).

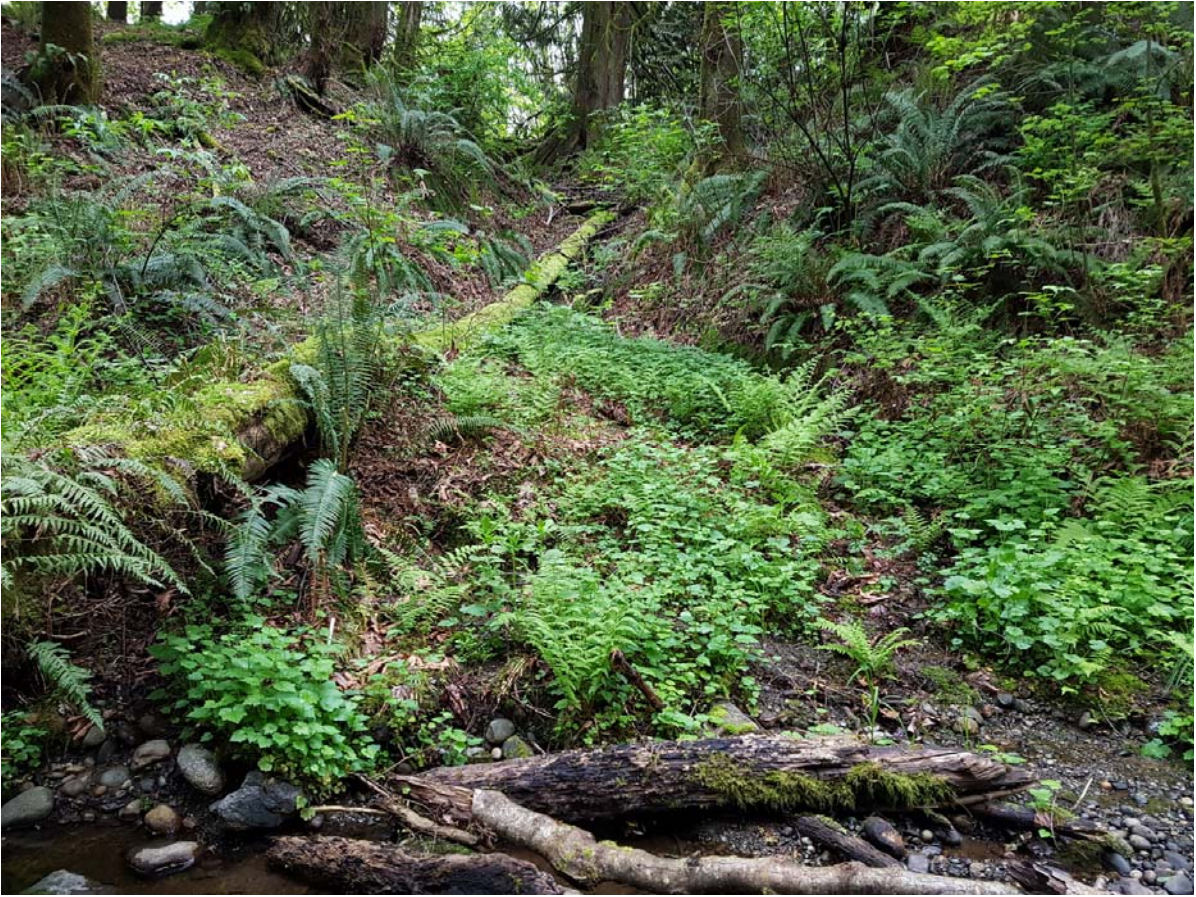
Photo 3. (WP20-6) Leoran Brook (upper section). Left bank erosion (southeast of 9820 181 Street).

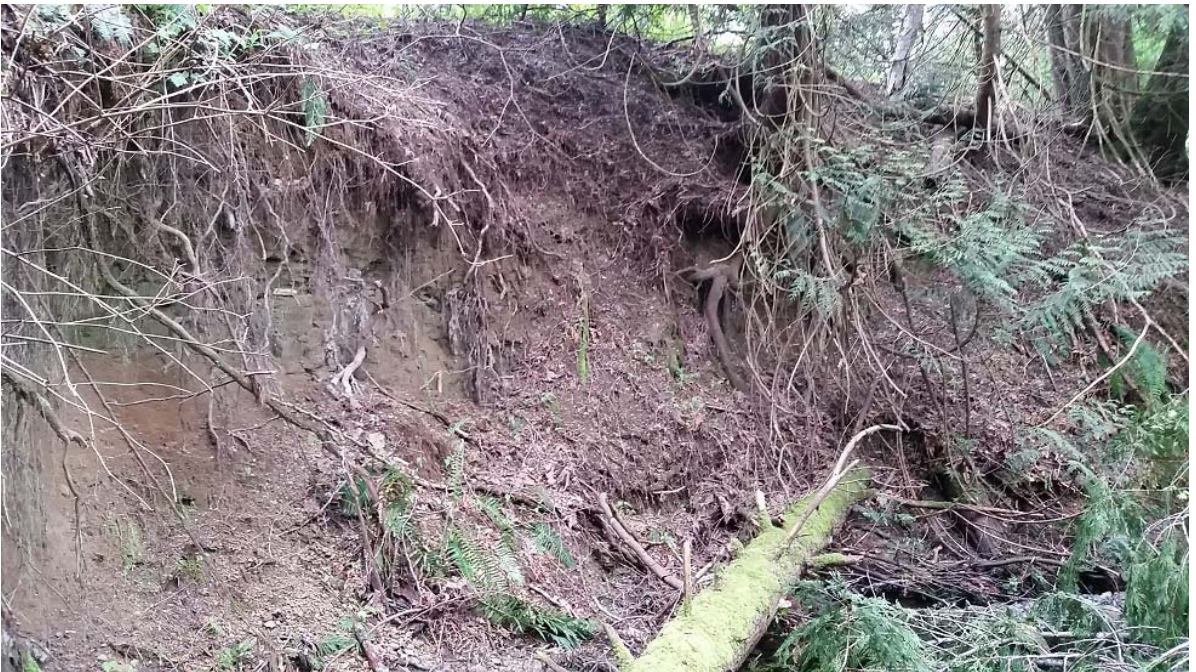
20-Erosion	Left bank erosion in the middle section of the creek.	The banks should be reviewed periodically for potential changes in erosion rates.	Low	None
	20-Bridge	Woody debris is accumulating under low clearance of amateur footbridge.	The bridge should be removed or replaced. Accumulated debris should be removed.	Low	None
	20-Pond	Man-made pond discharges onto a fish ladder that flows through a culvert installed in ravine fill. Potential risk to downstream highway and Railway crossing in the event of a pond overtopping or damn breach.	The stability of the fish ladder and associated ravine fill should be reviewed. An assessment of the pond structures should be carried out. Develop an operation and inspection plan for the pond.	Medium	Flows to the 99A Ave outfall to Leoran Brook to be maintained at or below existing conditions. The stability of the existing driveway culvert and fish ladder to be reviewed. A new outfall to be installed immediately downstream of the existing Culvert / Fish Ladder as part of the storm upgrade required at 99A Avenue

Photo 4. (WP20-EROSION) Leoran Brook (middle section). View of left bank erosion and woody debris

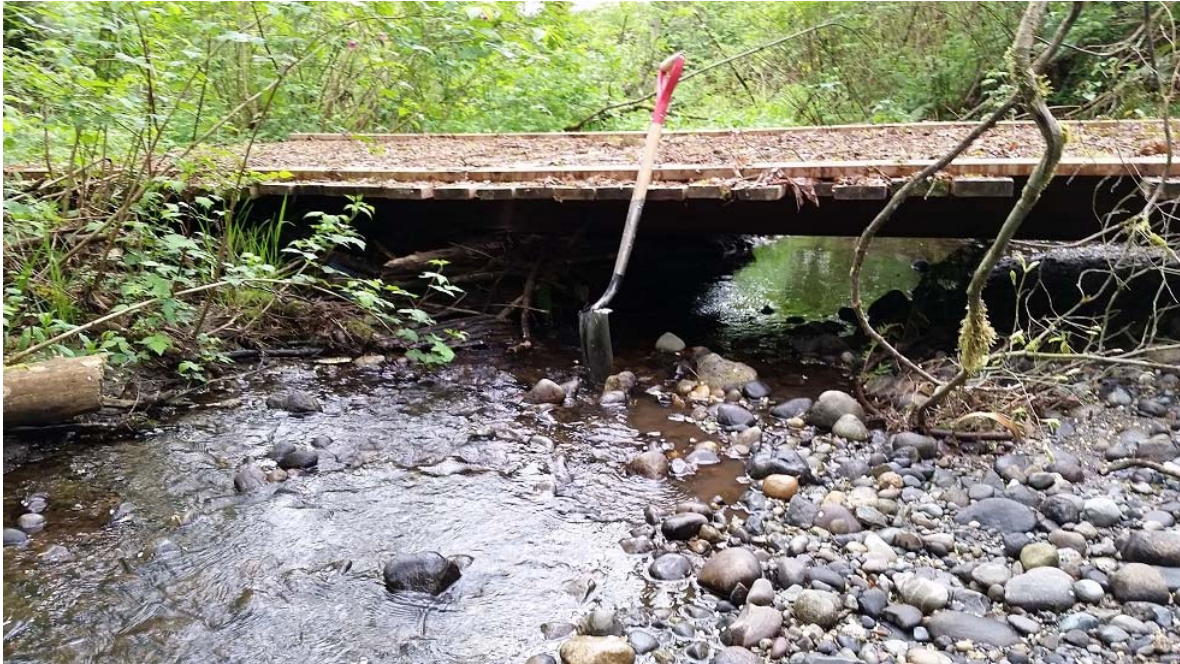
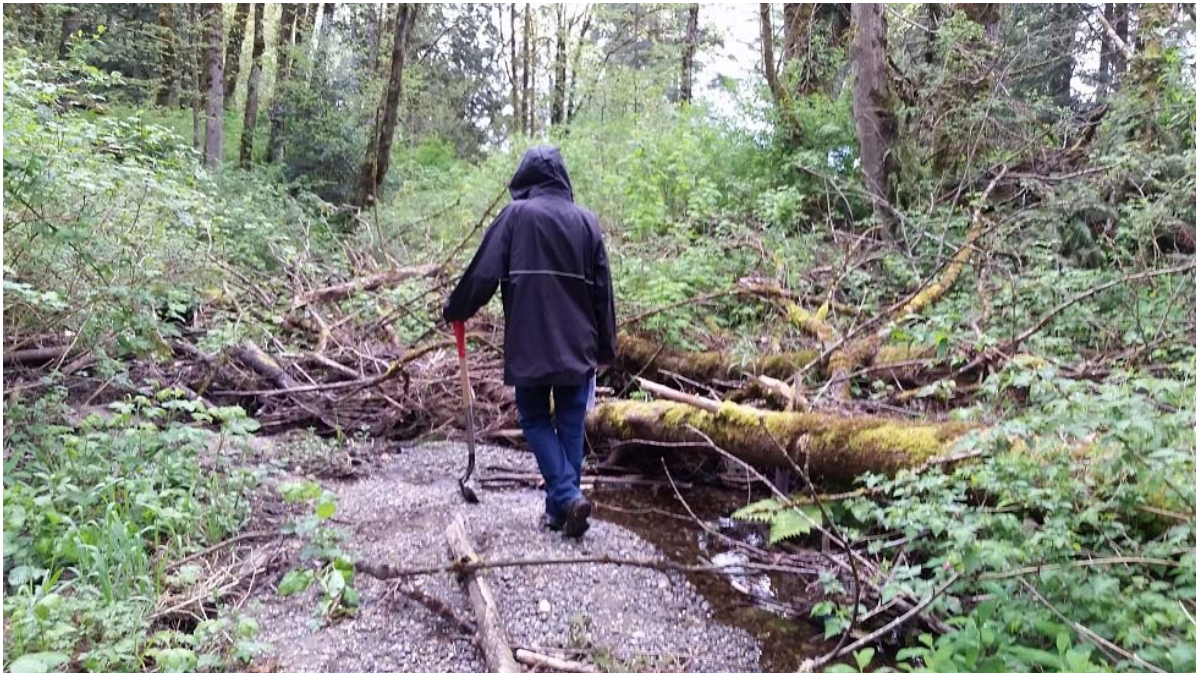
**Photo 5. (WP20-BRIDGE).** Leoran Brook (middle section). View of amateur footbridge crossing with woody debris accumulating under the bridge against the stringers.

**Photo 6. (WP20-BRIDGE).** Leoran Brook (middle section). View of woody debris accumulation and aggrading stream channel approximately 25m upstream from man-made pond.

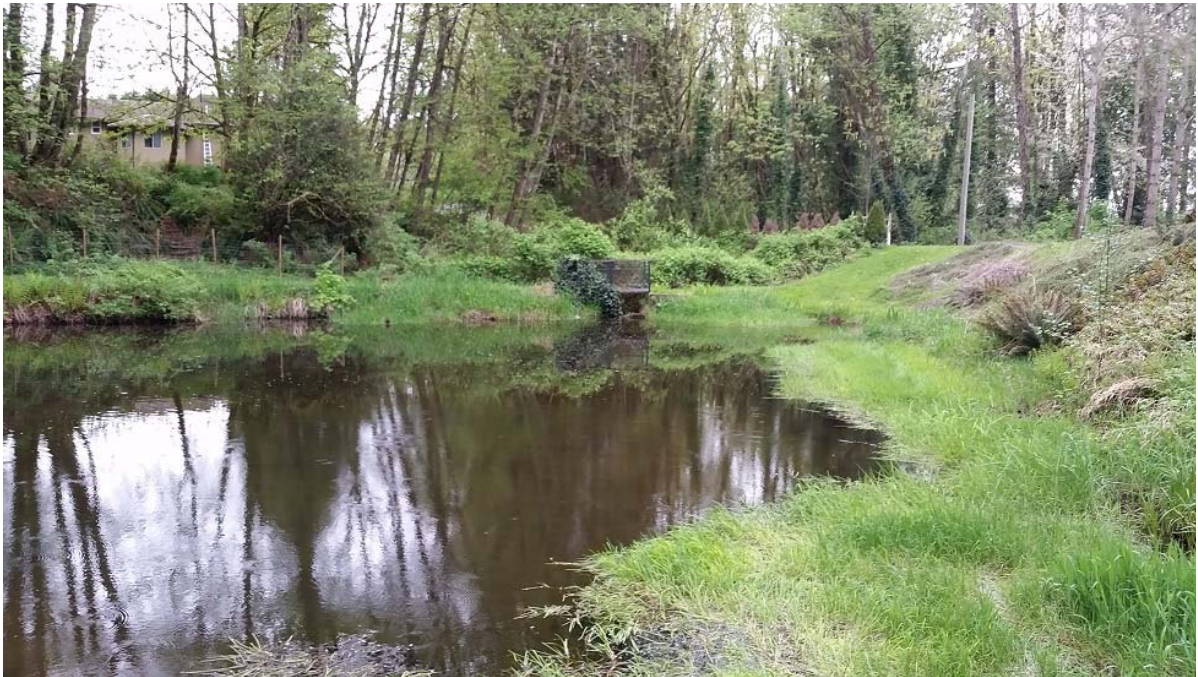
**Photo 7. (WP20-POND).** Leoran Brook (middle section). View of man-made pond. Outfall wiew with fish ladder structure visible at centre of image.

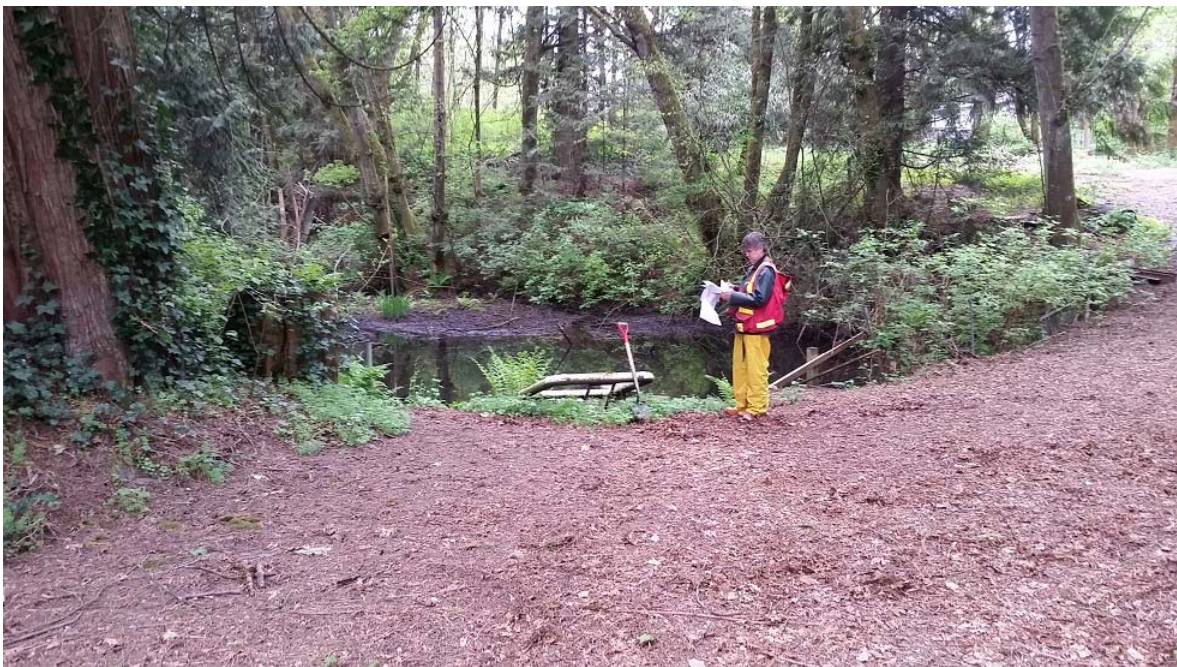
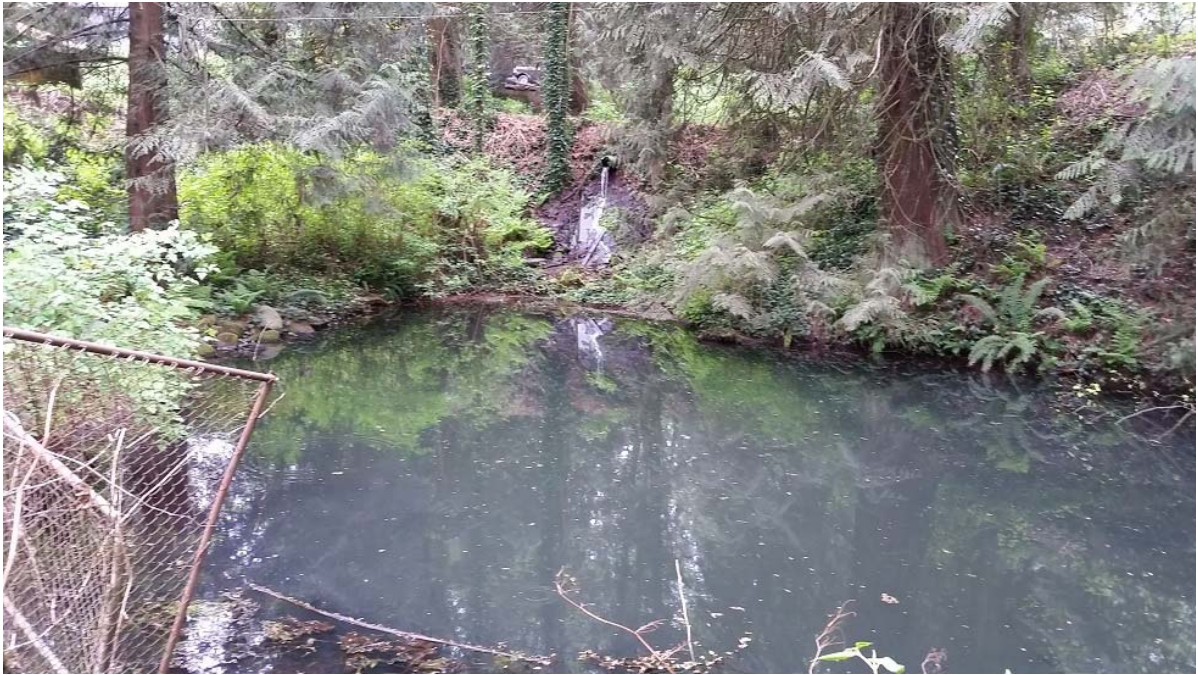
Location	Site ID <sup>1</sup>	Existing Conditions	Recommendations	Risk	Considerations during Future Development
Lyncean Creek East	19-14	A 7m high dam behind the property at 9999 179 Street creates a pond. A second dam to the north creates another pond. The main pond trash rack is damaged and partially clogged with debris. These dams are located on private property.	Geotechnical exploration and assessment of the existing fills and dams should be undertaken. Develop an operation and inspection plan for the pond.	High	No additional flows to this section of the Creek. Maintain or reduce discharge rates and volumes at this location.
	19-2	Over-steepened rip rap slope at west side of 179 Street culvert crossing (1H: 1.5V). Erosion below the Lock-Block wall causing undermining.	The condition of the rip rap should be reviewed periodically and repairs completed if required. Erosion below the Lock-Block wall should be reviewed and repaired as needed. Additional fill and/or slope reconfiguration should be completed.	Medium	Repairs should be made to the culvert inlet and outlet prior to any increase in flows at this location from upstream development.

**Photo 8. (WP19-14).** Lyncean Creek East. View of upper pond (access road ravine fill). Culvert trash rack partially clogged with debris

**Photo 9 (WP19-14).** Lyncean Creek East. View of main pond showing flow from upper pond through access road ravine fill. Main pond trash rack damaged and partially clogged with debris.

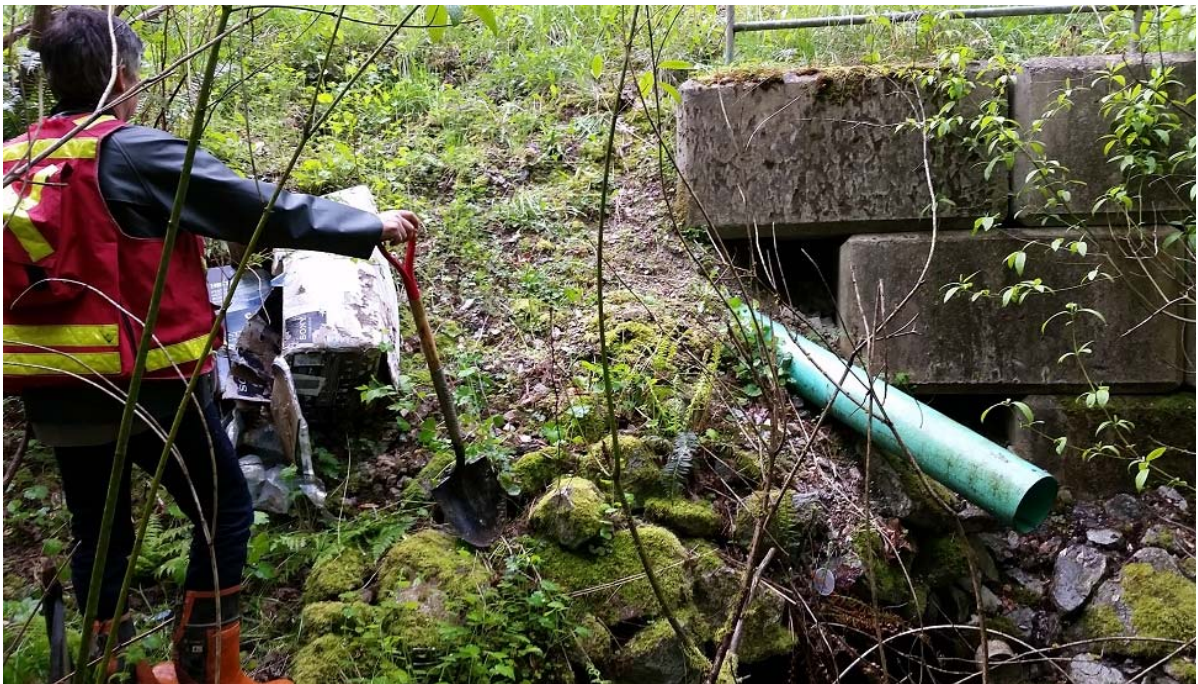
**Photo 10 (WP19-2).** Lyncean Creek East (179 Street culvert crossing). View of 200mm pipe draining northbound roadway scupper and Lock Block retaining wall erosion.

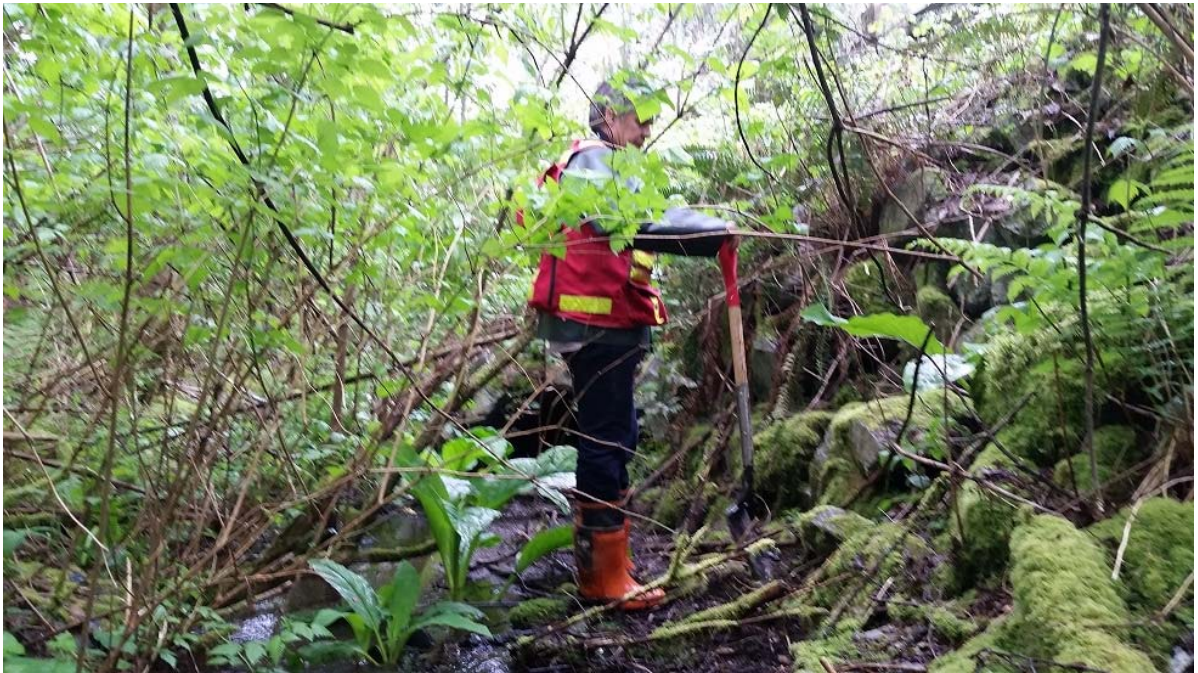
**Photo 11. (WP19-2).** Lyncean Creek East (179 Street culvert crossing). View of over-steepened rip rap slope at inlet culvert crossing

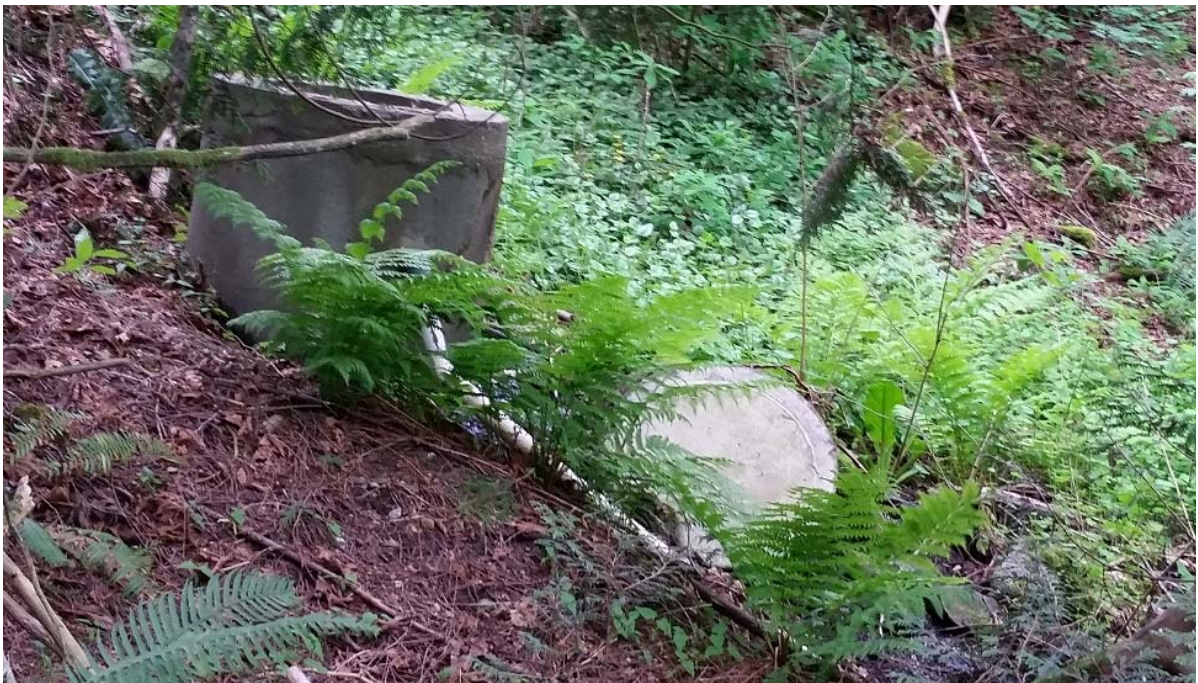
Lyncean Creek West	18-Fill / Sump	Dumping of residential garden waste was observed at intersection of 100 Avenue and Lyncean Drive.	Residents should be informed of potential damage if uncontrolled dumping continues.	Low	None
	18-4	Bank erosion above culvert at 100 Avenue and Lyncean Drive.	The replacement of the culvert should be carried out if its current design is considered inadequate.	Low	None
	18-3	A tree located southeast of 17780 100A Avenue has water flowing below it.	The tree should be reviewed by an arborist and removed if deemed unstable.	Low	None
	18-Soldier Piles	Soldier piles had been installed to stabilize the bank at the industrial property at 10095 179 Street.	The slopes should be assessed for long term stability under static and seismic loading conditions.	Low	None
Centre Creek	Centre Creek	Minor erosion in a short reach between 103 and 104 Avenue along 172 Street.	The banks should be reviewed periodically for changing conditions.	Low	None

**Photo 12. (WP18-FILL/SUMP).** Lyncean Creek West (East Tributary). Small scale stormwater control structure (vandalized) flowing approximately 5gpm.

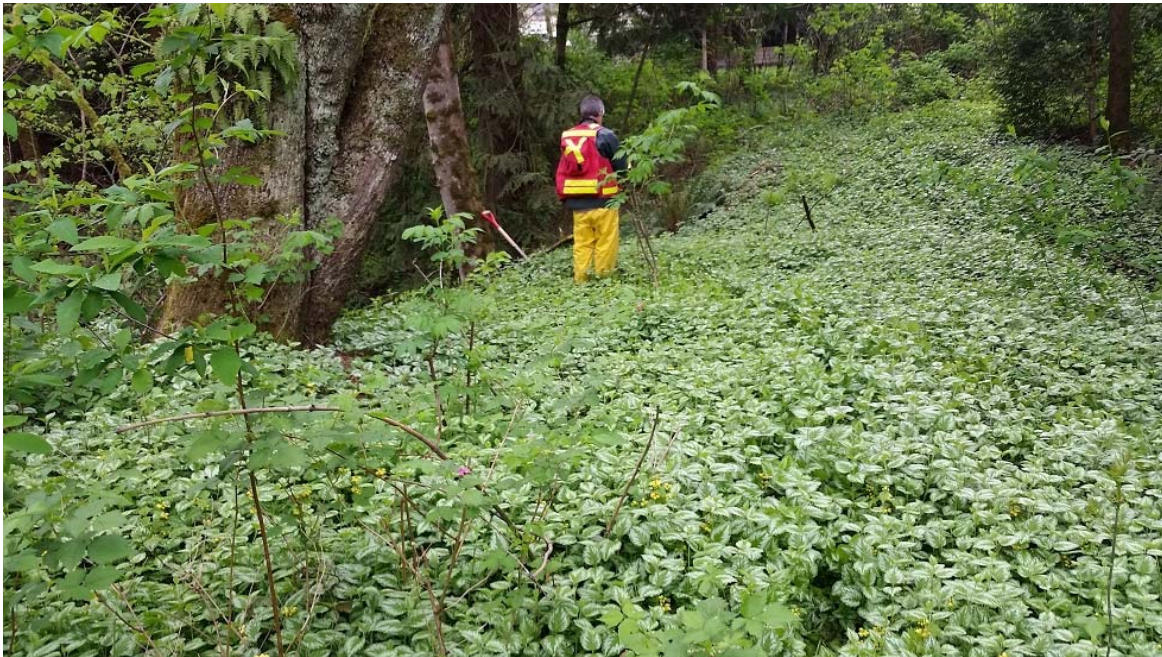
Photo 13. (WP18-FILL/SUMP). Lyncean Creek West (East Tributary). Ravine Fill with High/Low Inlet Culverts

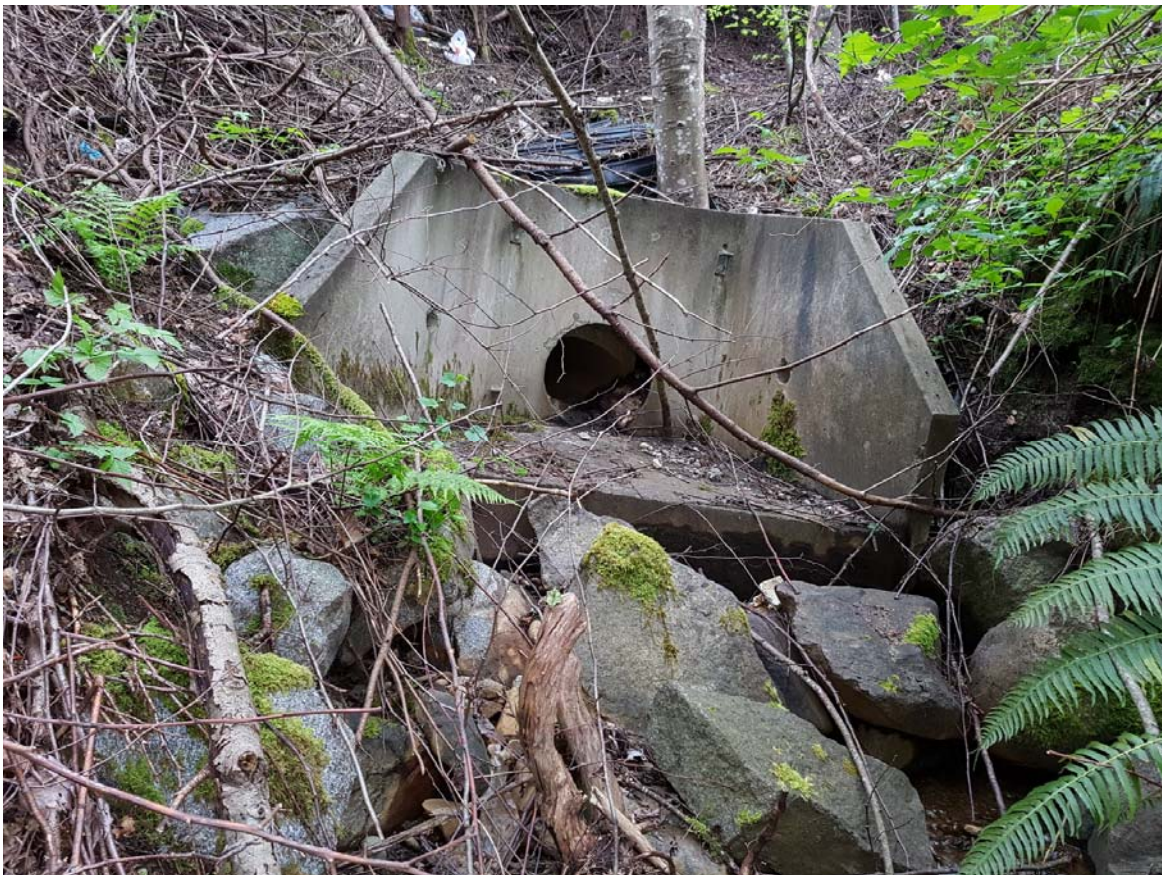
Photo 14. (WP18-4). Lyncean Creek West (West Tributary). Undermined Culvert Headwall at 100 Ave & Lyncean Drive.

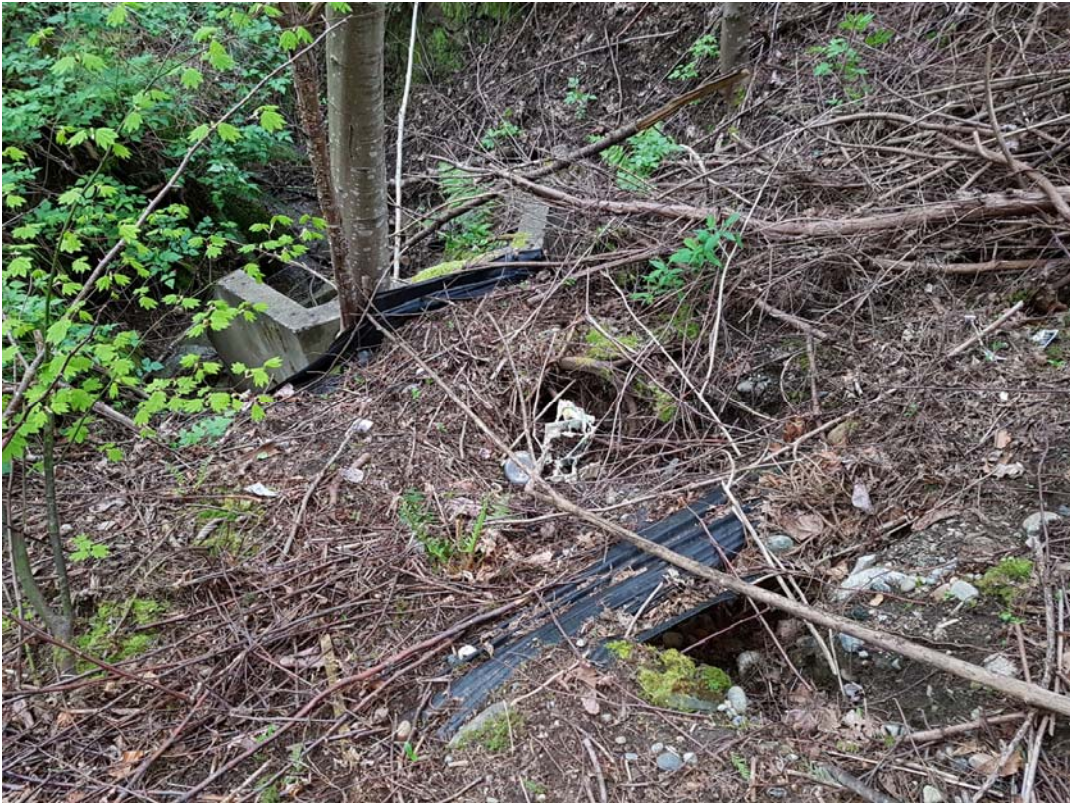
Photo 15. (WP18-4). Lyncean Creek West (West Tributary). Bank Erosion Above Culvert at 100 Ave & Lyncean Dr.

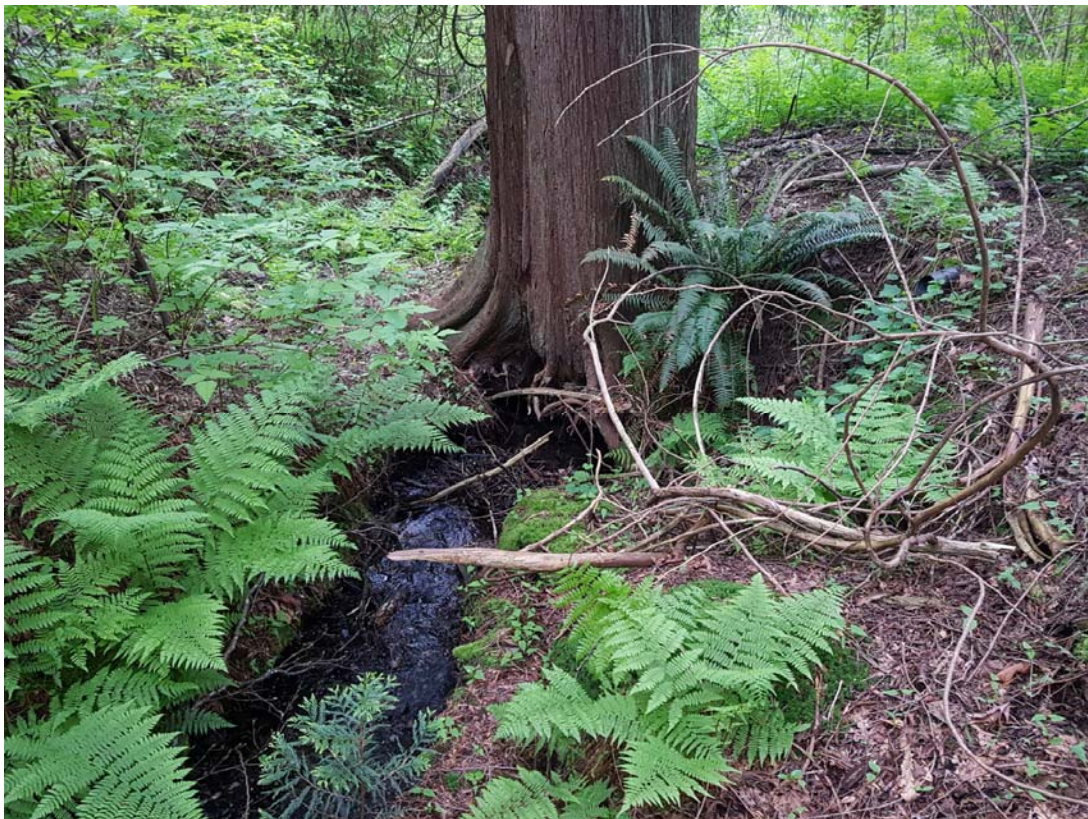
Photo 16. (WP18-3). Lyncean Creek West. Tree With Water Flowing Below East of 17780 100A Ave

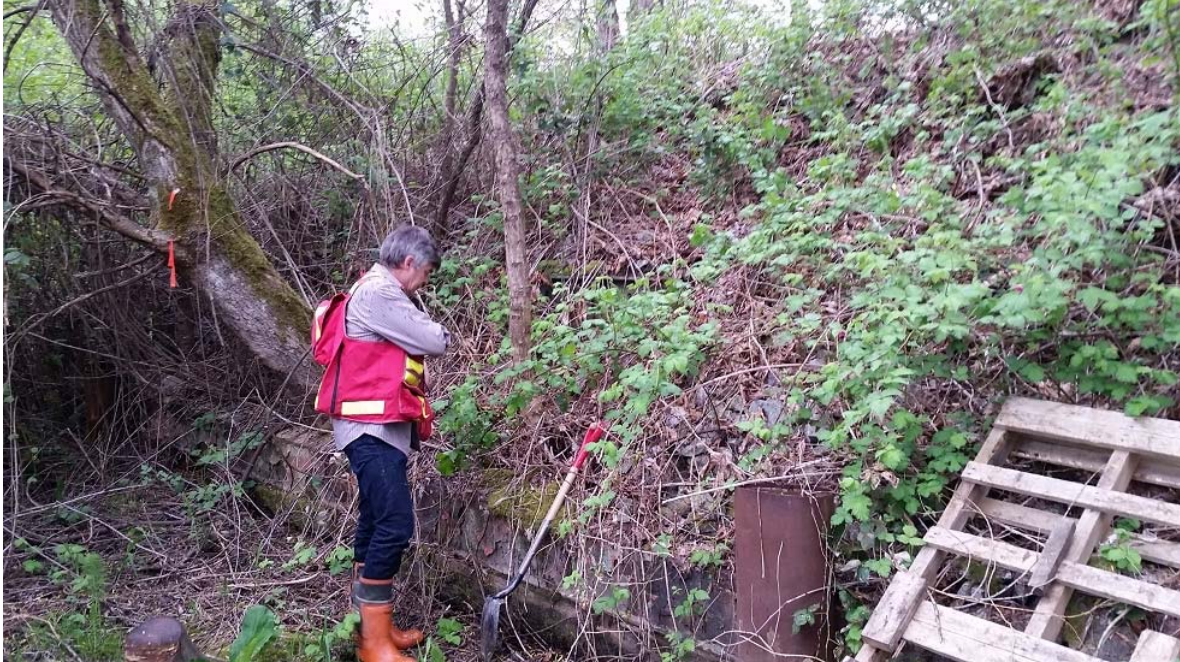
**Photo 17. (WP18-SOLDIER PILES).** Lyncean Creek West. View of left bank tiered soldierpile walls (~300mm steel pipe piles with various metal lagging).

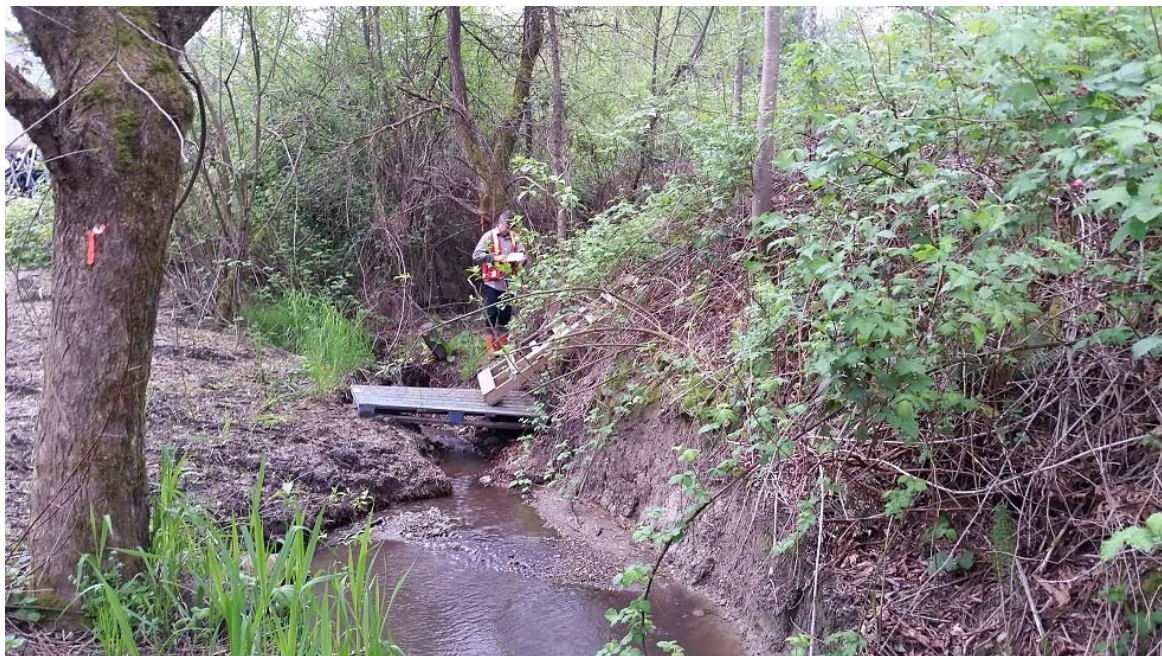
**Photo 18. (WP18-SOLDIER PILES).** Lyncean Creek West. View of right bank fill and near vertical (excavated) left bank slopes

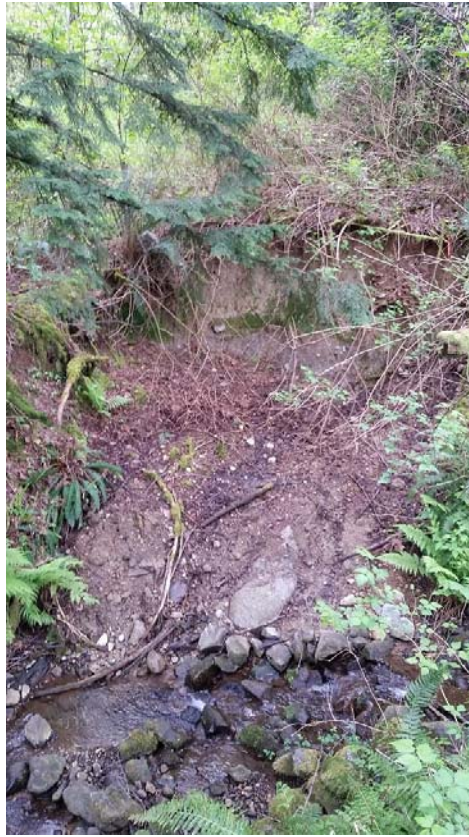
**Photo 19. (WP CENTER CREEK).** Centre Creek. Right Bank erosion and slide scar (~15m<sup>3</sup>). Age of event ~5-10 yrs

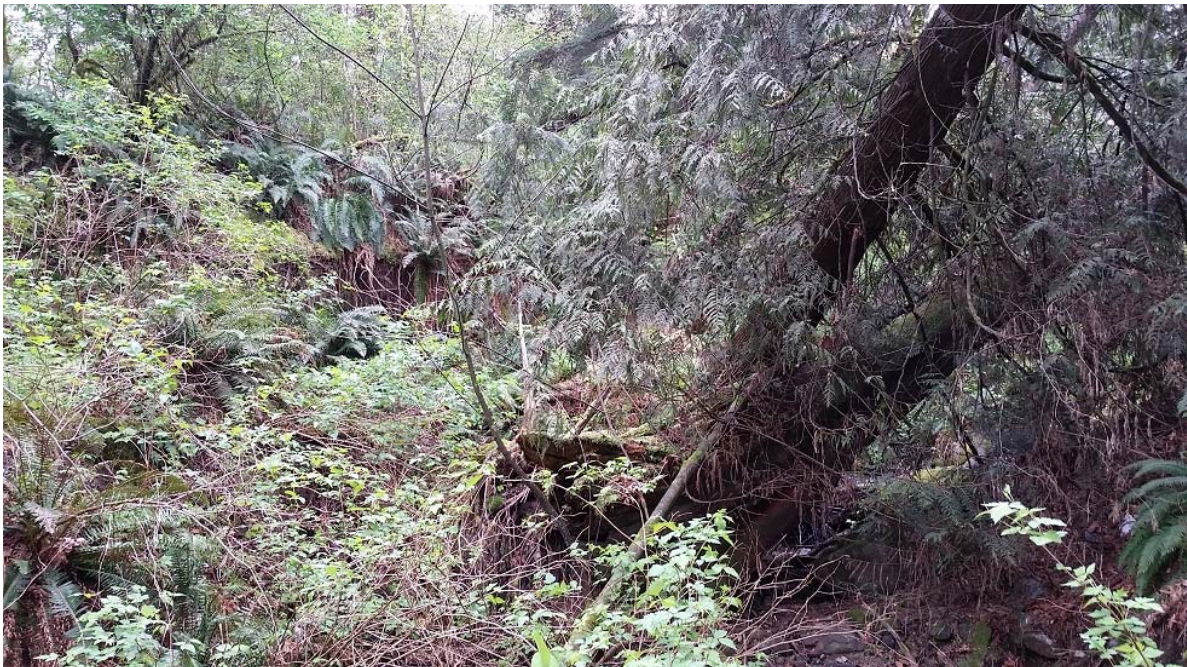
**Photo 20 (WP CENTER CREEK).** Centre Creek. View of Left Bank erosion and topple of 2 large trees. The older topple ~5-6 yrs ago based on tree top growth, the younger topple recent (<1 yr ago).
