ADDENDUM No. 1

REQUEST FOR QUOTATIONS (RFQ) No.: 1220-040-2020-040

TITLE: BRIDGEVIEW COMMUNITY CENTER – PARKING
LOT REHABILITATION AND UPGRADES

Re: Geotechnical Pavement Assessment
for Bridgeview Community Center Parking Lot
11475 126a St, Surrey, BC

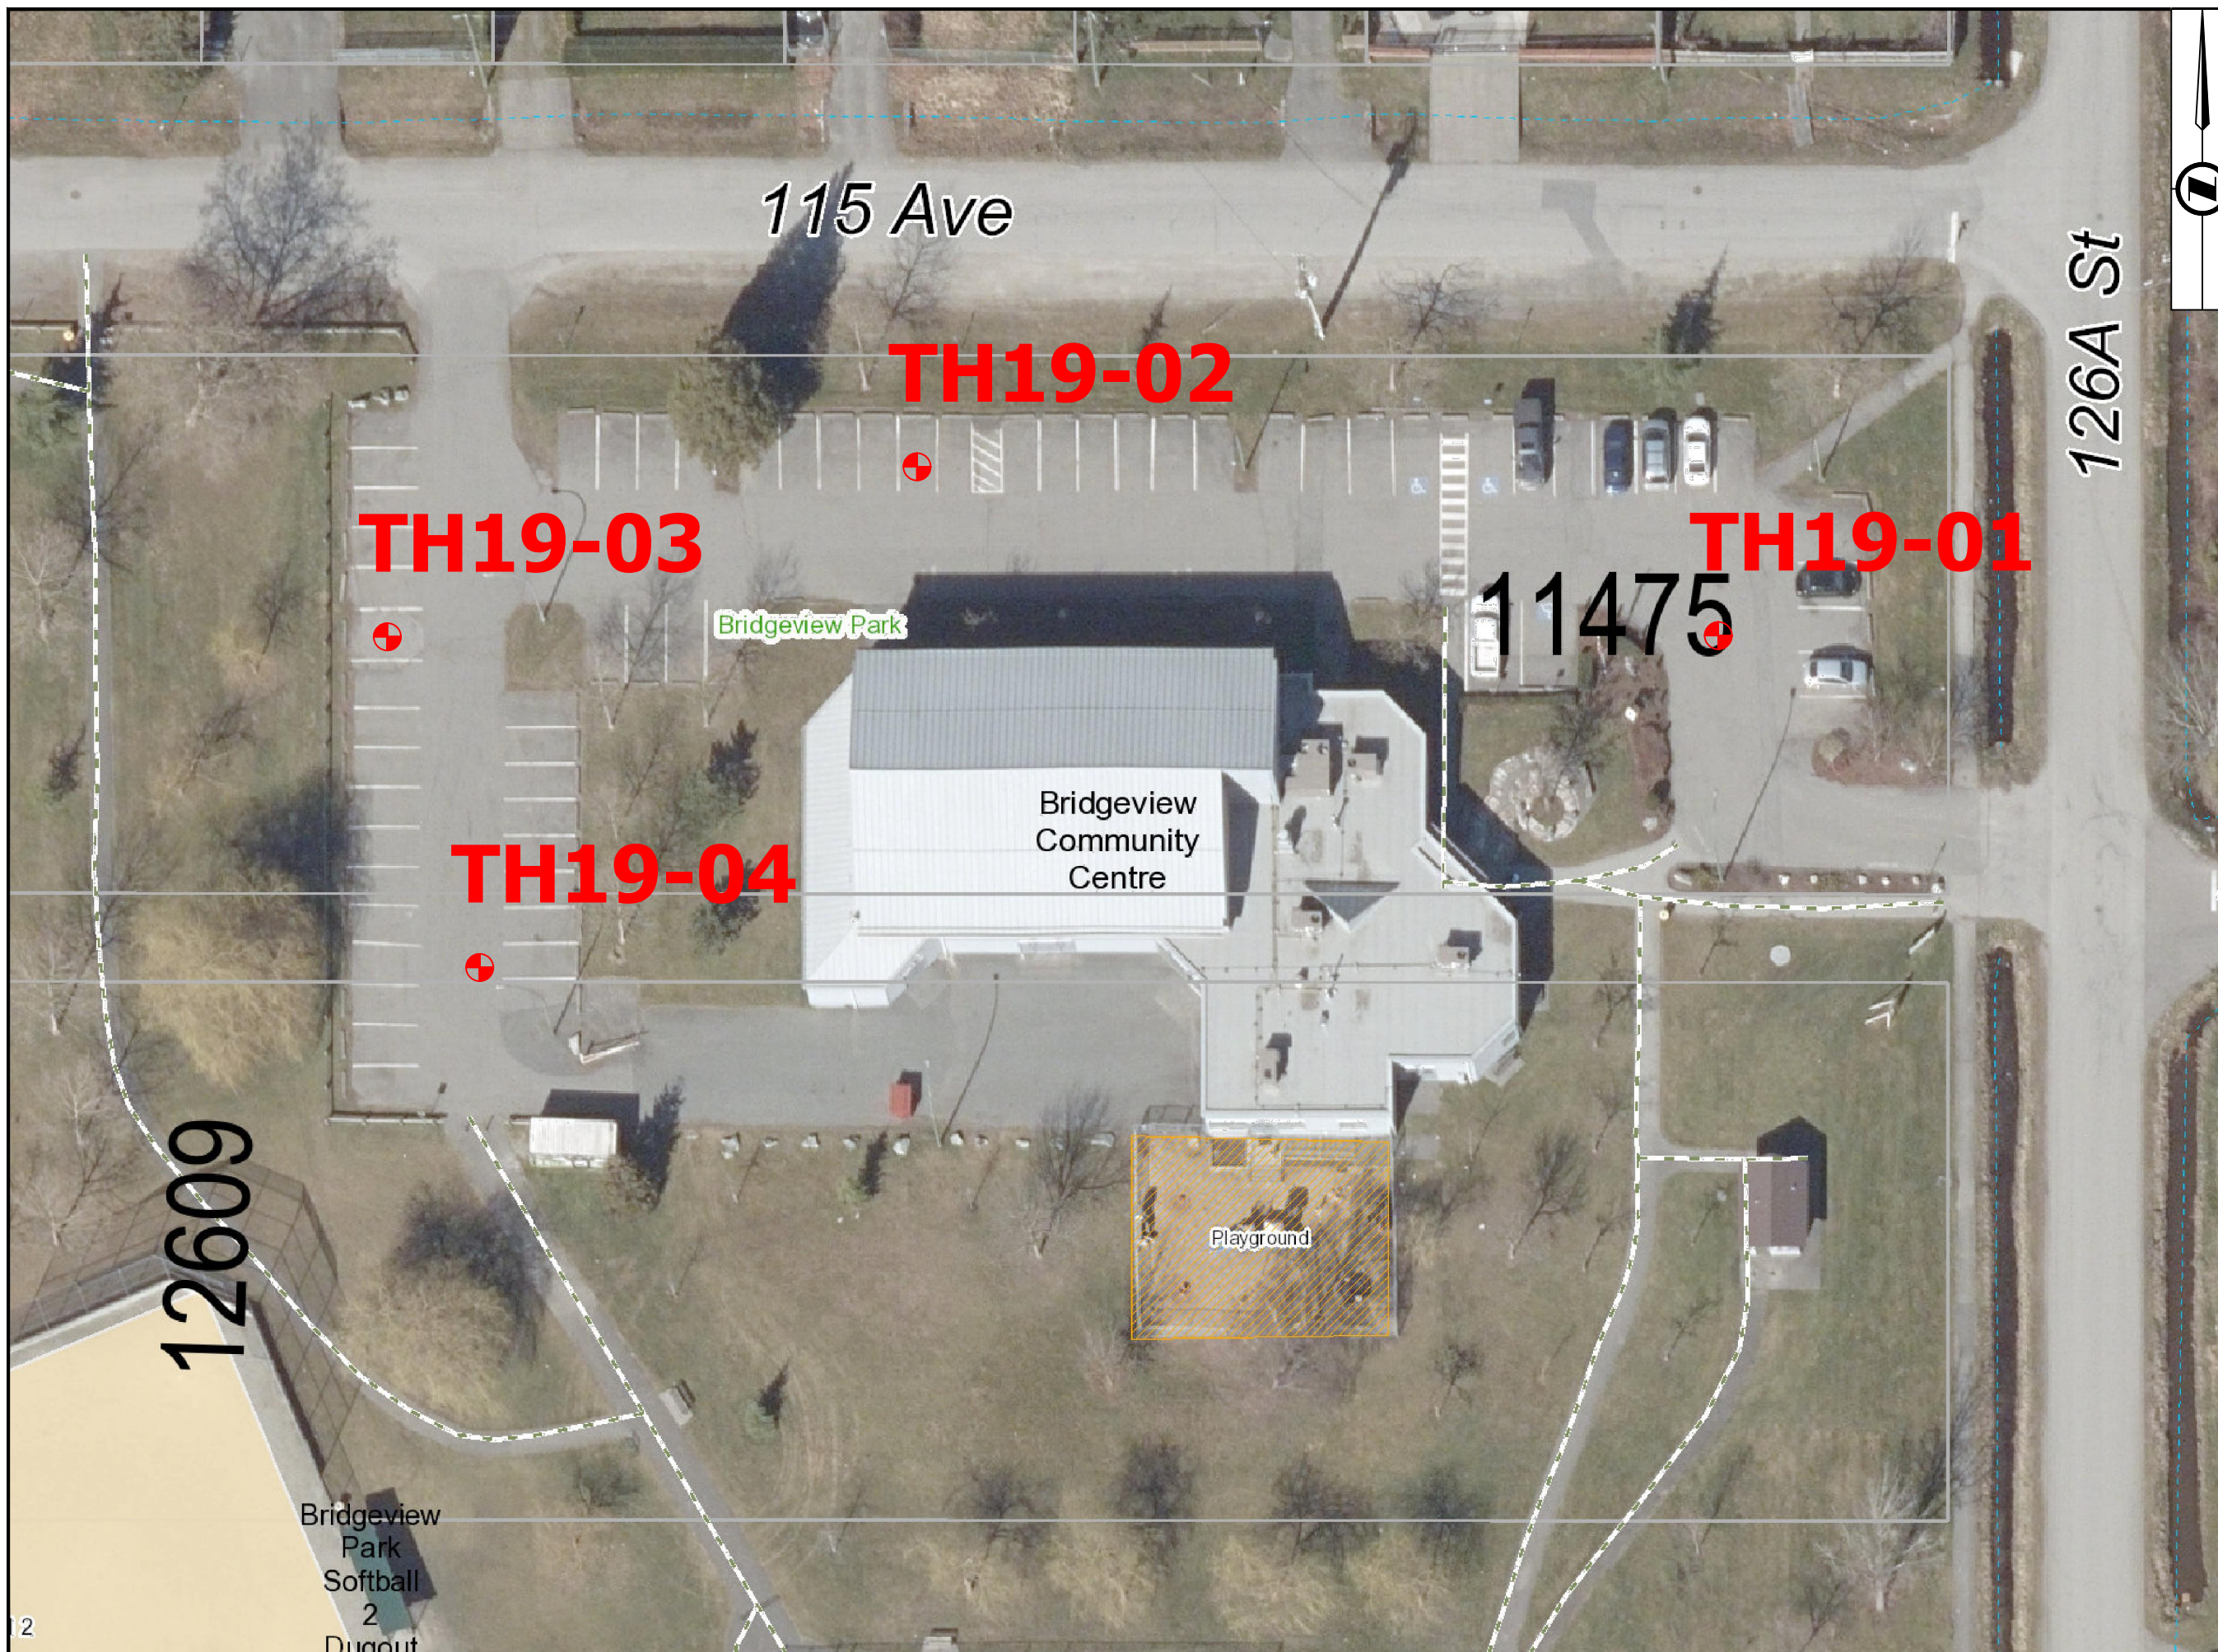
Drawing Number:	Figure 1
Project Number:	WF32002
Date of Original Drawing:	Sep 10, 2019
Date of Latest Revision:	Sep 10, 2019
Revision Number:	0
Designed By:	GM
Drawn By:	GM
Scale:	NTS

Test Hole Location Plan
 Bridgeview Community Center Parking Lot

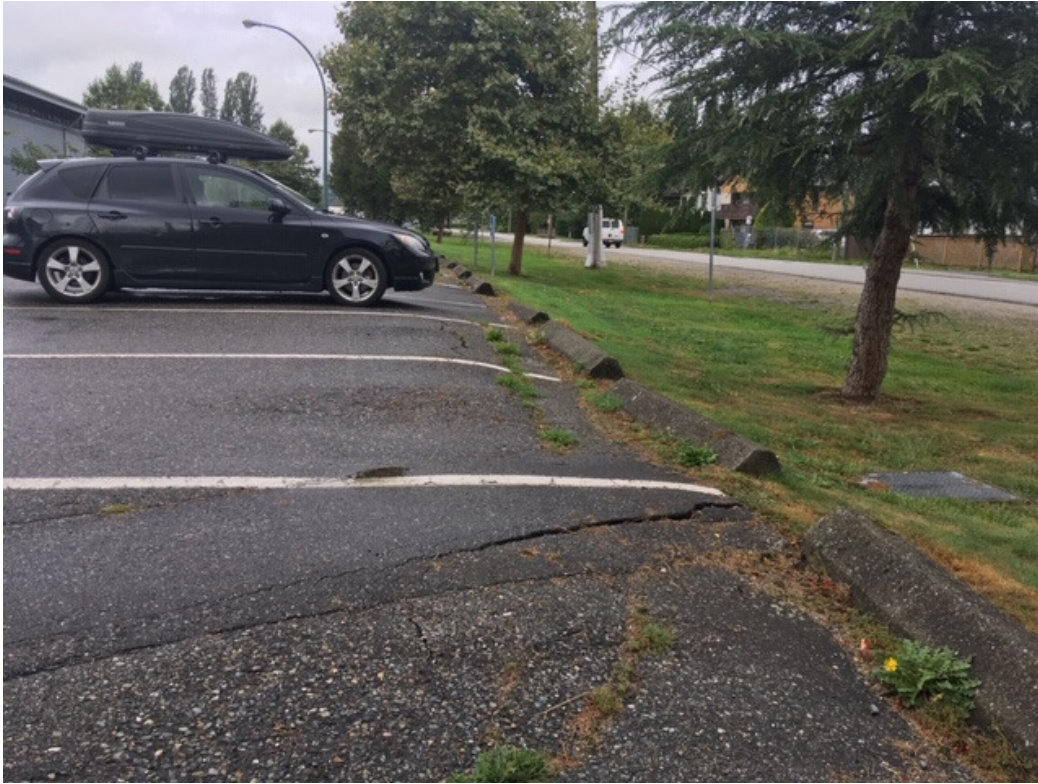
- The pavement is in poor to fair condition with intermittent sections of alligator cracking and distortions and settlement of the outer perimeter of the parking stalls (See attached Figures).
- The asphaltic concrete in this parking lot is about 40mm to 60mm thick with variable sources of base gravel or limestone crushed sand and gravel that was found to range between 385mm and 540mm thick. Underlying this pavement structure, a 350mm to 450mm thick layer of hogfuel fill was encountered in each of the four test holes. Beneath this layer of hogfuel fill, a soft, wet organic silt was encountered to the maximum depth investigated. Moisture content in this layer were found to range between 111% to 337%

Figure 1: Central Parking Lot looking west.

We recommend the existing asphalt shall be removed and it should be regraded with 50mm of additional 19mm minus base gravel and repaved with 85mm of asphalt, in two lifts. Following the placement of the additional gravel, the exposed base gravel surface should be compacted and proof rolled. Localized soft areas should be sub-excavated and replaced with compacted gravel. The anticipated service life expectancy will be improved, compared to the original pavement structure after it was first built, however some ongoing consolidation of the underlying soft soils should be anticipated over time. In order to mitigate further differential settlement in the outer perimeter of the parking stalls, the base gravel fill should be extended laterally, equal to the thickness of the existing fill. All engineered fill should

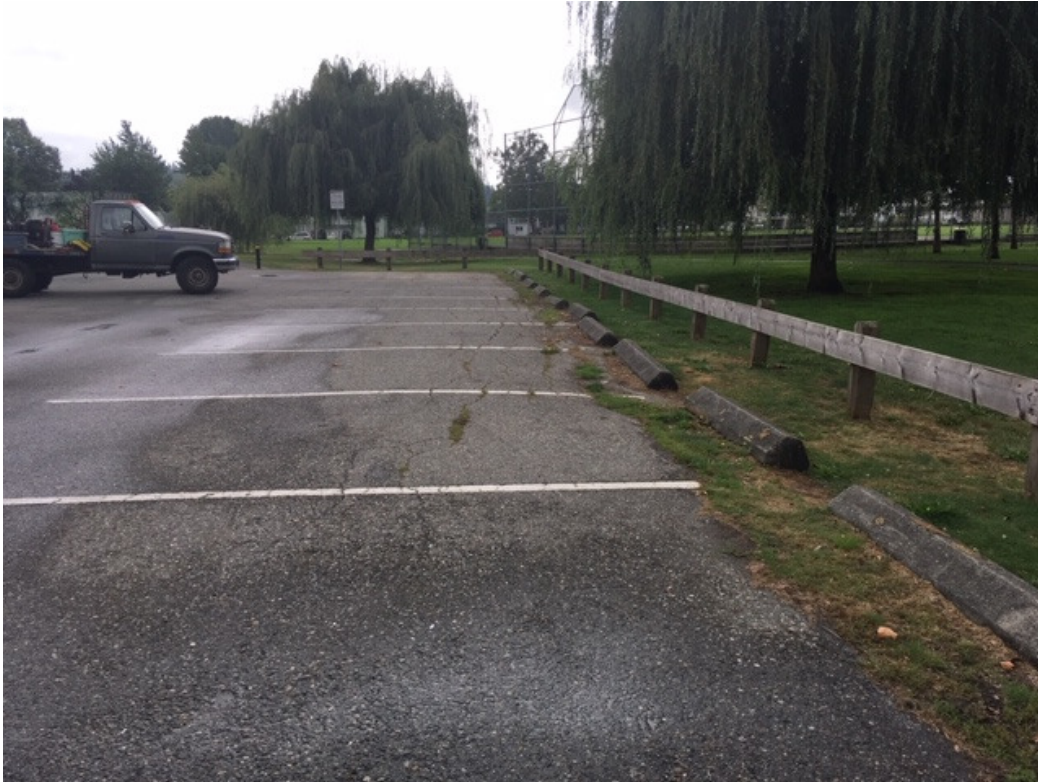
Figure 2: West parking lot, looking south

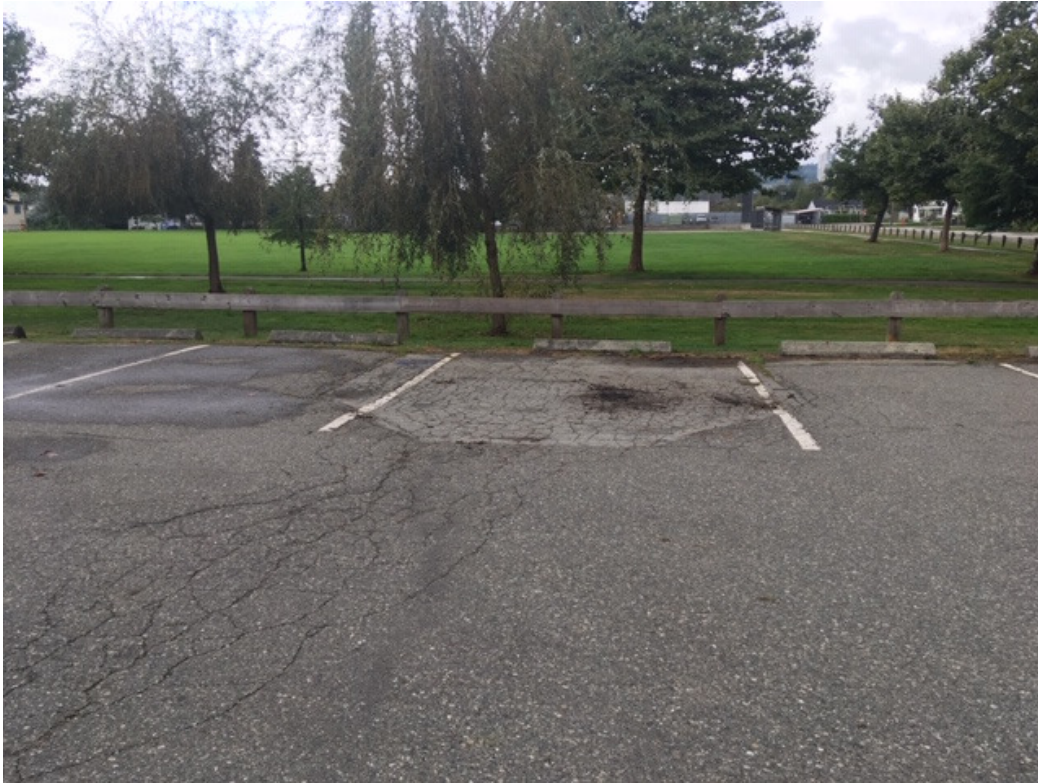
Figure 3: West parking lot, looking west

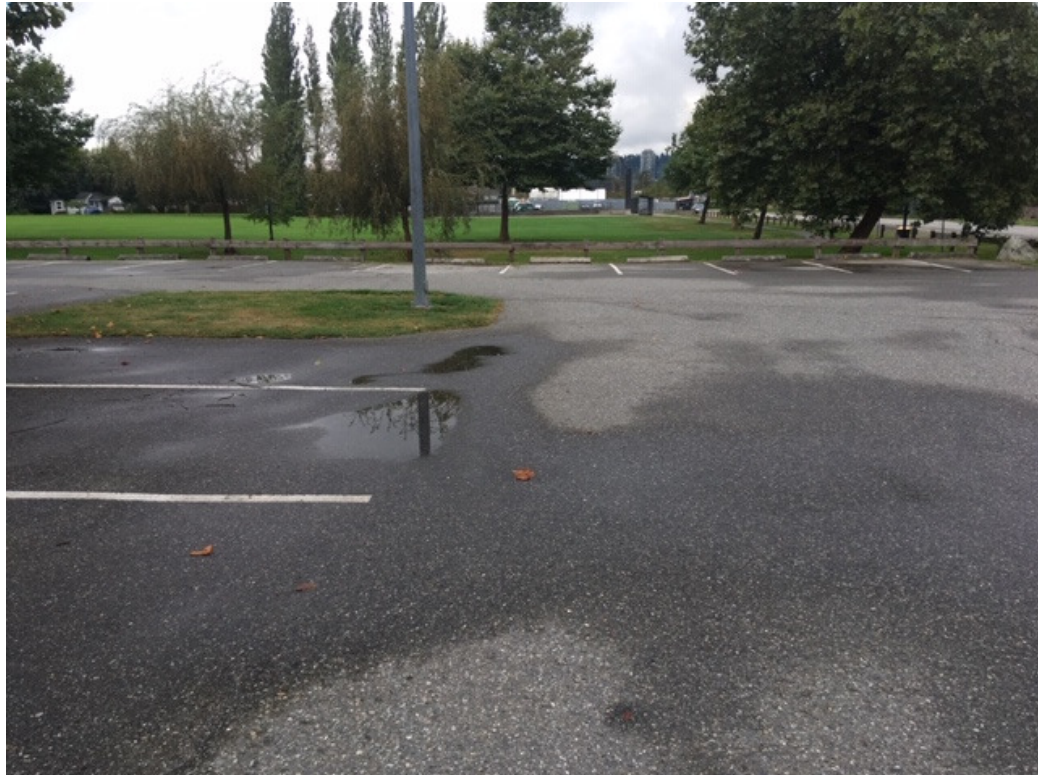
Figure 4: Center west parking lot, looking west
