# City of Surrey PLANNING & DEVELOPMENT REPORT File: 7912-0080-00

Planning Report Date: November 5, 2012

# BROOKSDALE ESTATE

19353 16<sup>th</sup> Avenue, Surrey Conservation plan

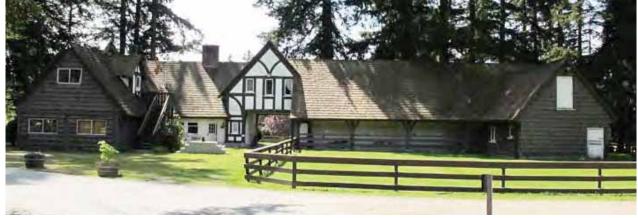
North elevation

The wood-framed walls of the Coach House are clad in large cedar shingles, with stucco and half-timbering in the gable ends of the north and east elevations. The north elevation features stucco cladding at the building's northeast entrance and wooden lapped siding along the former stables. The building also features several front-gabled dormers with stucco and half-timbering detailing. The shingles, stucco, and wooden elements are in good condition, however, the environment has had an effect on the original materials, and areas of biological growth are evident throughout the building. Most walls show some wear, though the majority of damage appears cosmetic and can be easily remedied with proper maintenance. Due to water splashback and adjacent vegetation, wood siding located close to grade is slightly more deteriorated; siding located adjacent to drainpipes is also more deteriorated. Non-intrusive design interventions, such as a landscape rock bed, could prevent further deterioration. This is especially important on the northeastern elevation, in order to address pressing drainage concerns.

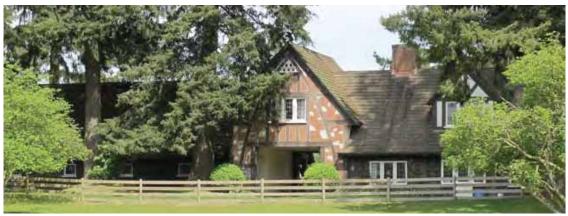
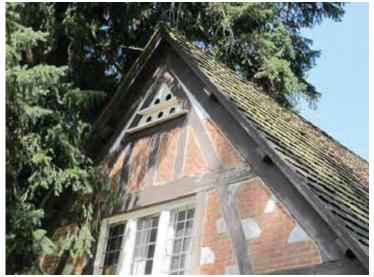
South elevation gable end detail

The gable end on the south elevation of the Coach House features brick, in a herringbone pattern in some sections, half-timbering and stone, in contrast to the stucco that is found in the other gable ends of the building. This unique design detail is prominent, as it faces the site's current access driveway. The south elevation gable end also features the typical Tudor Revival-style half-timbering detailing, which is similar to that which is found on the other gable ends.

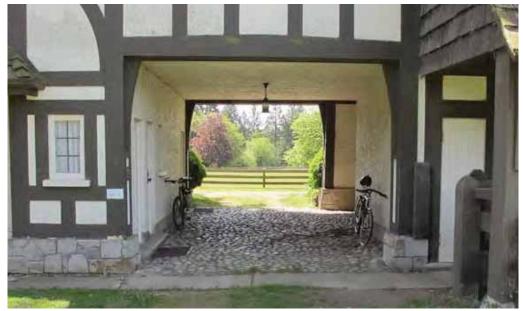
Tunnel, looking south

The carriage tunnel that passes through the centre of the Coach House features stucco walls and ceiling, granite stone foundation at the entrance, and a cobblestone pathway. There is also a hanging light fixture near the centre of the tunnel.

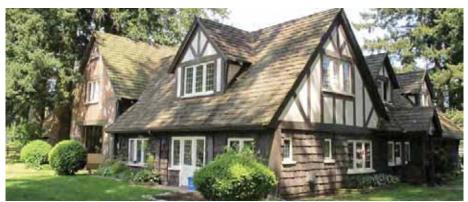
Original windows on the south and east elevations

Most window openings on the Coach House feature original frames, sashes and single glazing, although some replacement windows are extant on the northeastern elevation. All incompatible/non-original windows should be replaced with new, wooden assemblies, including the frame, sash and sills, which are compatible in size, material, and design to the original windows present on the building. Original windows should be preserved and repaired, as necessary, which includes the broken window panes on the south elevation.

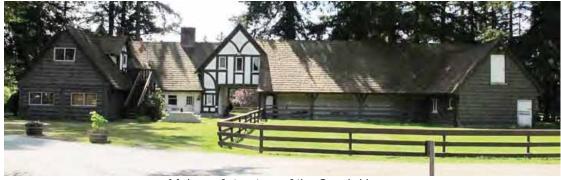
Main roof structure of the Coach House

The original roof design of the Coach House consists of a main side-gabled roof structure bookended by two front-gabled wings, resulting in a squared capital 'C' shape from above. The roof structure also features several front-gabled dormers with stucco and half-timbering detailing. The main structure is intersected through its centre by a front-gabled carriage tunnel with living quarters above. The original roof remains intact and the cedar shingle covering in good condition. Signs of biological growth and a heavy covering of pine needles exist on parts of the roof. There are two internal red brick chimneys, which should be preserved, cleaned and rehabilitated, as necessary.

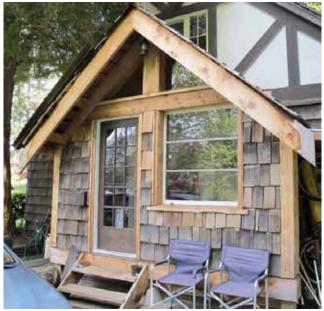
The south elevation entryway was recently adapted into an addition. This addition can remain because it enhances the livability of the cottage, however, some rehabilitation work is necessary to better integrate the addition into the historic fabric of the structure. The door and window should more appropriately match the originals that remain intact on the building. The bargeboards, cornerboards and shingles should be painted or stained to match the original sections of the cottage. The original brick entry stairs should be extended with new or salvaged red bricks in order to match the entryway on the north elevation, along with other entryways on the other Brooksdale Estate buildings. The brick extension should provide enough coverage to fill the void under the addition.

South elevation entryway addition: door, window, bargeboards, cornerboards and shingles should more closely match the remainder of the cottage

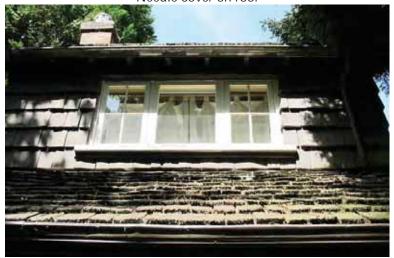
The front-gabled roof structure of the Caretaker's Cottage is original and is clad in cedar shingles. There is a shed roof dormer on both the west and east elevations. The roof appears to be in fair to good condition; however there is a significant amount of needle cover on the southwest corner. The addition on the south elevation is not original and will be rehabilitated to more closely match the historic appearance of the cottage. There is an internal brick chimney near the centre of the cottage that appears to be in good condition.

East elevation shed roof dormer with interior brick chimney on upper left
