CITY OF SURREY

Anniedale-Tynehead NCP Area Wetland Inventory and Watercourse Assessment

October 2020 - Final - 20-2332

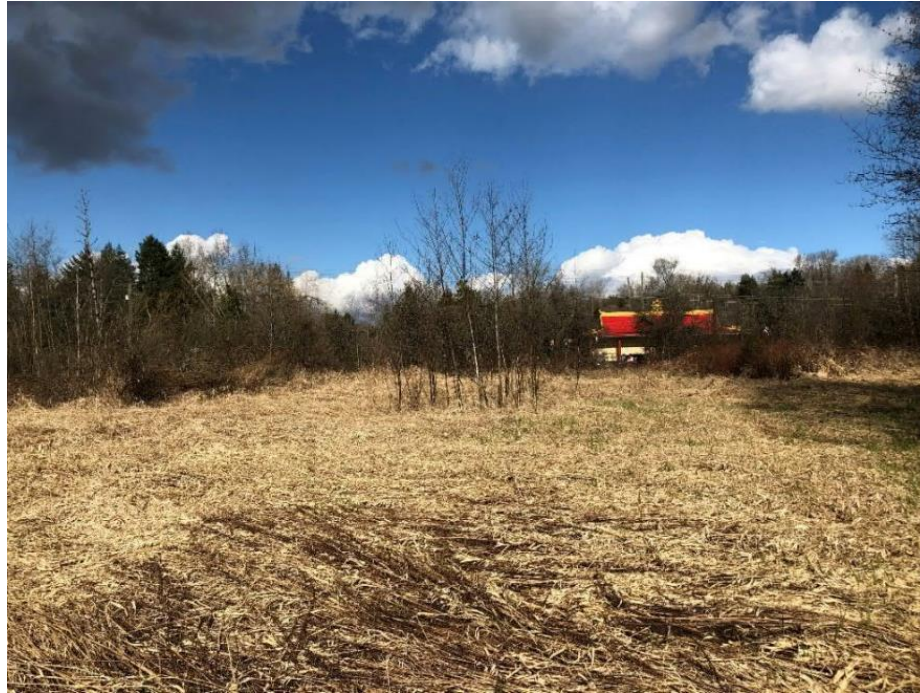
Photo 1: Reed canary grass wetland at W3, 16836 94A Avenue.

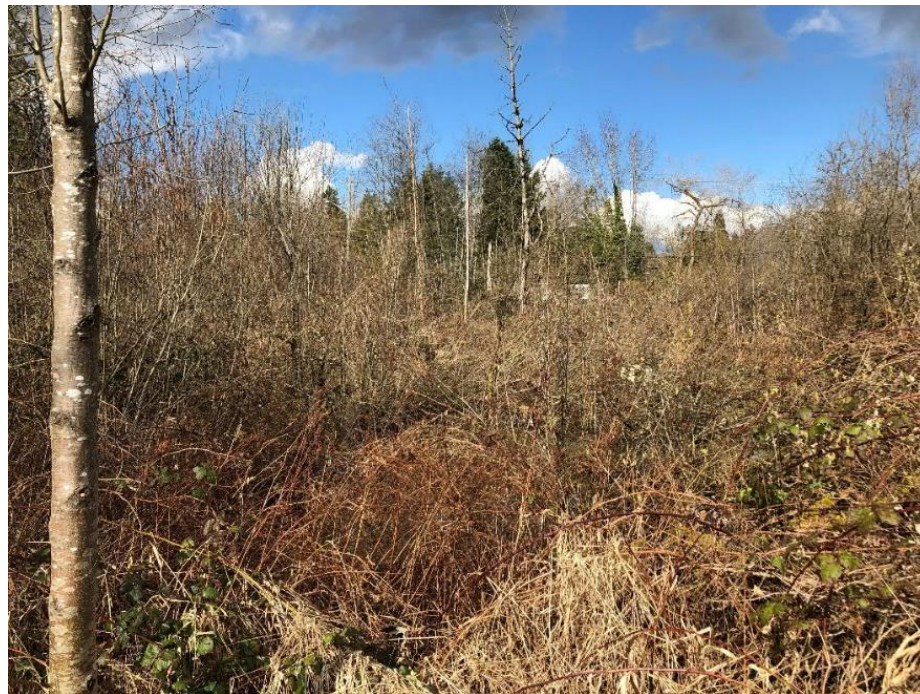
Photo 2: Confirmed wetland at W3, 16836 94A Avenue along Class A watercourse on western boundary of property.

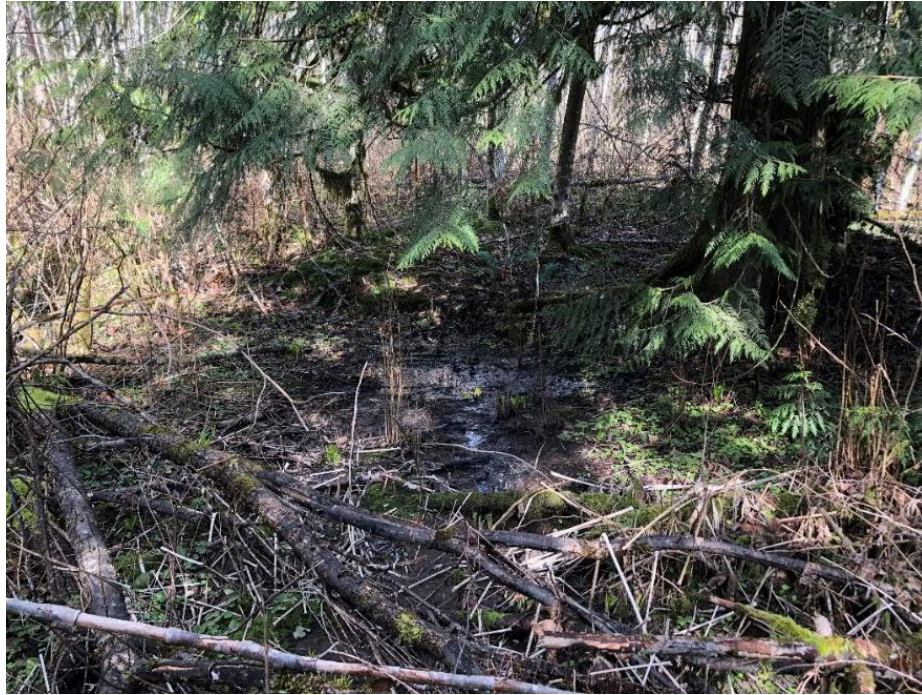
Photo 3: Swamp wetland at W8, 17734 92 Avenue

| Wetland Site ID | Address | Wetland Presence Confirmed (yes/no) | Soil Sampling Conducted (yes/no) | Outflow / Inflow | General Characteristic on Vegetation and Location |
|---|---|---|---|--|---|
| W8 | 17734 92 Avenue | Yes | No | No distinct outflow channel. Inflow from diffuse seepage along the steep north bank with scouring rush. | Water-filled bowl in dense forest. No aquatic plants noted in open water. Surrounded by mature and young, regenerating western redcedar, red alder, salmonberry, English ivy, common periwinkle, and scouring rush which is abundant on north seepage slope. Wetland condition looks poor, age unknown. |

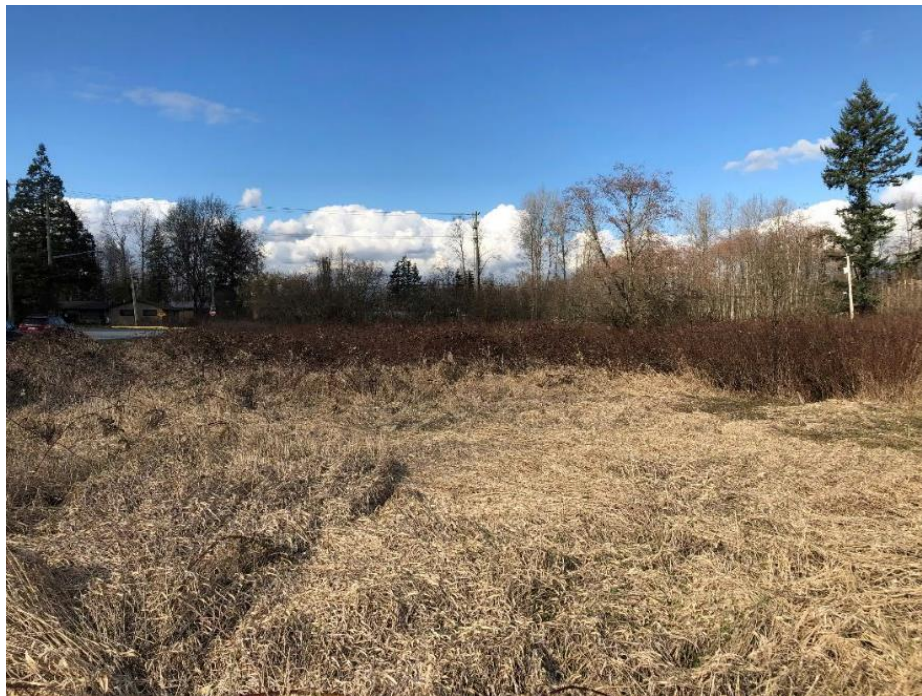
Photo 4: Reed canary grass wetland at W9, 18044 96 Avenue, surrounded by hardhack thickets. Note this is the northern portion of 18044 96 Avenue, north of Golden Ears Way.

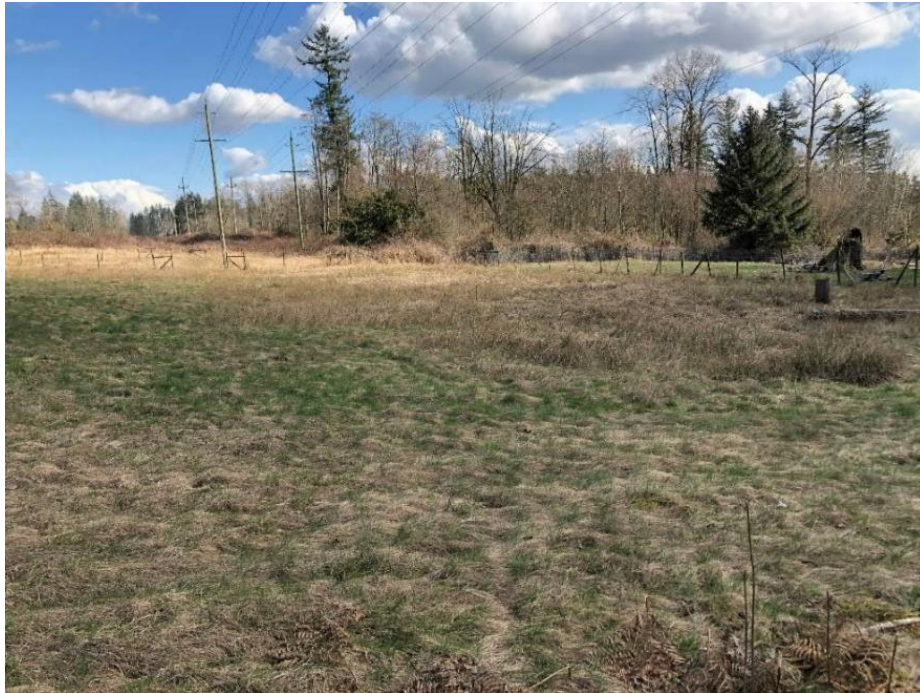
Photo 5: Common rush and reed canary grass depression at AOI-5 (high potential), 9450 172 Street.

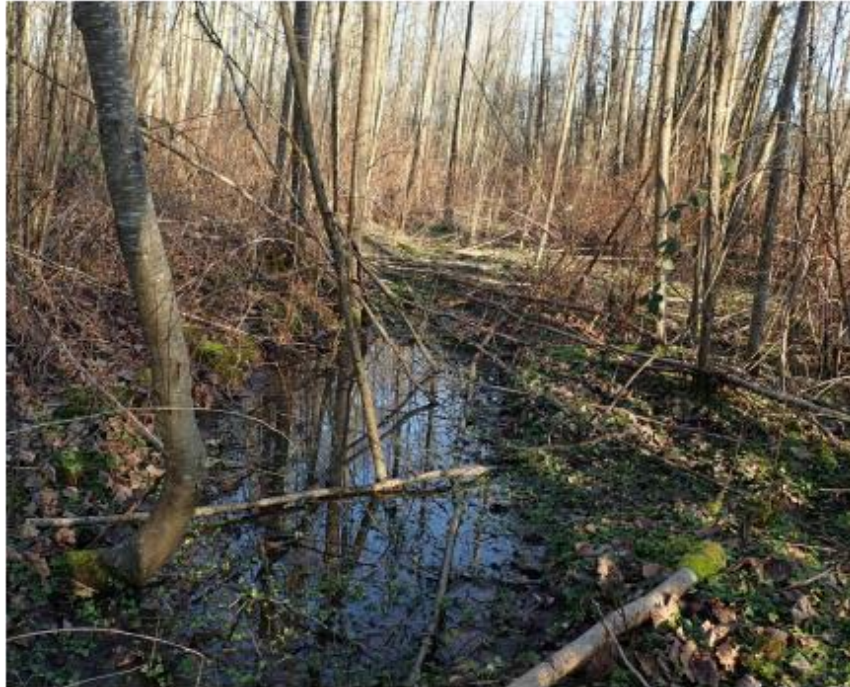
Photo 6: Pooled water at AOI-7 (medium potential), 9356 176 Street.

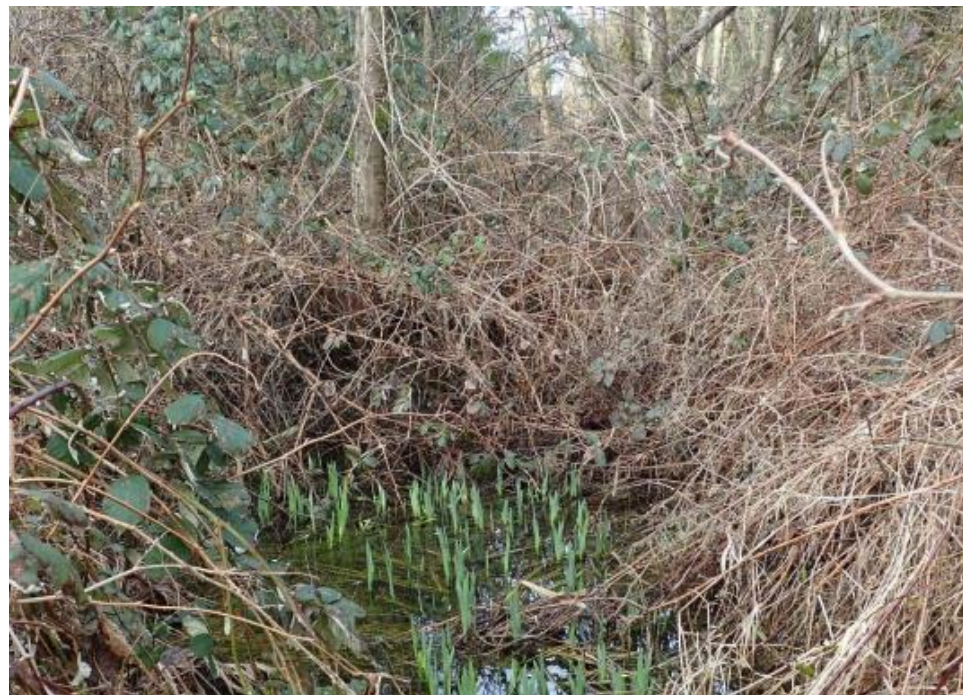
Photo 7: Remnant natural vegetation along small channel at AOI-11 (high potential), 9358 184 Street.

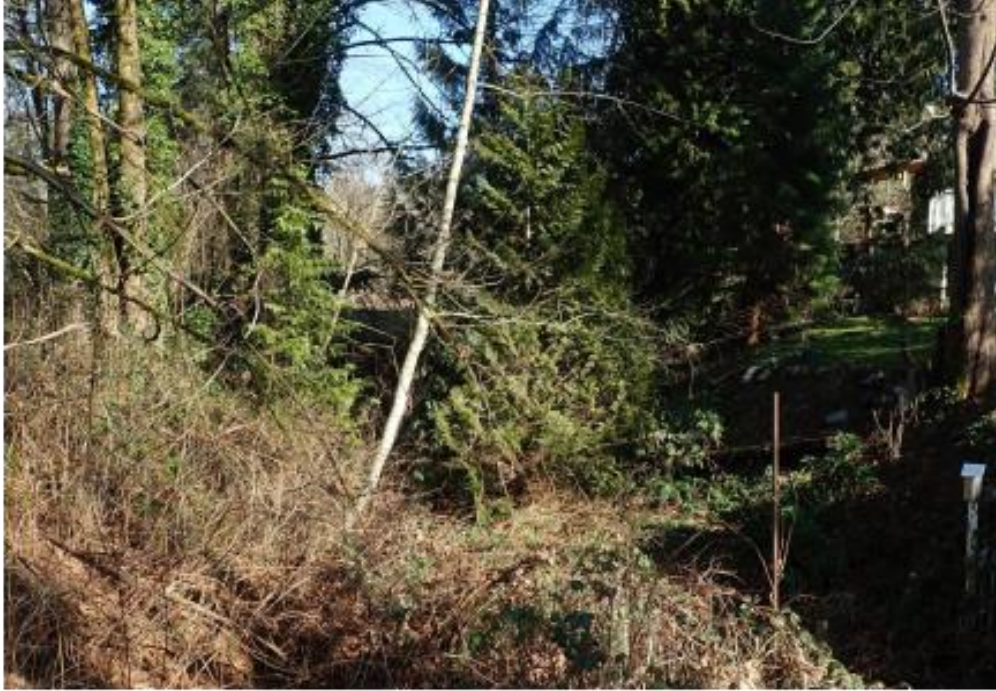
Photo 8: Forested areas along existing watercourse at AOI-4 may support wetlands at 17070 94A Avenue (low potential).

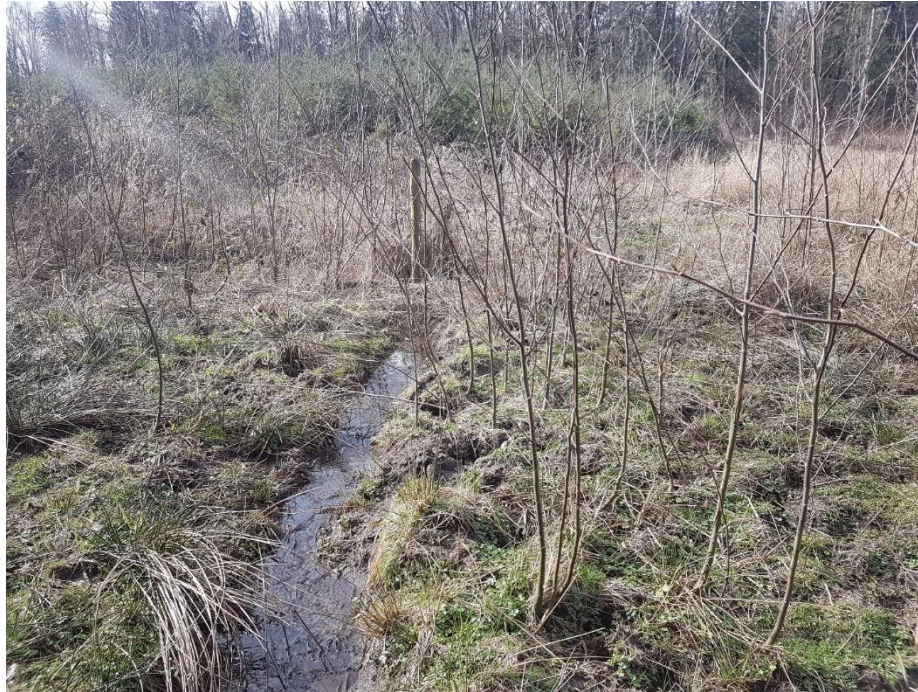
Photo 9: Watercourse C40, an example of a typical watercourse previously classified as Class C, but has been reclassified to Class B to reflect the WSA and RAPR definitions of a stream.

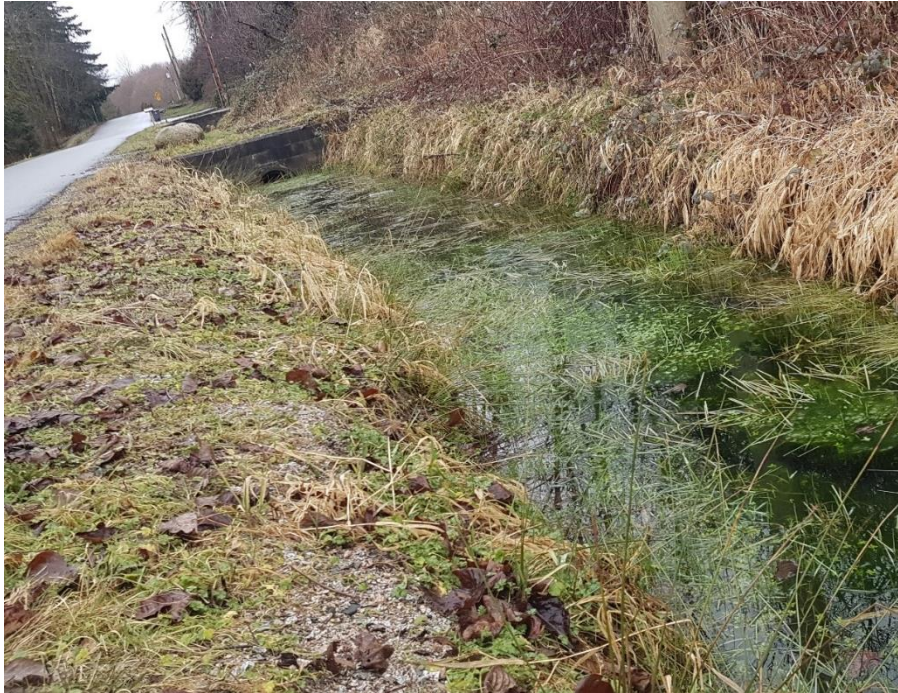
| ID | Location | Existing Classification | Recommended Classification | Description Traits/Values |
|---|---|---|---|---|
| D8 | North side of 92 Avenue and west side of 172 Street, approximately 200 m long | A | A | Linear roadside ditch. Established native and ornamental tree cover, but shrub layer is dominated by Himalayan blackberry. Significant volume of water at the time of the site visit. Substrate is unknown but likely dominated by organics and fines. Aquatic vegetation was noted. |

Photo 10: Ditch D8, an example of a typical Class A ditch with channel definition, likely sufficient water quantity, substrate and riparian vegetation for year-round salmonid habitat.

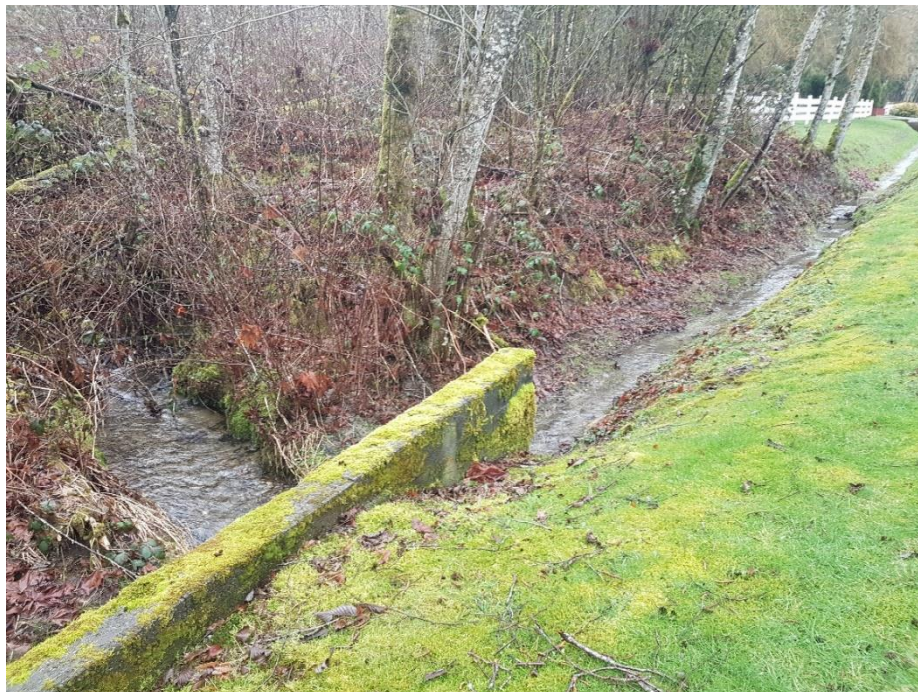
| ID | Location | Existing Classification | Recommended Classification | Description Traits/Values |
|---|--|---|---|---|
| D13A | East side of Bothwell Drive south of D13B, approximately 190 m long | A(O) | A(O) | Linear roadside ditch. Connected to the unnamed creek crossing Bothwell Drive. Established native riparian vegetation. Pooling water was noted at the time of site visit. Substrate is predominantly small gravel. |

Photo 11: Ditch D13A, an example of a typical Class A(O) watercourse with channel definition, likely sufficient water quantity, substrate and riparian vegetation for overwintering salmonid habitat.

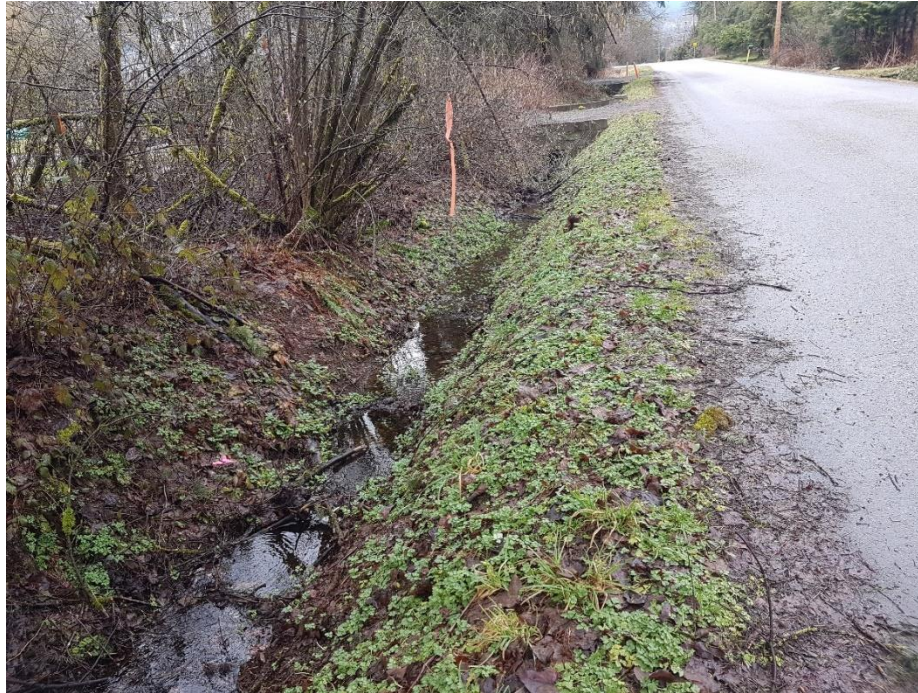
Photo 12: Ditch D3, an example of a typical Class B watercourse with channel definition and riparian vegetation that is likely a source of food and nutrients to downstream fish habitat.

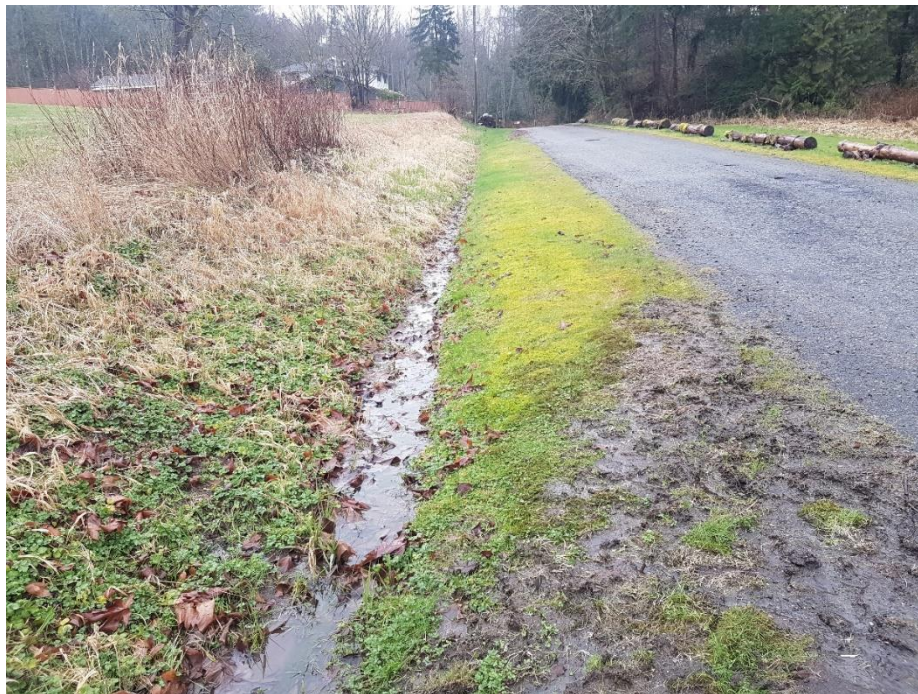
Photo 13: Ditch D7, an example of a typical Class C watercourse not considered a stream under the current WSA definition.
