PIER Phase 1 Report

PIER: Prioritizing Infrastructure and Ecosystem Risk from Coastal Processes in Mud Bay

PIER Phase 1

Mud Bay Shoreline Erosion Assessment Mapping Study

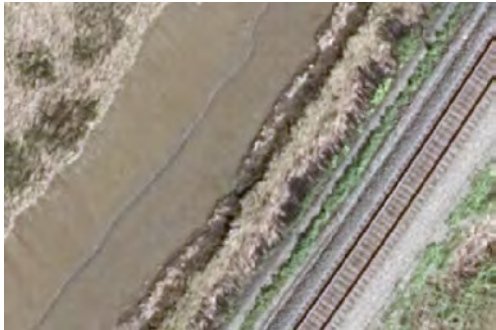
DESCRIPTION Value	Description	Example
UNARMoured	Dyke toe is unprotected or vegetated. Determined by a green colour indicating vegetation or by no cobble or rock material visible.

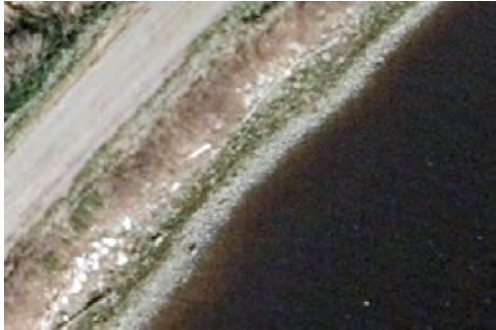
COBBLE	Cobble material at the toe of the dyke. Identified by colour and texture of the surface.

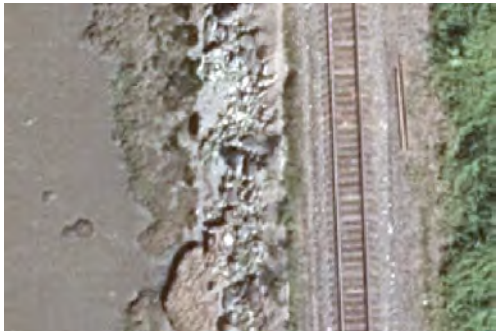
ROCK	Stone material larger than cobble. Individual rock units able to be distinguished in the orthophoto.

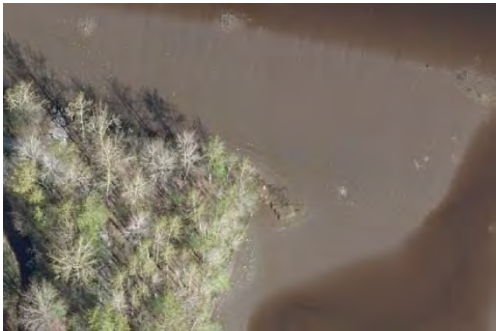
MUD BENCH Value	Description	Example
YES	There is a mud bench is visible at the toe of the dyke/edge of shoreline. The mud bench extends out from the toe/edge of shoreline a minimum of 10 metres in the 2015 orthophoto.

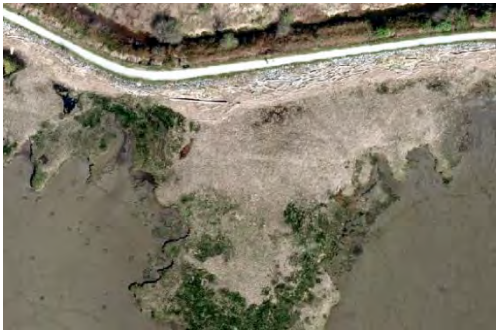
VEG	Vegetation visible on a mud bench at the toe of the dyke/edge of shoreline and extends no less than 10 m out onto the mud bench. Within the 10 m in front of the toe/edge of shoreline, the vegetation is not patchy and there are no un-vegetated drainage channels cut.

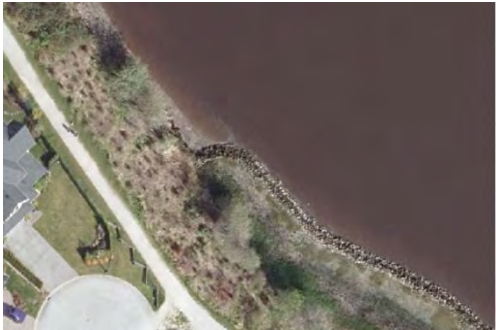
NO	Very narrow or no mud bench; the waterline is located within approximately 10 metres of the toe of the dyke/edge of shoreline in the 2015 orthophoto. This category was only used on the banks of the Serpentine and Nicomekl Rivers.

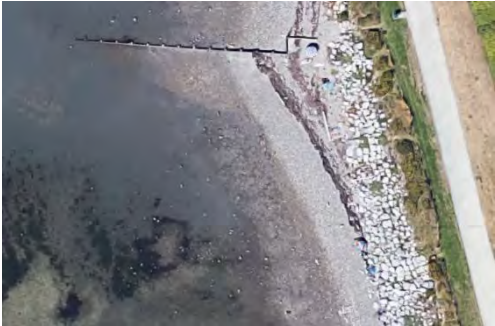
MUD BENCH Value	Description	Example
BEACH	Beach (sand) material at the toe of the dyke/edge of shoreline. The beach material extends a minimum of 10 m from the toe of the dyke/edge of shoreline. This category was only used in the Crescent Beach reach.

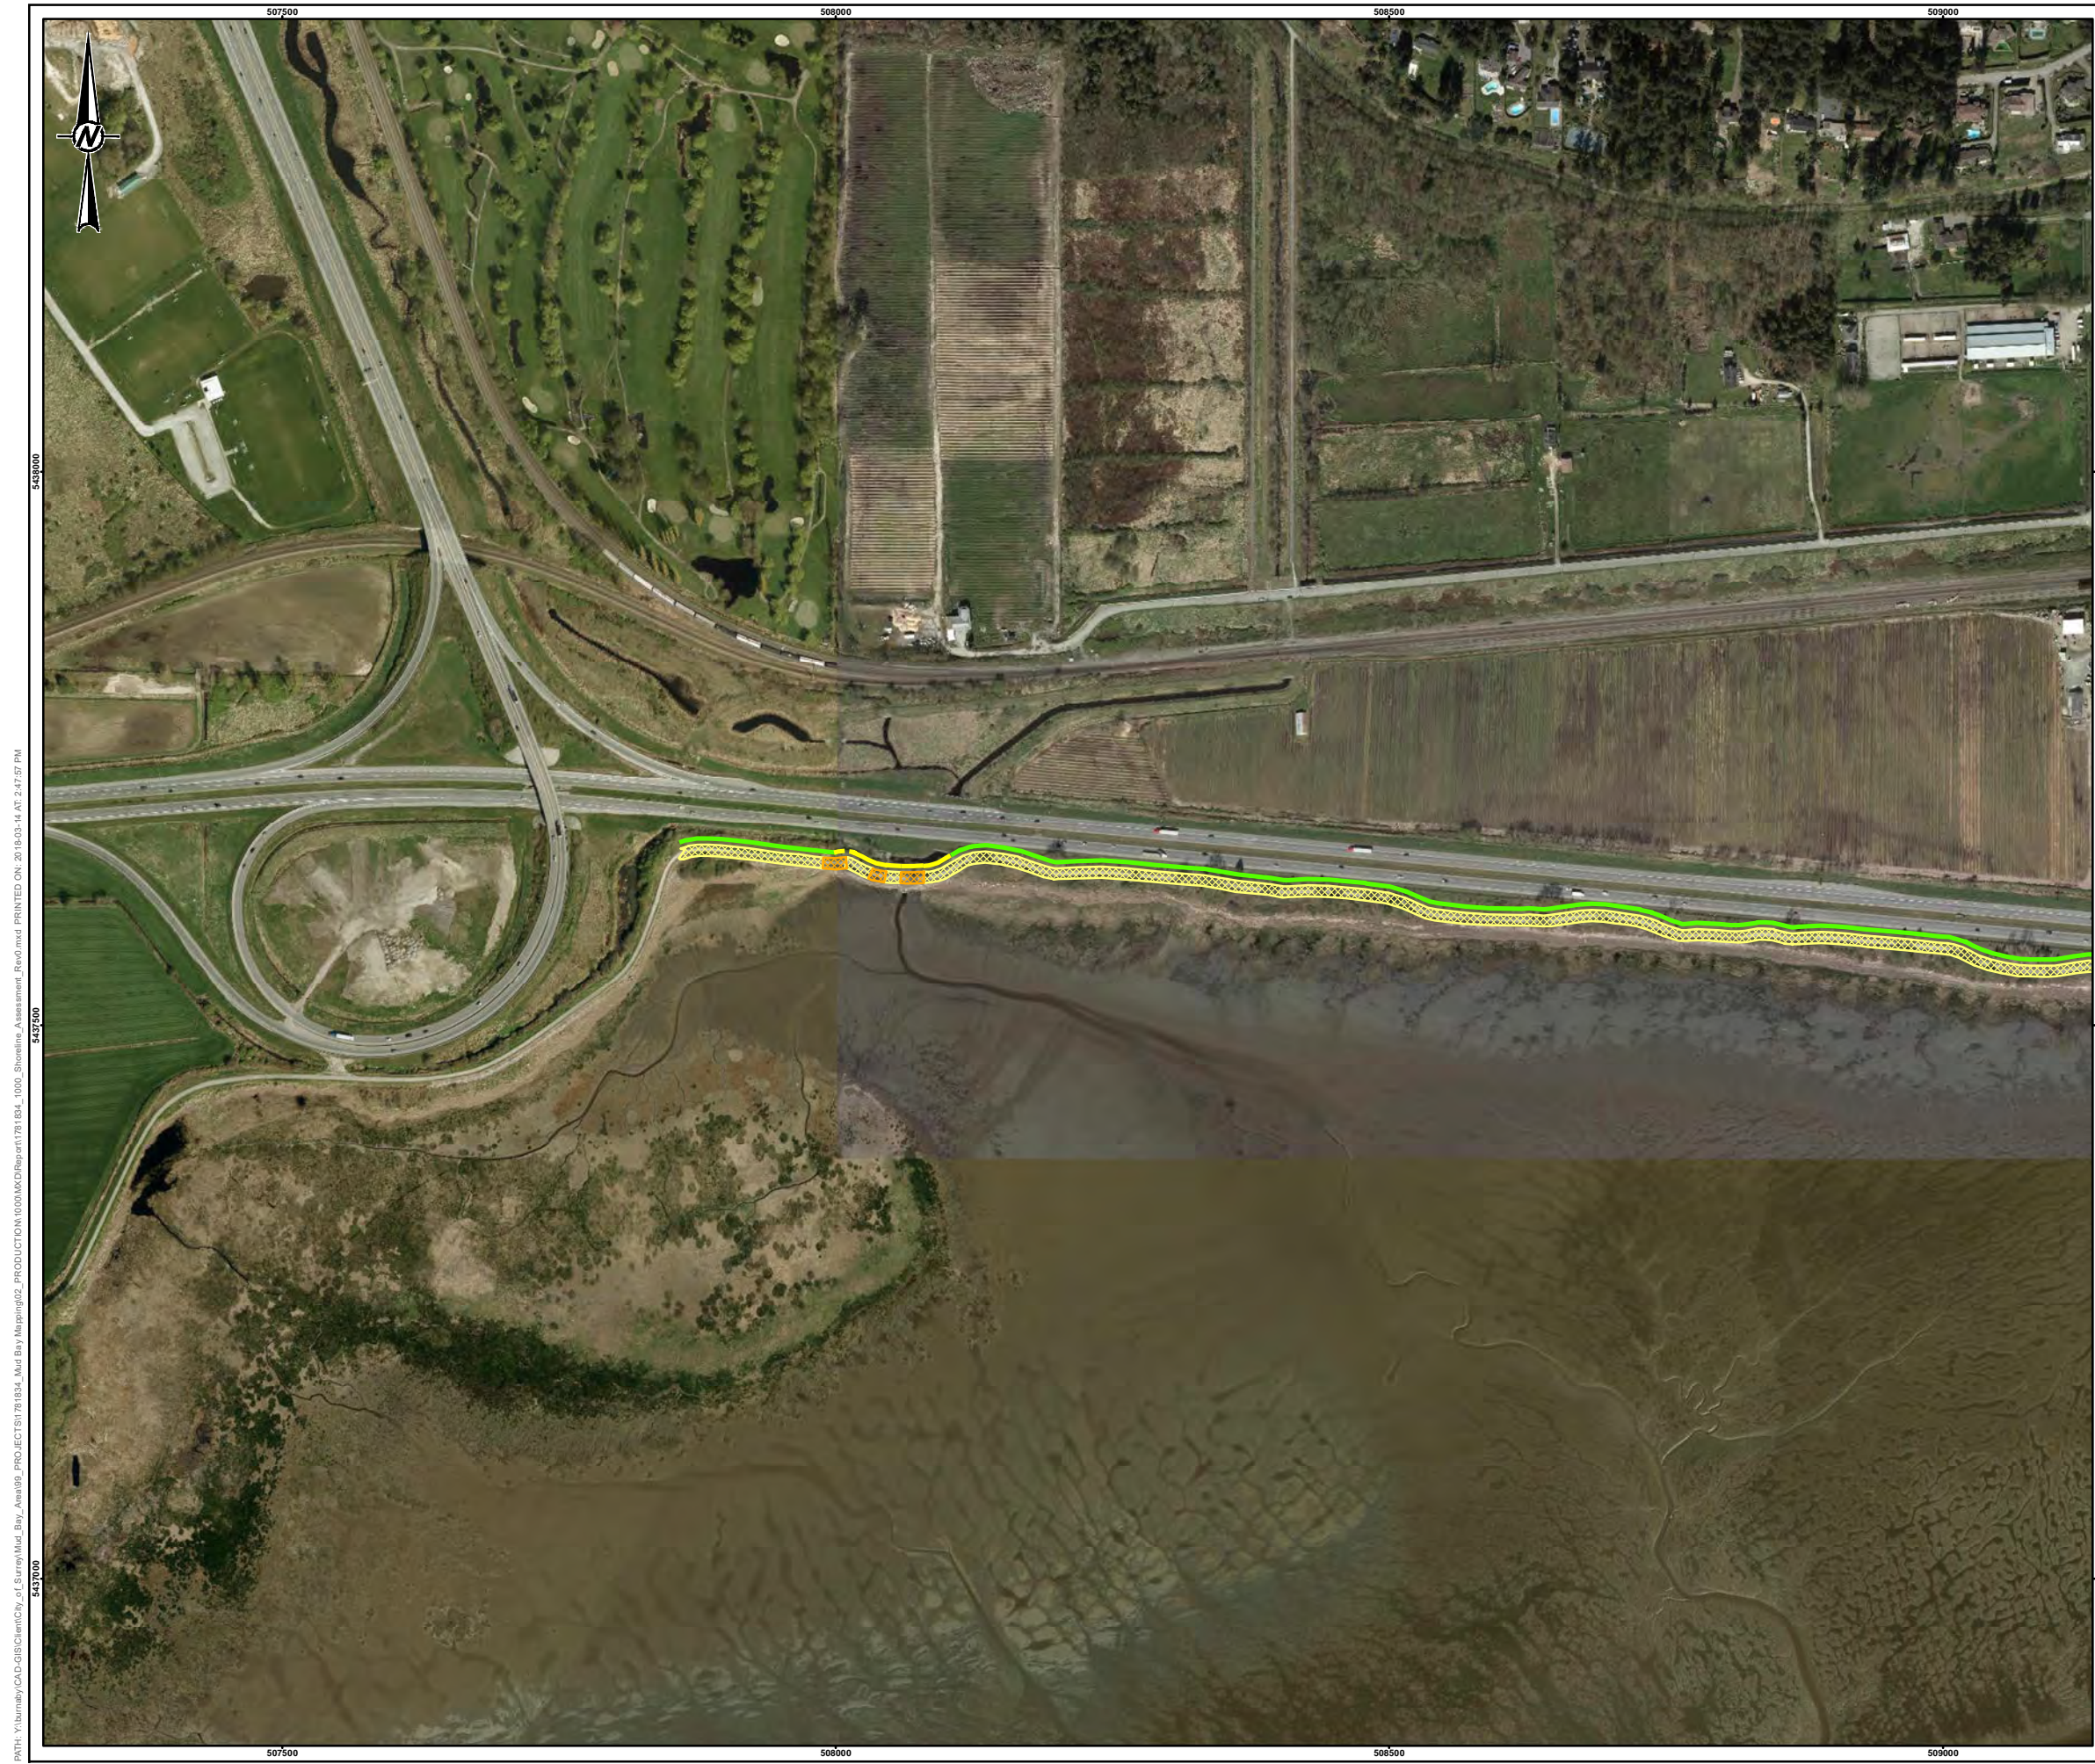
- LEGEND**
- ARMOURING**
- COBBLE
 - ROCK
 - UNARMoured
- MUD BENCH**
- YES
 - VEG
 - BEACH
 - NO

The mud bench classification is shown as a polygon on the waterside of the armouring classification. Mud bench is coloured orange, vegetation is coloured yellow and beach is coloured green. There is no colour shown for the sections of shoreline with no mud bench. The colouring of the mud bench criteria was used to correspond to the expected susceptibility to SLR, where the beach (green) is expected to adapt the best to SLR, vegetation may be subject to coastal squeeze and the mud bench will allow greater access of waves to the dyke toe under raised sea levels. As noted in section 3.2, a vegetation buffer only exists where there is a mud bench present on the shoreline.

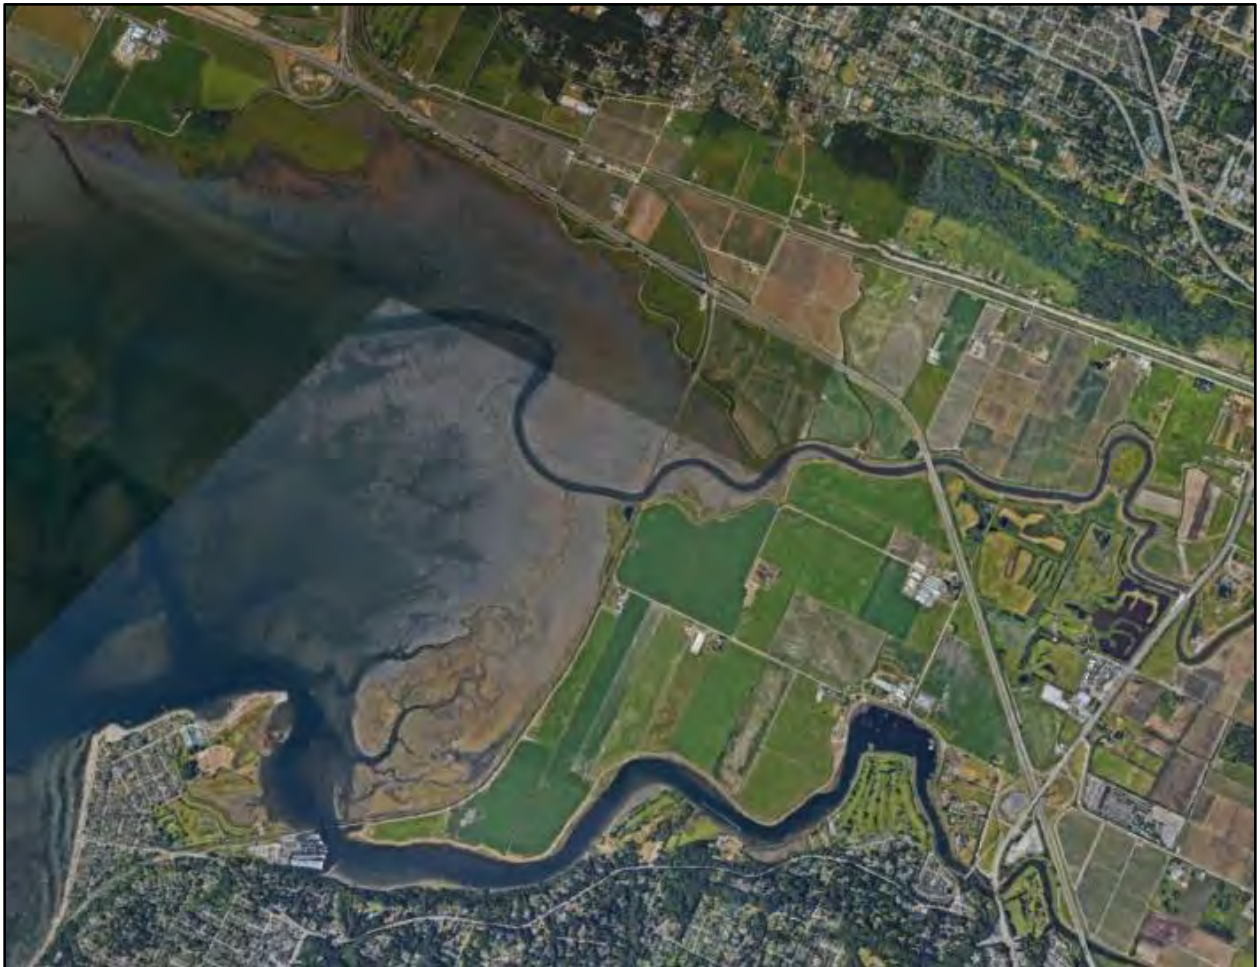
Figure 1: Mud Bay, 2017 Google Earth imagery

Mud Bay is situated within the City of Surrey and forms continuous tidal habitat with Boundary Bay to the west. Mud Bay is influenced by the Serpentine River in the north and the Nicomekl River in the south and is bounded by dikes at the landward side (Figure 1). Immediately adjacent land uses include agriculture, parks, residential areas, Highway 99, and a marina. The Serpentine Wildlife Management Area is located upstream along the south bank of the Serpentine River, immediately east of Highway 99.

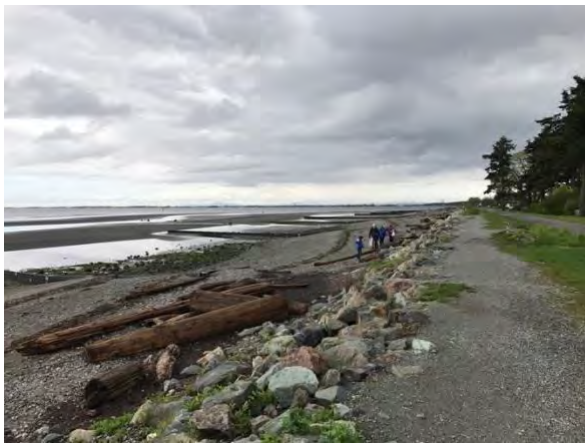
Figure 4 Shoreline near Beecher St showing groins, impacted backshore and potential spawning habitat for forage fish

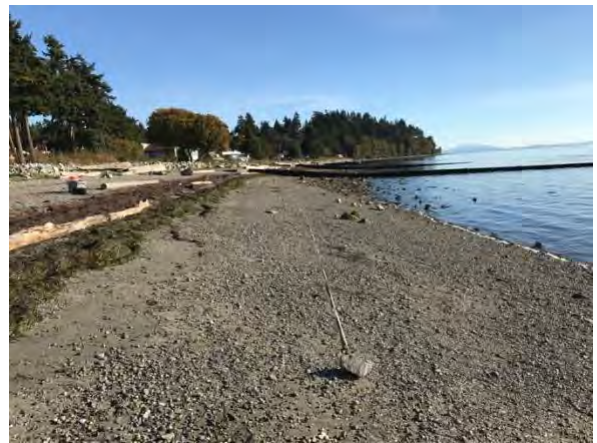
Figure 5 Coarse gravel on top of fine sand beach

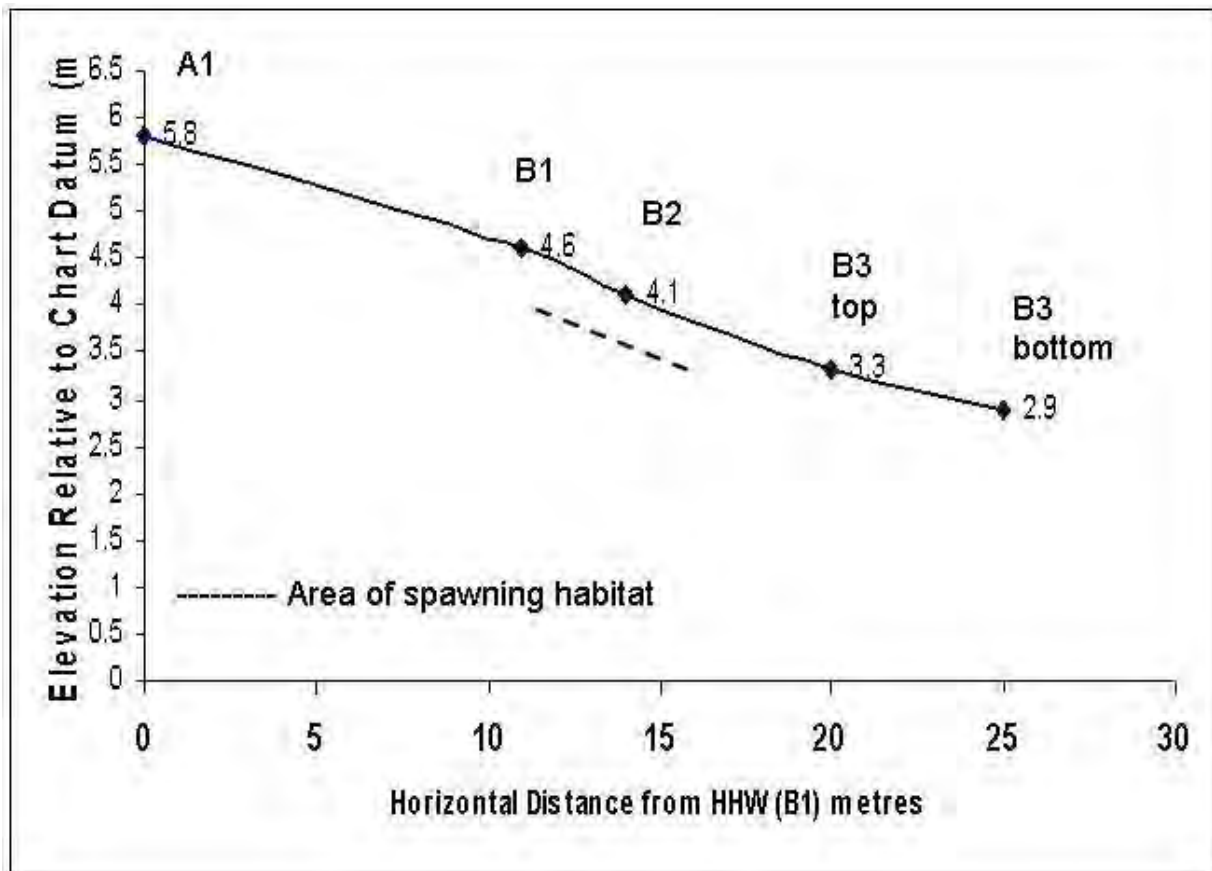
**measured against tide height of approximately 2.9 m at the beach face B3-bottom

Figure 6 Crescent Beach Forage Fish Spawning Location Shoreline Profile (De Graaf 2007)

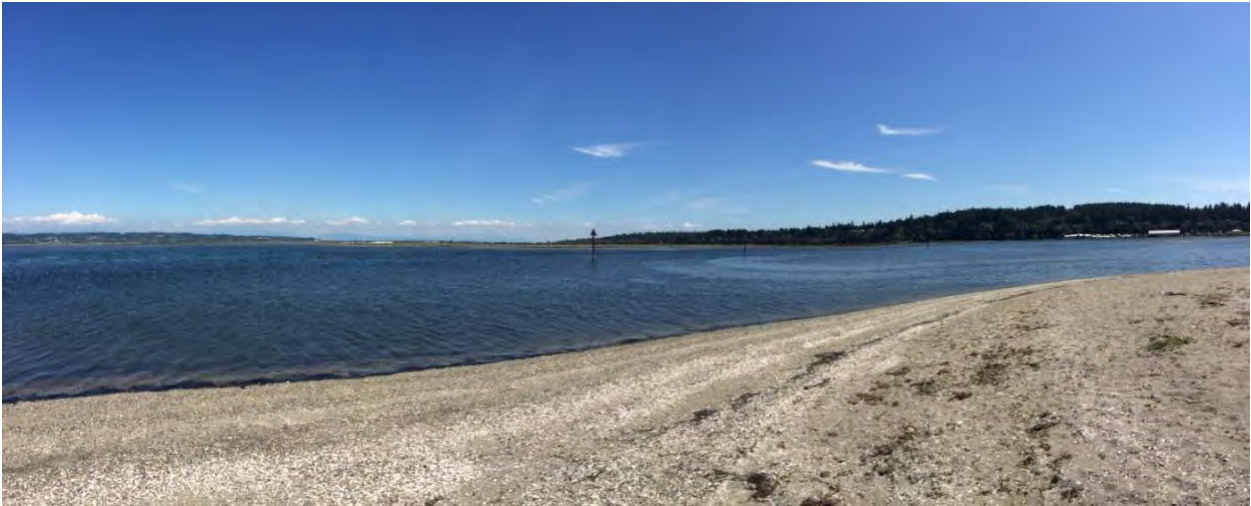
Figure 7 Gravel and shell hash substrate at Blackie Spit

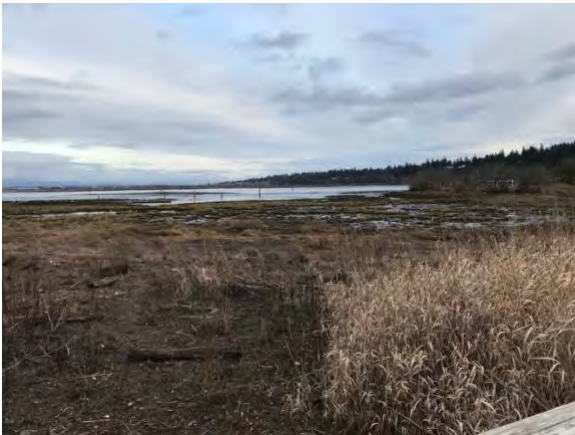
Figure 8 Salt marsh at Blackie Spit Park

This area includes expansive salt marshes with tidal channels. The land ward edge of the salt marshes includes some trees and shrubs. Invasive *Spartina anglica* can also be found in some of these salt marsh areas.

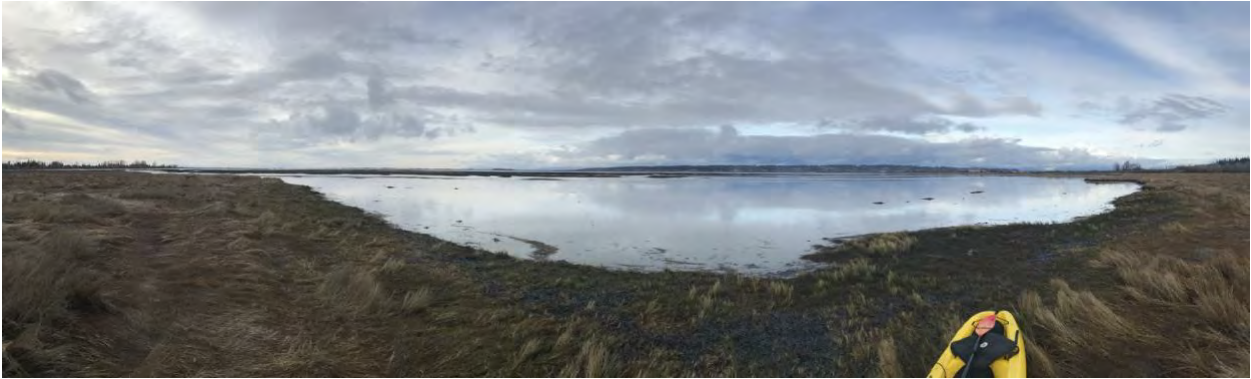
Figure 9 Sloping salt marsh

The southern extent of this shoreline segment includes a 58.70 hectare parcel of fee simple land owned by The Nature Trust of BC, The Nature Conservancy of Canada and the Province of BC (Wood et al 2017). The three agencies purchased this land in partnership in 1982 to protect the important salt marsh habitat at the mouths of the Serpentine and Nicomekl Rivers (Wood et al 2017). The shoreline includes a narrow salt marsh bands (< 10 m), larger ones and some gravel beaches. Raised benches and sloping salt marshes are found here with at least one gravel beach (Figure 11). The wrack line shows that high tides can reach with a few feet of the rail bed.

The study area has expanses of fringing salt marsh including both raised salt marsh benches (Figure 21) and sloping graduated salt marshes (Figure 9) with transitional vegetation. The surveys were completed in winter months, limiting the ability to detect vegetation species in detail. Generally, the high salt marshes had the following plant species present: *Distichlis spicata*, *Juncas gerrardi*, *Grindelia stricta*. Low salt marshes species were dominated by *Salicornia spp.* with some evidence of *Triglochin maritima* and *Carex lyngbei*. *Spartina anglica* was observed throughout the study area.

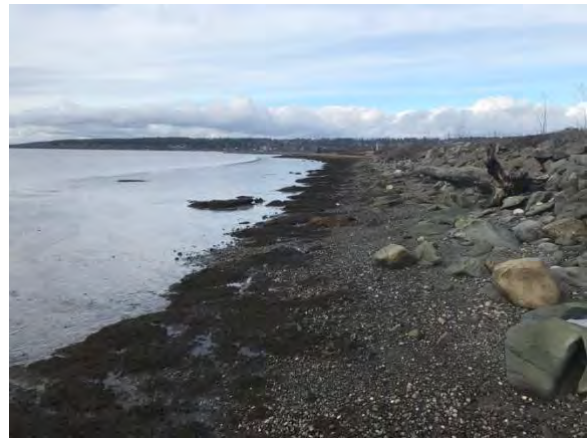
Figure 11 Narrow gravel beach in front of armored dike

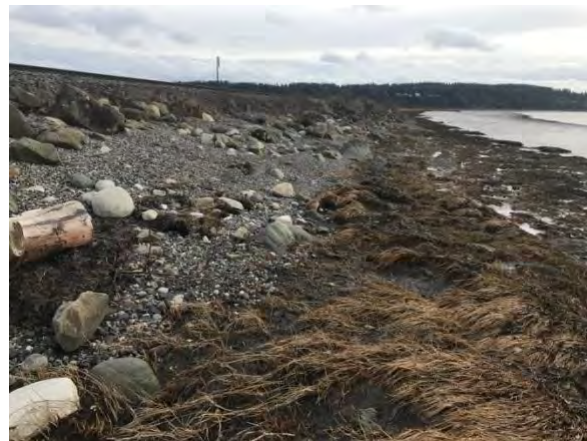
Figure 12 Rock armored with vegetated bench

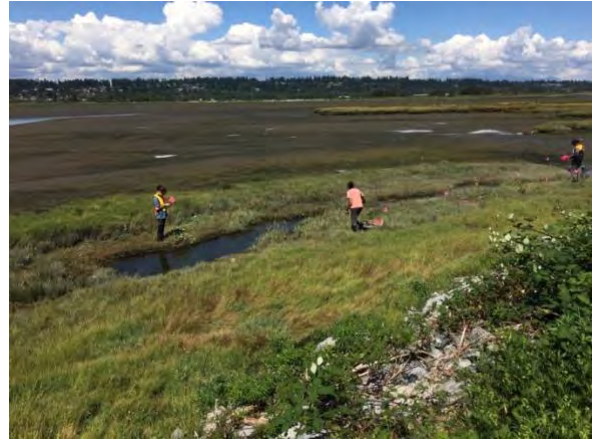
Figure 13 Salt marsh in the mouth of the Serpentine east of the trestle

Salt marshes are found along the toe of the dyke and as islands in the between the Mud Bay North shoreline segment and Colebrook shoreline segment. There are also tidal channels and pools throughout these salt marsh areas. Overhanging vegetation is not present likely as a result of regular mowing.

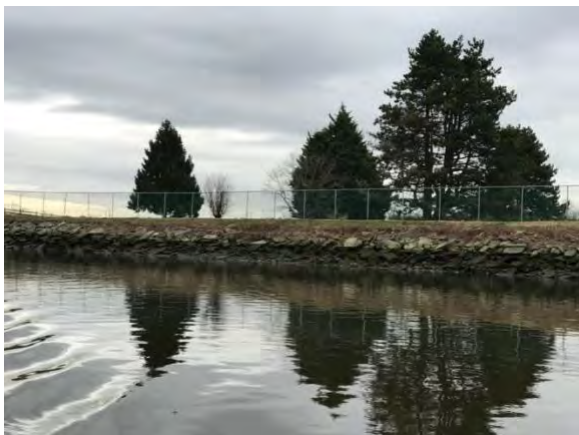
Figure 15 Armored with no mud bench

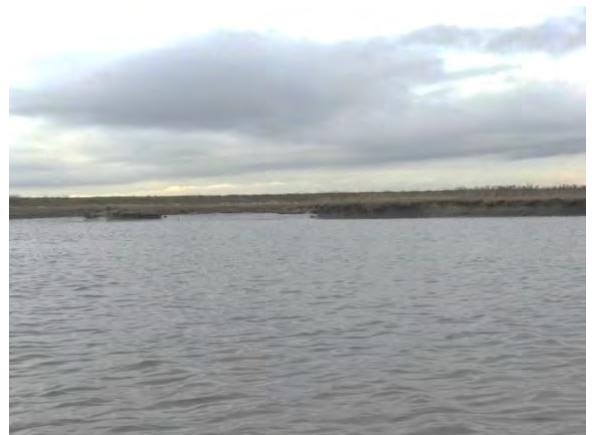
Figure 16 Unarmored with vegetated mud bench

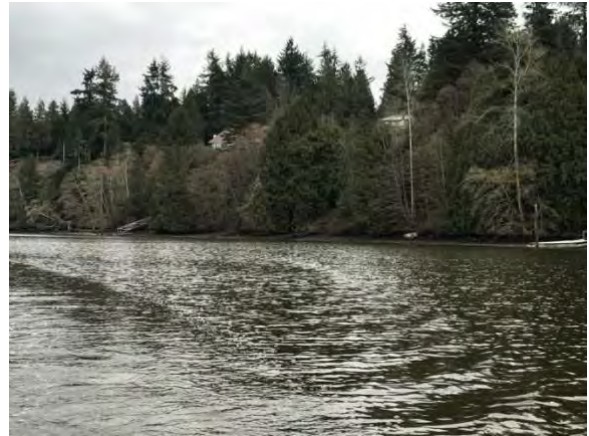
Figure 18 Steep treed bluff with residential housing

This section of shoreline includes a steep treed bluff (Figure 18), several private recreational docks, public and private marinas and a golf course.

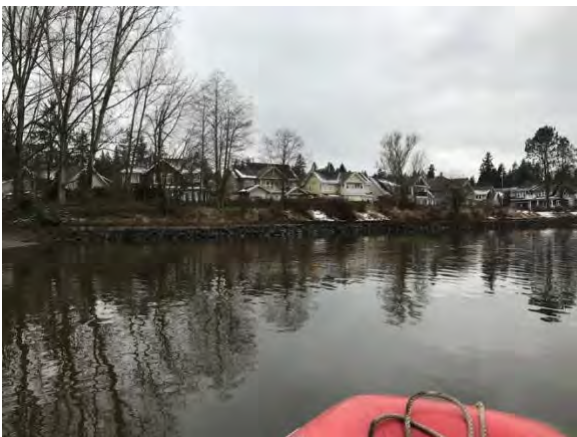
Figure 19 Constructed habitat bench

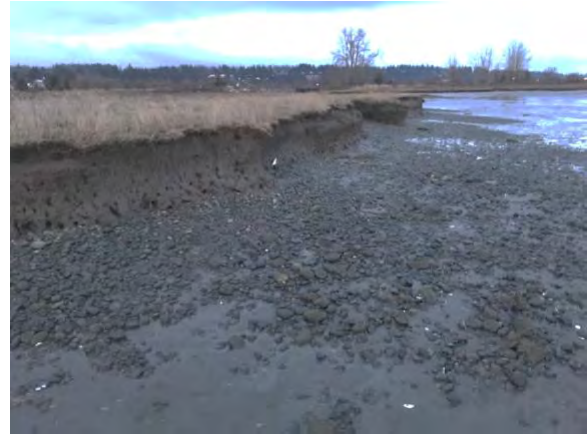
Figure 21 Elevated salt marsh bench

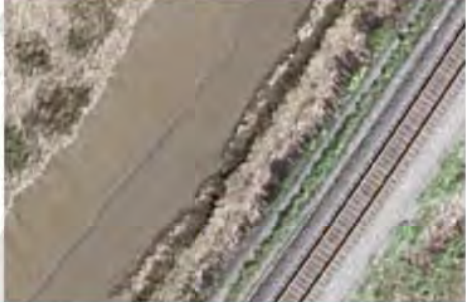
DESCRIPTION Value	Description	Example
UNARMoured	Dike toe is unprotected or vegetated. Determined by a green colour indicating vegetation or by no cobble or rock material visible.

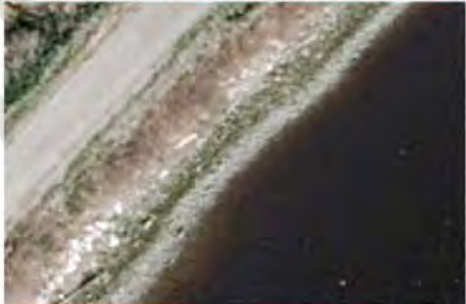
COBBLE	Cobble material at the toe of the dike. Identified by colour and texture of the surface.

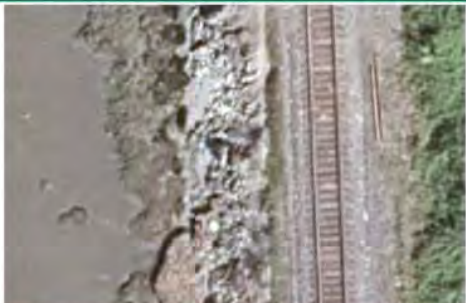
ROCK	Stone material larger than cobble. Individual rock units able to be distinguished in the orthophoto.

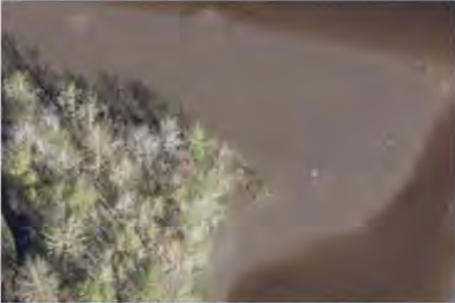
MUD BENCH Value	Description	Example
YES	There is a mud bench is visible at the toe of the dike. The mud bench extends out from the toe a minimum of 10 metres in the 2015 orthophoto.

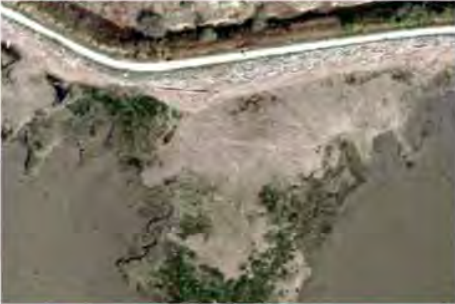
VEG	Vegetation visible at the toe of the dike and extends out onto the mud bench a minimum of 10 m. Within the 10 m in front of the toe, the vegetation is not patchy and there are no un-vegetated drainage channels cut.

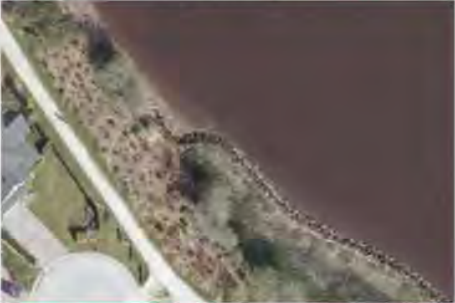
NO	Very narrow or no mud bench; the waterline is located within approximately 10 metres of the toe of the dike in the 2015 orthophoto. This category was only used on the banks of the Serpentine and Nicomekl Rivers.

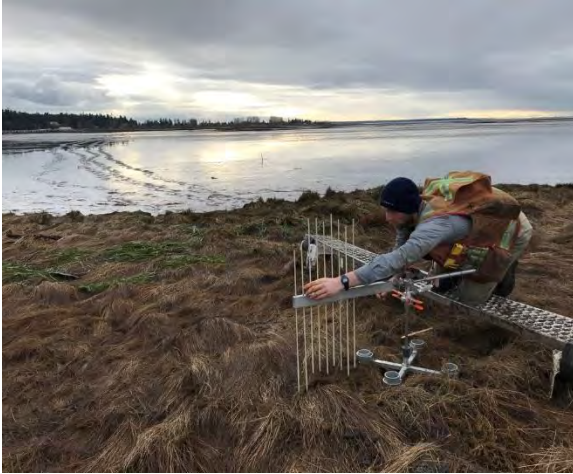
Figure 2 Photo of installed rSET and measurements being taken
