1081 Canada Avenue  
Duncan, BC V9L 1V2  
P: 250.746.5545  
F: 250.746.5850  
www.madrone.ca  
info@madrone.ca

June 4, 2010

**Response to questions in focal areas 1 – 4 - Anniedale-Tynehead NCP.**

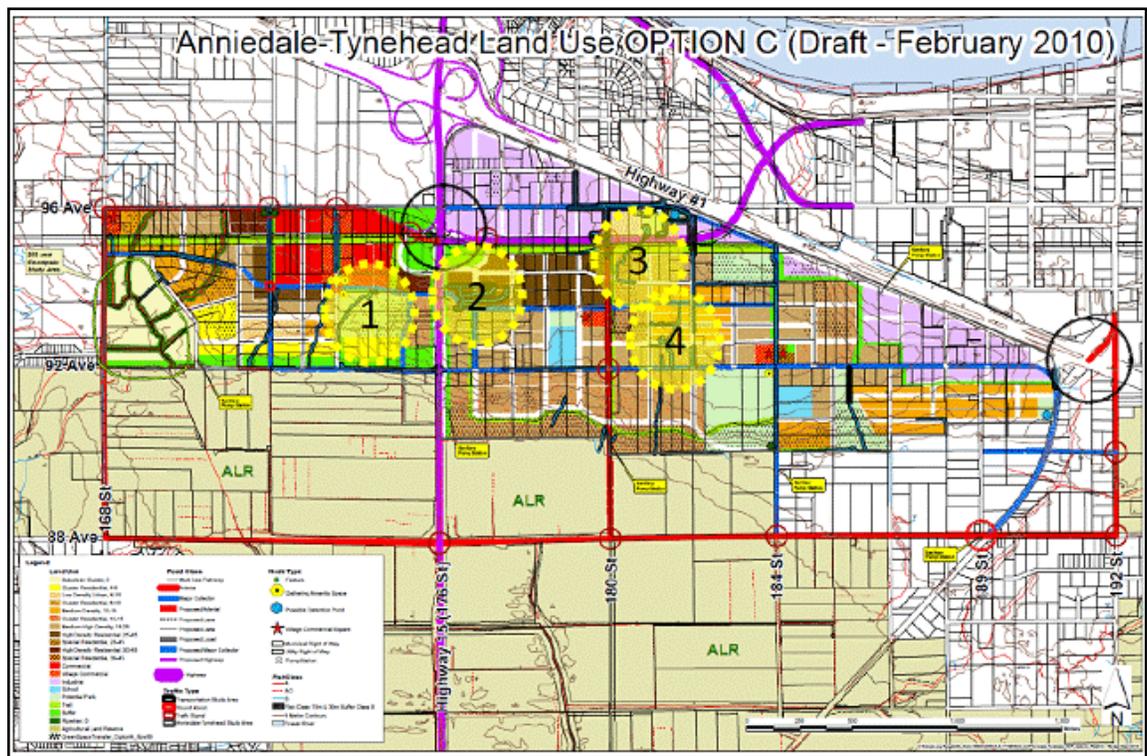
**Figure 1.** Focal Areas of Interest 1 – 4.

Further to the completion of the Anniedale – Tynehead – NCP Area Overview Environmental Assessment (Madrone – September 2009), we understand that you have specific questions related to four separate areas, highlighted on the map you provided us with (Figure 1). The scope of the initial assessment was limited to an overview-level study, but the following responses have been formulated using a higher level of detail.

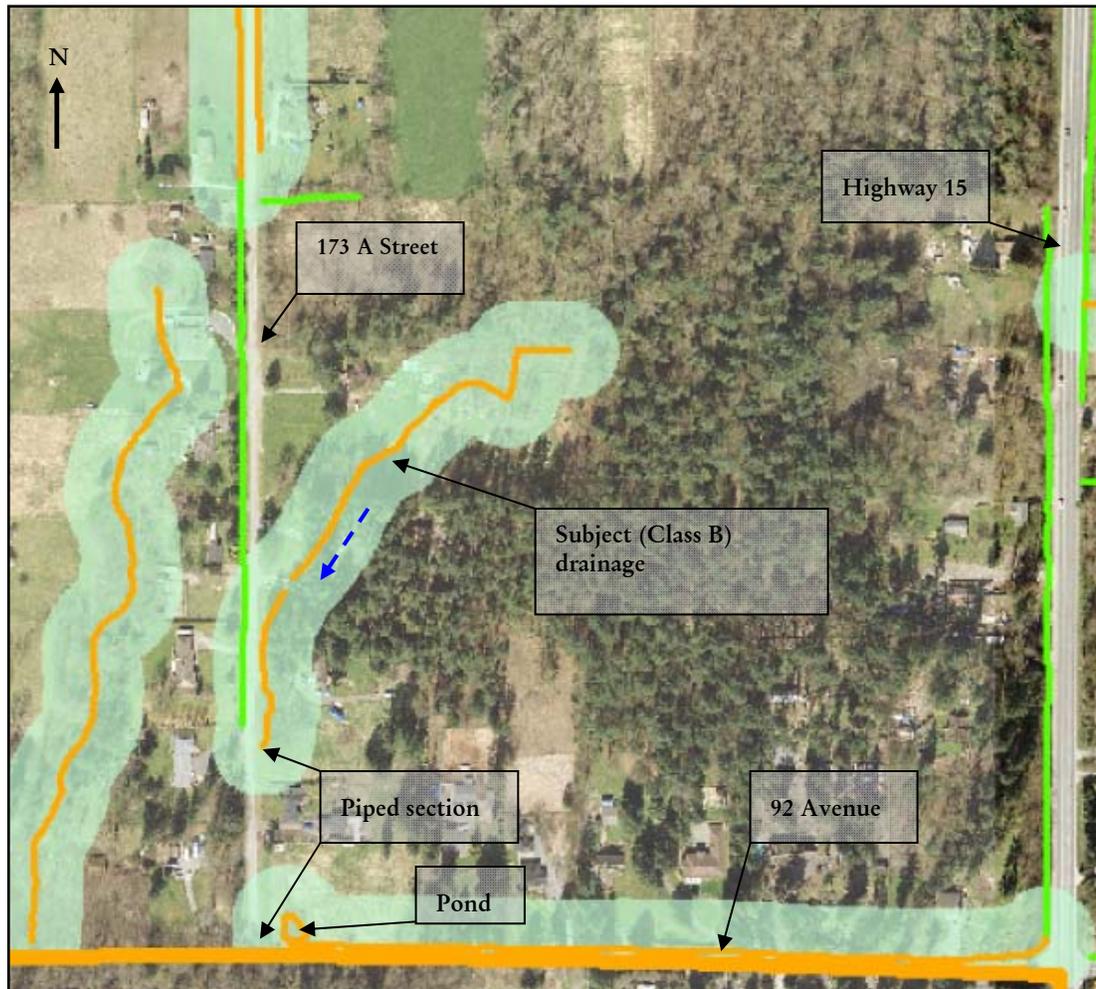
**Figure 2.** Subject Class B drainage – Area 1.

We found evidence of a narrow, poorly defined channel in the moist, forested area to the northeast of 173A Street. Water flows to the southwest, but any natural channel system has been impacted by historical development along the eastern side of 173A Street. A very poorly-defined shallow swale parallels 173A Street, which suggests that the majority of water originating from the moist forest to the north east is piped underground. Numerous catch basins along the edge of 173A Street further suggest that water in this Class B drainage is piped (Figure 2).

Despite the poorly defined nature of the drainage and the fact that it is piped along the eastern side of 173A Street, surface flow connectivity occurs with the well defined creek located to the south of 92<sup>nd</sup> Avenue. The drainage should, therefore, maintain its Class B status.

The pond located on the corner of 173A Street and 92<sup>nd</sup> Avenue appears to receive subsurface water from the moist area to the north, as no defined surface inflow was detected. The pond is drained by a 20 cm diameter plastic pipe, with water flowing to the south, ultimately into the more well-defined stream located immediately to the south of the study area boundary.

Large-format commercial development to the north of this riparian area may impact both water supply and water quality, although specific impacts would depend upon the precise location of development footprints. Appropriate techniques should be employed during the development phase to ensure that stormwater emanating from the development area is properly managed. Specifically, paving large areas and promoting rapid conveyance of water into a stormwater system would result in substantially reduced flows in the summer and the higher incidence of peak flows in the winter, which could have deleterious implications on connected fish habitat (refer to response for Area 3 for more detail on stormwater management).

Mitigation measures should also be implemented that address water quality, given the potential for contaminants originating from the developed commercial area.

For example, catchment areas should be constructed that capture run-off from parking areas, to help minimize the introduction of hydrocarbons into drainage areas. Oil/water separators should be installed in drains to prevent the movement of hydrocarbons from the development.

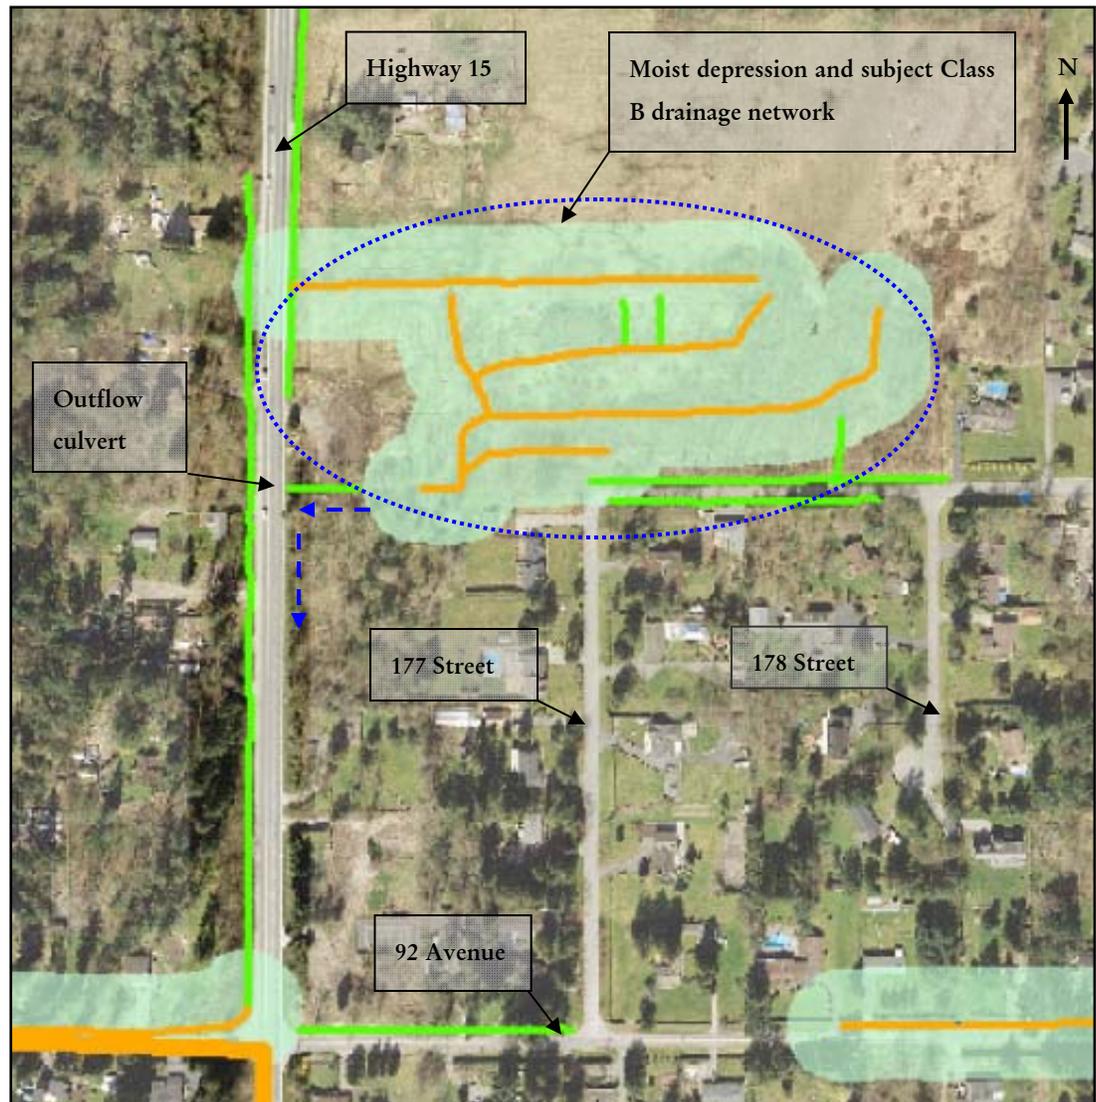
**Figure 4.** Subject Class B drainage network – Area 2.

The depression collects water on a seasonal basis, which drains to the west towards Highway 15. Drainage from the depression collects in a poorly defined swale, which connects directly to a culvert running underneath the highway (Figure 4).

We assumed that the culvert was connected to fish habitat, but this was not confirmed during the overview EA survey. The main focus of the overview assessment was to place a priority on assessing currently mapped Class B, C, or unclassified drainages in proximity to Class A or Class AO creeks to check for potential fish presence or the existence of fish habitat. As such, the existing default “Class B” classification was kept.

Future, more detailed site visits may be warranted for this “Class B” network, as it may be a candidate for down-grading. Fish habitat is distally located and there is an absence of clearly defined conveyance zones. It may be difficult, however, to quantify the significance of nutrient supply.

Compensation for negative impacts to this area should focus on maintaining the function of the depressional area as a water retention zone. It will be difficult to quantify appropriate compensation for losses to fish habitat values, due to the lack of habitat attributes and probable lack of reasonable downstream benefits in the form of nutrient supply. Any future development in this area must ensure that water leaving the site is clean and that there is no net increase in stormwater flow. Maintaining water quality and managing stormwater flow should be addressed during both the development phase and post-development (over the long term).

Stormwater Management and Water Quality
Confirm value of drainage network to downstream fish habitat.
Maintain the area as a water retention site.
Encourage residential home owners to capture stormwater through site-specific methods (e.g. rain-gardens and/or “green rooftops”).
Capture stormwater flow and help filter pollutants through implementation of bioswales and retention ponds.
Minimize the areas to be paved.
Use permeable paving and/or gravel surfaces wherever possible.
Educate future landowners about stormwater management and maintaining water quality – e.g. limiting use of chemical fertilizers/pesticides.
Employ appropriately qualified professionals at an early stage to help achieve a “no net gain” in stormwater leaving the site.

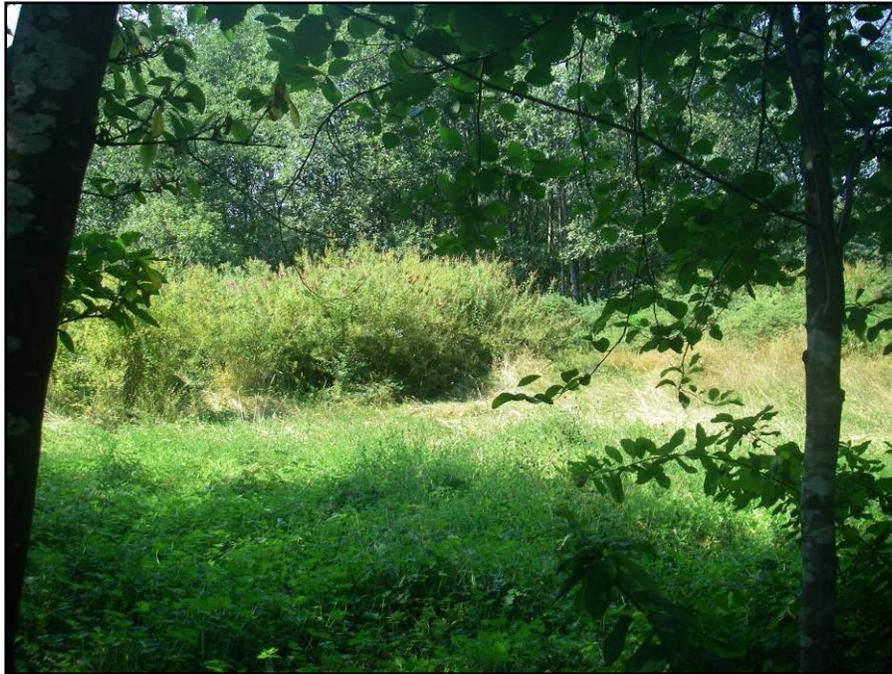
This area represents a moist depression, with pockets of hydrophytic vegetation. Hardhack (*Spiraea douglasii*) occurs in dense patches, but specific, defined, drainage channels were difficult to determine. Attributes commonly associated with fluvial environments and flowing water were limited, and there were no alluvial deposits or scoured channels. Surface water was not present during the original overview EA assessment, but seasonal inundation of water was evident in depressions and poorly defined linear “channels”. Vegetation characteristics are also suggestive of seasonal inundation.

Looking towards one of the dense hardhack pockets which represent the Class B riparian network in “Area 2”.

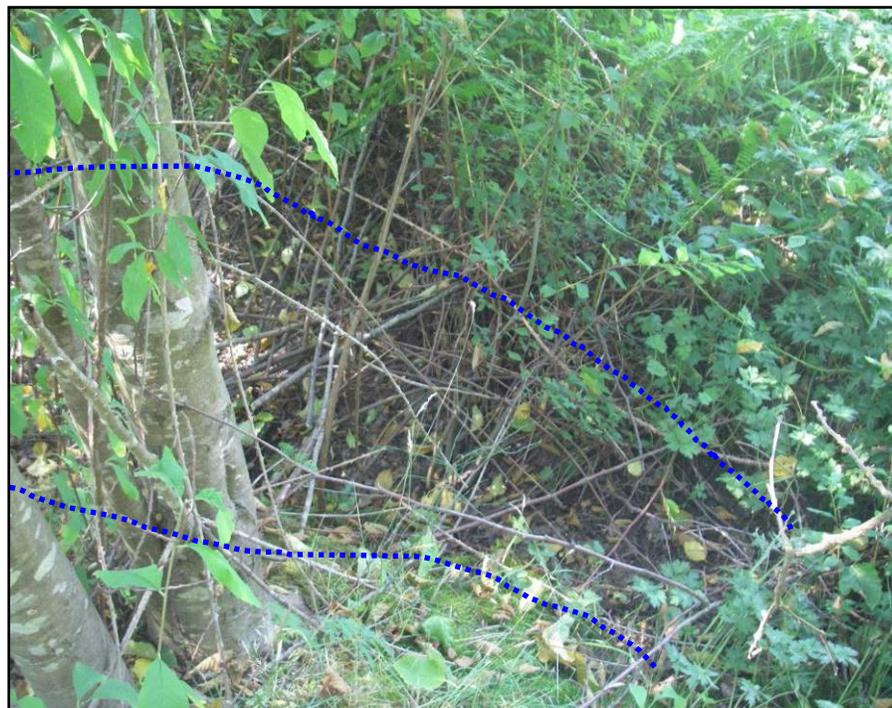
Highlighted area represents an example of a moist depression seasonally inundated with water in “Area 2”. Note lack of alluvial deposits and lack of “stream” characteristics.

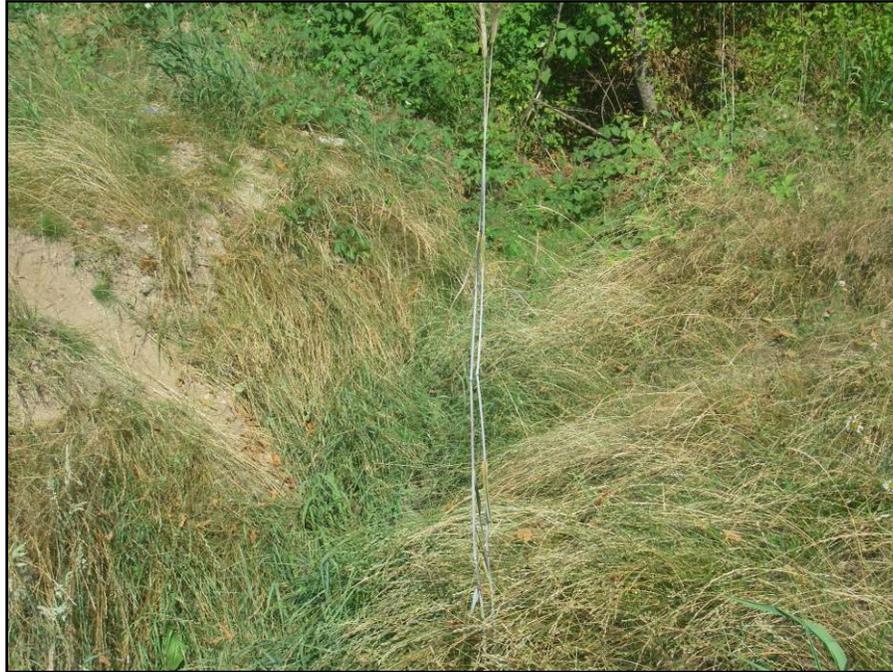
Swale draining to the west towards Highway 15 out of the seasonally inundated depression comprising "Area 2".

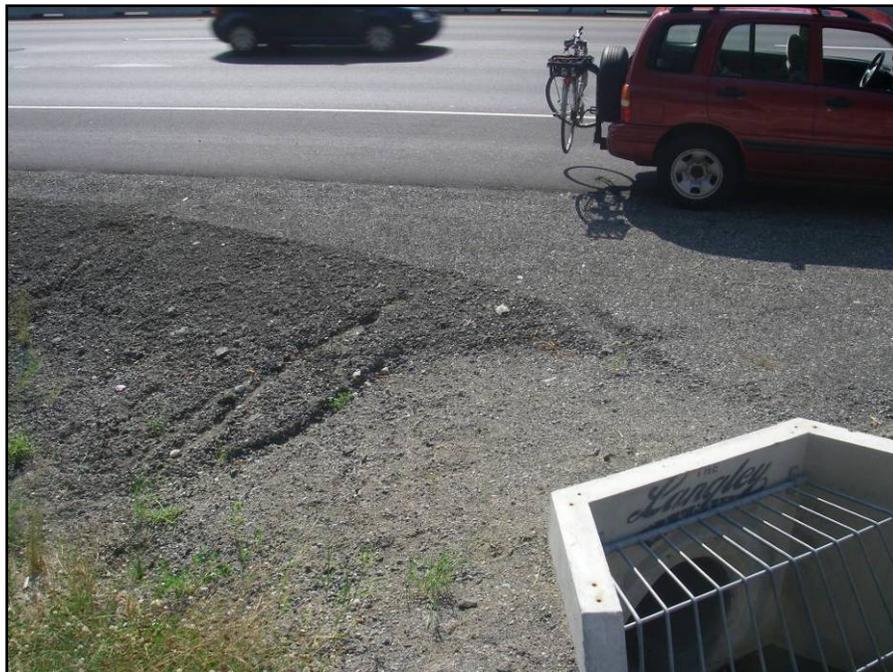
Inflow of culvert underneath Highway 15, which receives water on a seasonal basis emanating from "Area 2".

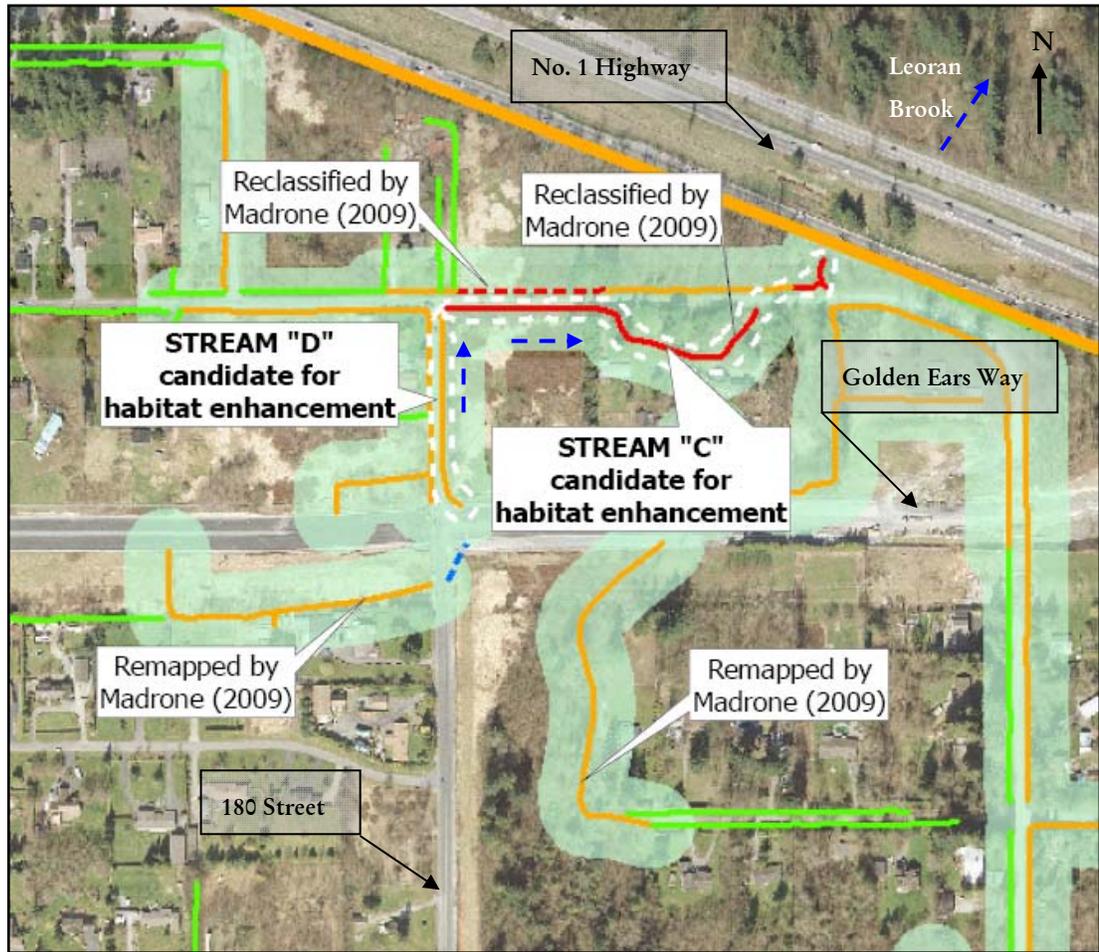
Figure 5. Subject drainage network – Area 3.

While this “Class B” drainage currently resembles a ditch adjacent to 180 Street, it contains perennial flow and connects directly to fish habitat (the “Class A” drainage on the southern side of 96<sup>th</sup> Avenue) – Figure 5. With improved accessibility and habitat improvements (e.g. through riparian planting and/or improvement of instream diversity through LWD placement), it could be used by fish, at least on a seasonal basis.

In its current state, the riparian zone directly adjacent to the subject drainage is providing little in the way of nutrient input, shade and/or litter fall.

The drainage does, however, serve as a conduit for nutrients originating from the seasonally inundated area that is heavily vegetated with hydrophytes (mainly hardhack) underneath the power lines on the southern side of Golden Ears Way. The establishment of a functioning riparian zone over time, albeit on the east bank away from the road right of way, will add benefits to downstream fish habitat. At the very least, therefore, the drainage should maintain its “Class B” status.

Any development in this identified focal area must take into account potential impacts to water quality and water volume, given the proximity of fish habitat. The drainage that parallels the southern side of 96<sup>th</sup> Avenue is known to support fish, as does Leoran Brook. Development-related pressures must be mitigated, to ensure that impacts are identified and addressed.

One of the more obvious potential impacts is related to stormwater flow. Development activities typically result in a decrease in natural infiltration rates and increased stormwater runoff due to the increase in impervious surface cover. Peak flows in streams usually increase as a result of urban development (if not properly managed), which can have direct impacts on numerous fluvial processes, including sediment movement/deposition and bank stability. The frequency of very low summer flows is also increased as a result of an increase in the amount of impermeable surface cover. Proposed development in this area, therefore, must aim to achieve a “no net gain” in stormwater runoff.

Mitigation techniques regarding stormwater management may include installing bioswales, constructing rain gardens to capture storm run-off from roof tops, using permeable products for paved surfaces or constructing rock drains to encourage infiltration. An appropriately qualified professional should be involved from the planning phase when proposing development in this area to ensure that a site-specific stormwater management plan is designed and implemented.

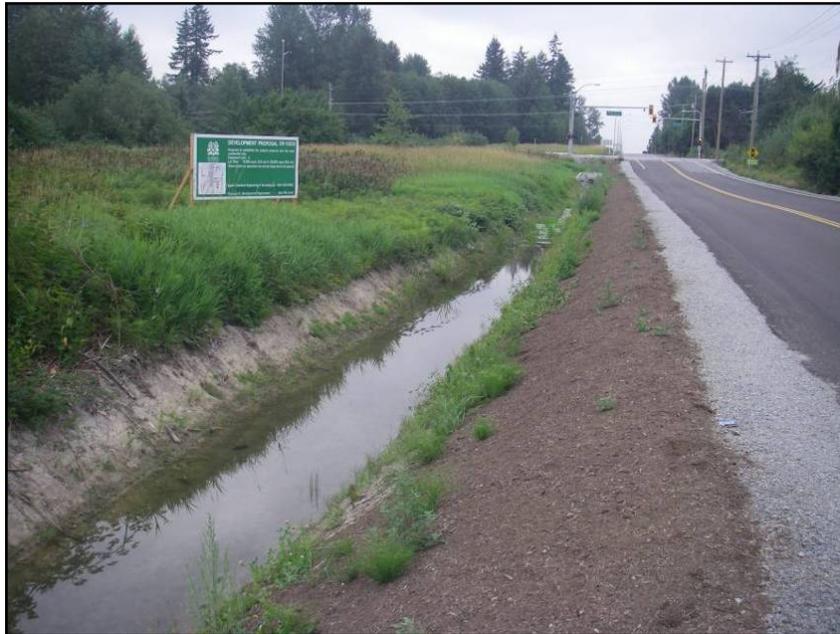
Looking south along the perennial ditch running parallel to 180<sup>th</sup> Street. Note existing lack of functioning riparian vegetation. Riparian vegetation will be perpetually limited on the west side, given the proximity of the road right of way.

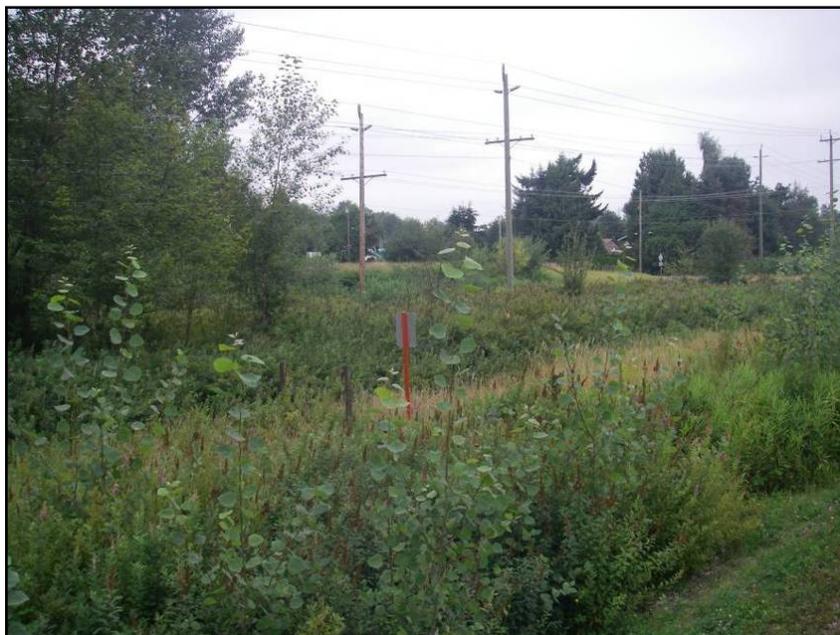
Seasonally flooded hardhack-dominated area following the power lines on the southern side of Golden Ears Way. Water collecting in this area drains into the watercourse pictured above and ultimately forms part of the Leoran Brook watershed.

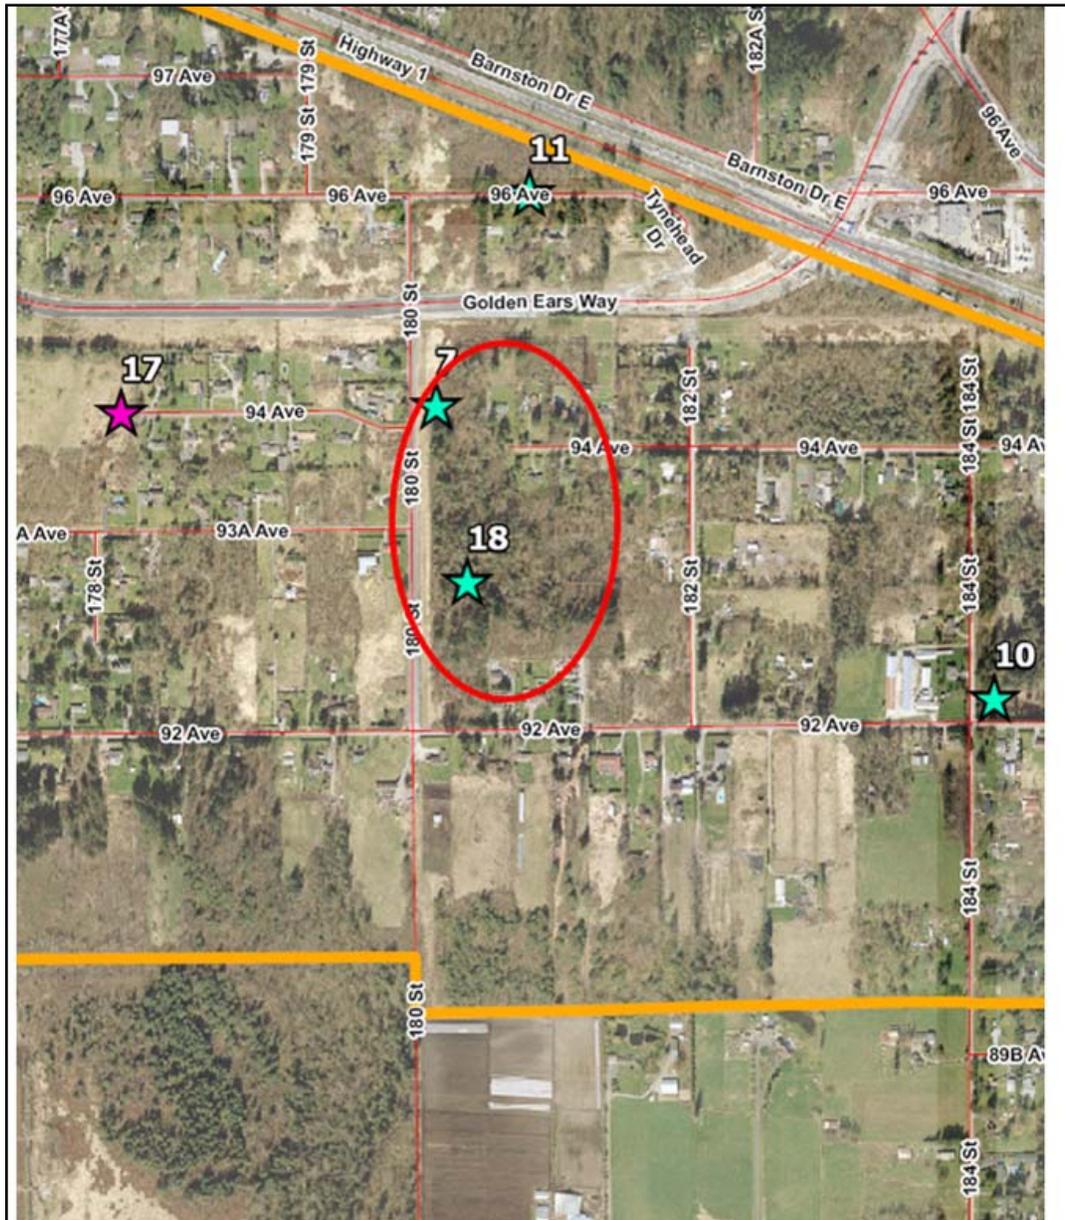
The ecological attributes in Area 3 – Figure 6 - (e.g. vegetation cover, wildlife trees and other significant mature trees) can be maintained with 40% retention if appropriate planning is employed. Development plans should identify wildlife trees and other significant trees and maintain large patches of vegetation (15 m to 20 m diameter or greater). If possible, these wildlife patches should be composed of an even mixture of coniferous and deciduous species in an unevenly aged distribution. The wildlife patches should include berry producing tree and shrub species (e.g. salmonberry – *Rubus spectabilis*, red elderberry – *Sambucus racemosa*, thimbleberry – *Rubus parviflorum*, red huckleberry – *Vaccinium parvifolium* and bitter cherry – *Prunus emarginata*) and wildlife trees, as these promote bird activity and species diversity. Wildlife trees and course woody debris left on the ground are beneficial to numerous wildlife species.

**Figure 6.** Existing forest conditions in Area 3 where survey point 18 for the original EA report was taken. Currently this area is lightly developed and is in close proximity to patches of forested habitat. Forty percent tree retention could achieve wildlife conservation goals if appropriate management practices for urban land development are implemented.

In the built portion of the site, significant mature trees should be identified and retained if possible. Other trees destined to be cut should be topped to retain the snag for the production of future wildlife tree habitat, assuming the remaining snag is not a safety hazard.

Area 3 will benefit from removal of invasive plants. Future land owners should be encouraged to respect the adjacent wildlife habitat and discouraged from dumping garden waste, which readily transmits ornamental invasive plants.

In addition, the biological function of the wildlife patches will be improved by buffering the retention areas by planting a dense layer of native shrubs that discourages human and dog encroachment and provides cover and protection to wildlife and birds. Retention areas should be connected by properly designed travel corridors as discussed in Area 1.

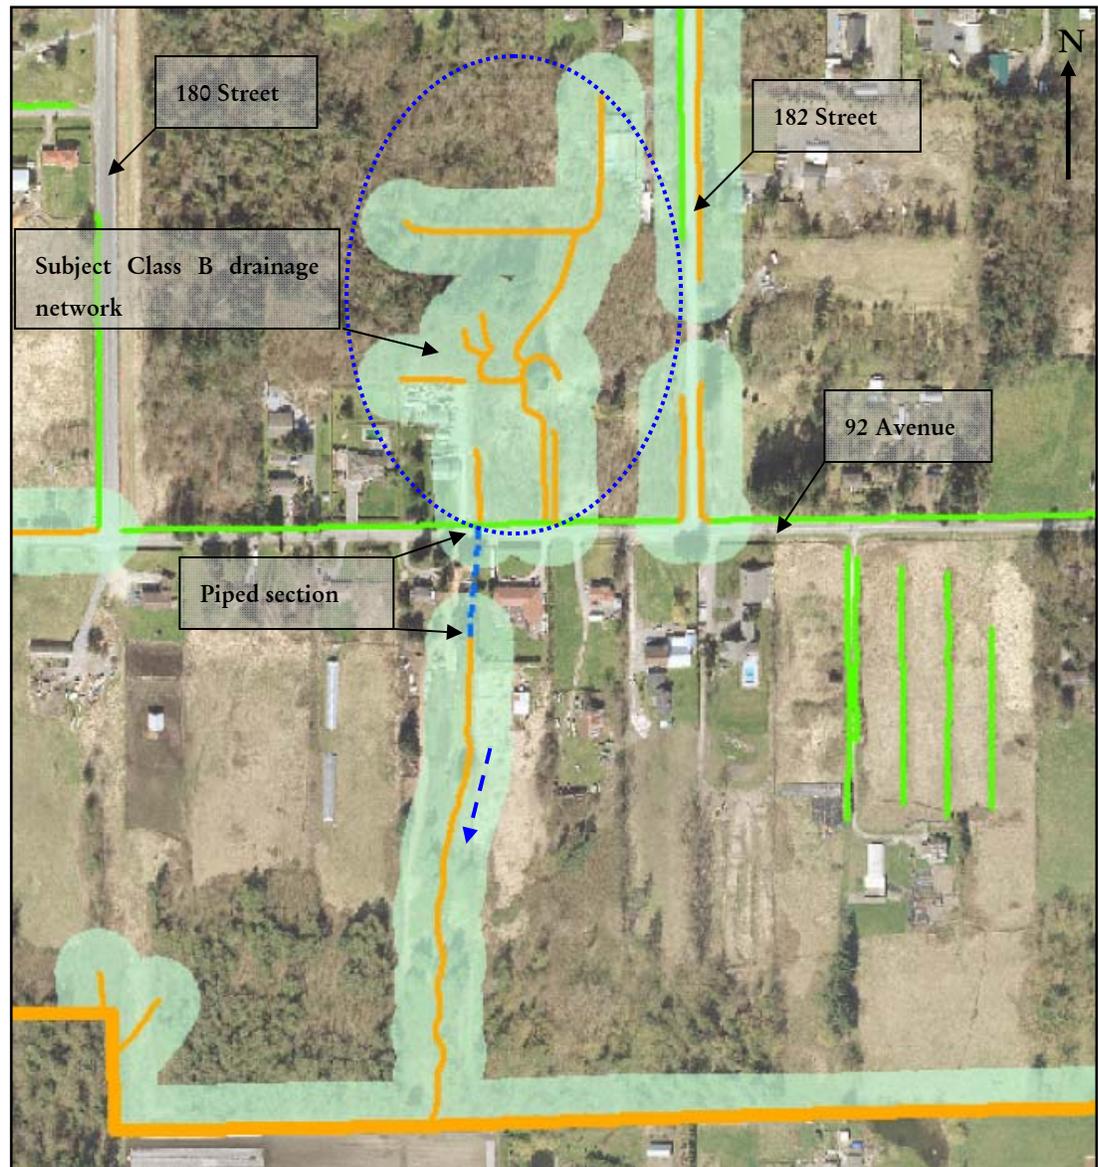
Figure 7. Subject drainage network – Area 4.

Area 4 represents a catchment for water that flows to the south and connects with the Class B drainage on the southern side of 92<sup>nd</sup> Avenue. Water draining from the site is piped from the southern side of 92<sup>nd</sup> Avenue, although it becomes daylighted again, as part of a natural system that connects with a “Class AO” system to the south (Figure 7).

Development in Area 4, especially if significant fill is required, would likely lead to an alteration of the existing drainage pattern. Fish habitat located downstream may be adversely impacted, given the connectivity of the Class B drainage to the south of 92<sup>nd</sup> Avenue with seasonal fish habitat.

Again, the goal of the development process must be to properly manage stormwater run-off, which will help to avoid negative impacts associated with increased peak flows and reduced summer flows in connected systems. Mitigation measures for both stormwater management and water quality for this area should follow the same general techniques listed previously. More detailed fieldwork may be required prior to the development phase to properly identify the main water conveyance zones and water retention areas.

<b>Stormwater Management and Water Quality</b>
Delineate water retention and conveyance zones in the moist depression.
Emulate existing flow/retention rates from the site through proper stormwater management, to decrease potential flow regime impacts on connected downstream systems.
Minimize the areas to be paved.
Use permeable paving and/or gravel surfaces wherever possible.
Educate landowners about stormwater management techniques and maintaining water quality – e.g. limiting use of chemical fertilizers/pesticides and installing raingardens or “green rooftops” to capture, or reduce, stormwater run-off from impermeable surfaces.
Aim towards a “no net gain” in stormwater leaving the developed area by employing appropriately qualified professionals at the early development stage.

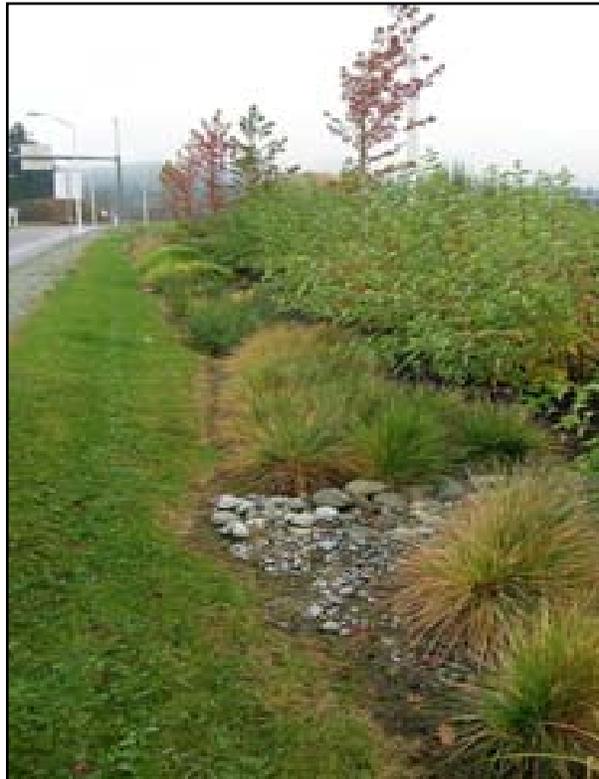
Vegetated roadside bioswale.

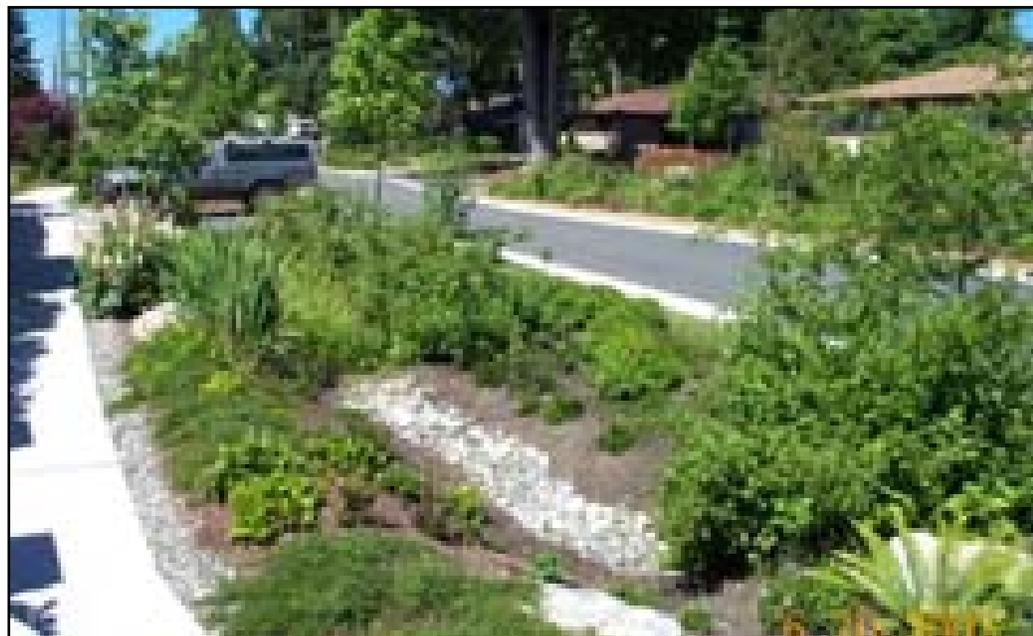
Vegetated / gravel-lined bio-swale in subdivision setting.

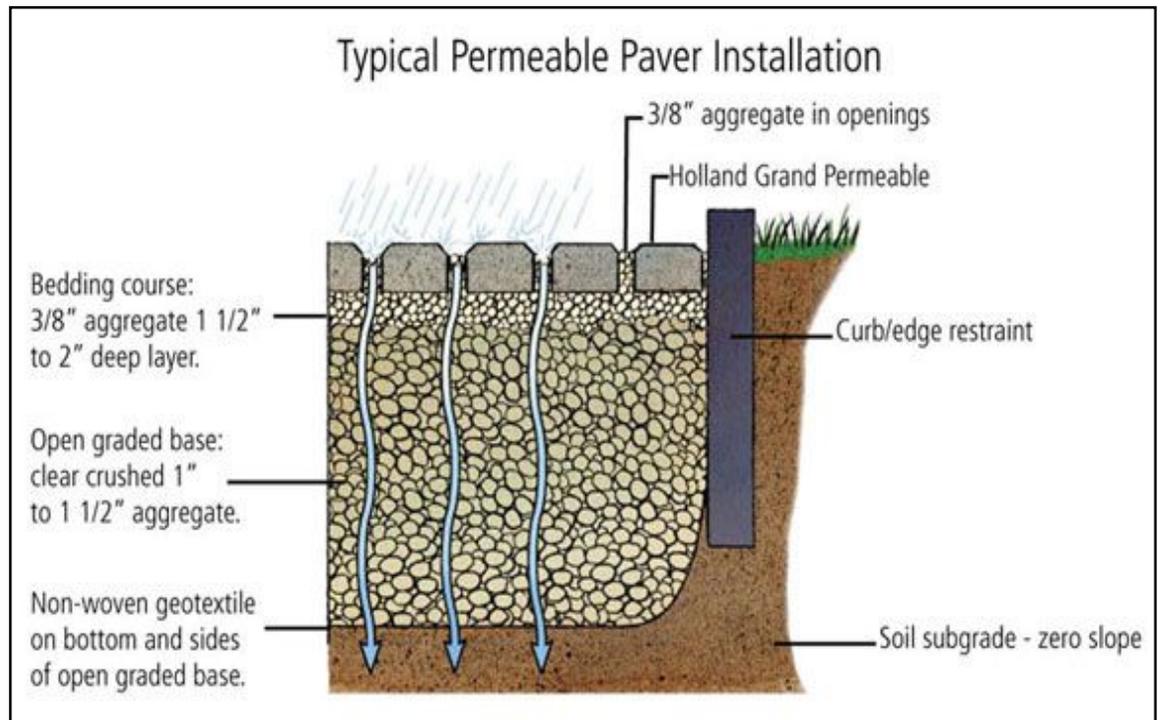
Permeable paving technique example.

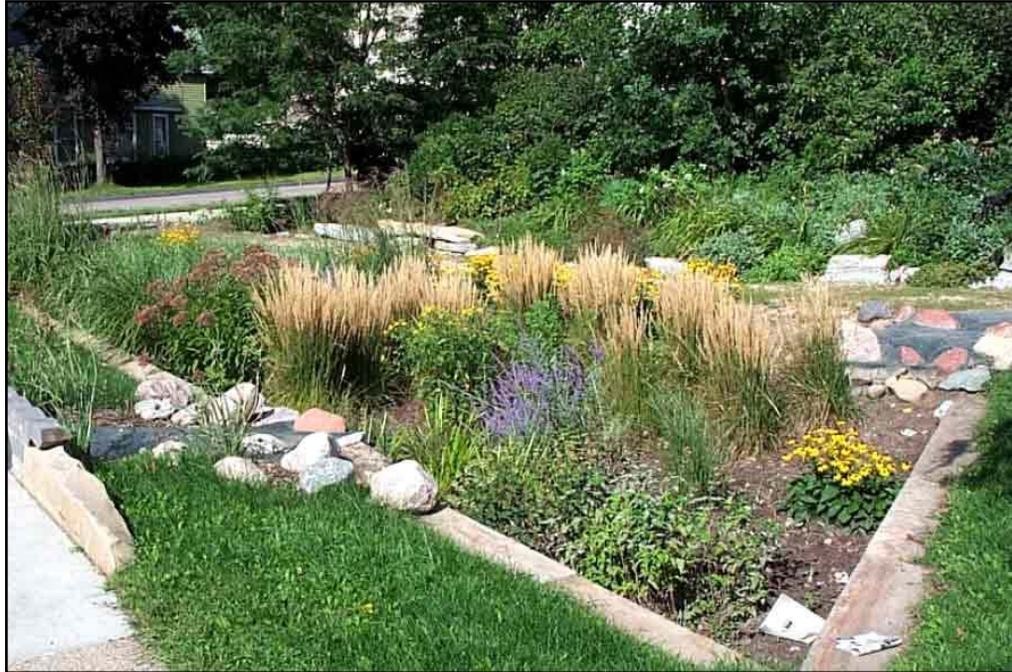
Example of an urban-setting rain garden.
