# Nicomekl Riverfront Environmental Assessment Report

November 2018

This environmental overview assessment identifies existing natural values, opportunities for enhancement, and constraints associated with the site. The intent of this report is to inform the planning and design phase for this park.

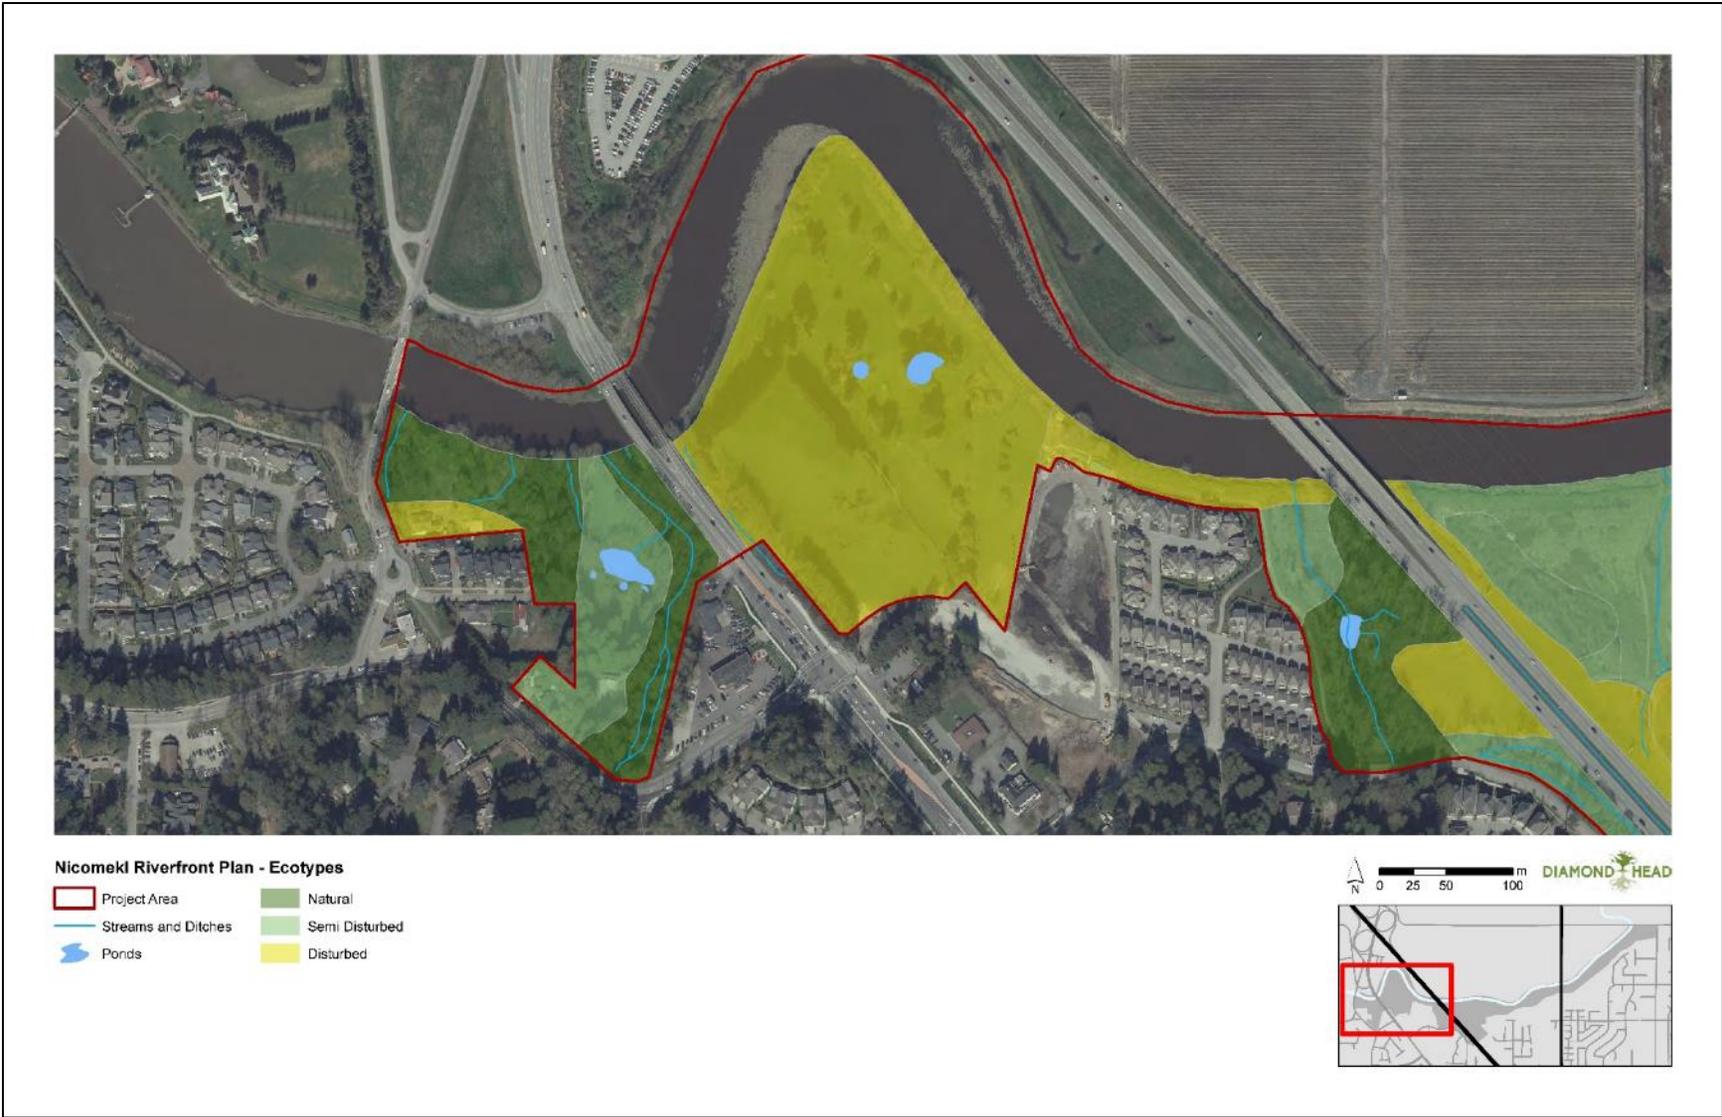
Figure 2: Level of disturbance on west end of site.

development or agriculture in the early 20<sup>th</sup> century. In many areas, it has been cleared again for development and infrastructure. The plant communities that exist range from young regenerating pioneer forests to some well-established and diverse older mature forests. Some trees in remote areas that would have been difficult to clear are estimated to range from 150-250 years old.

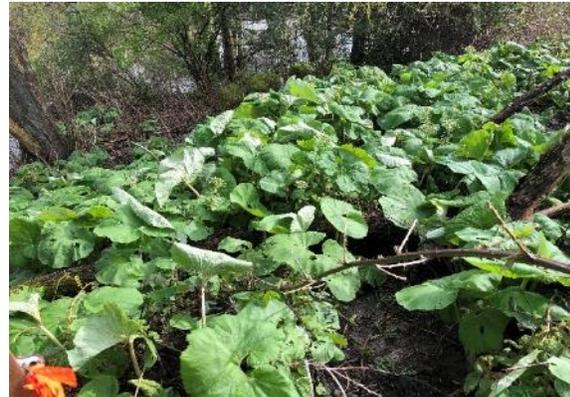
Japanese Butterbur is a species of concern found spreading into the riparian area of the Nicomekl

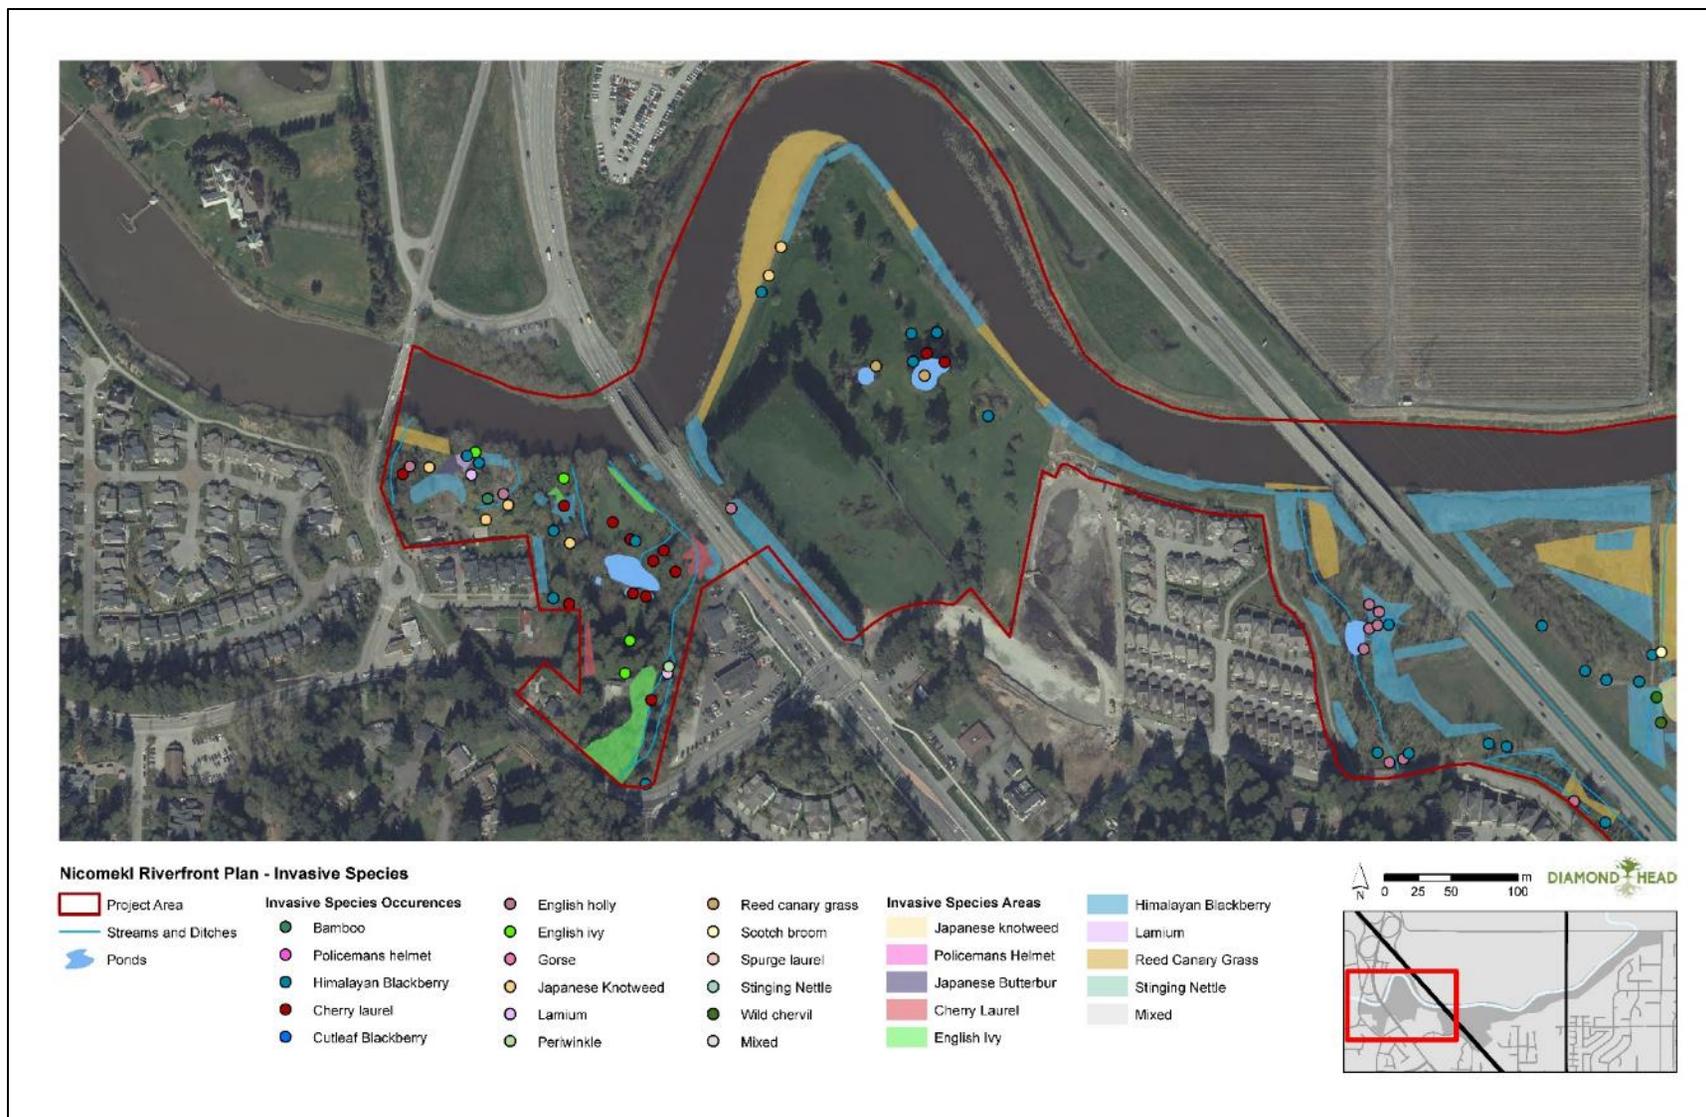
Figure 5: Invasive species found on the west end of site.

In general, invasive species are found adjacent to the areas that have been historically developed as well as along waterways (Figures 5-7). These include Himalayan blackberry (*Rubus armeniacus*), Scotch broom (*Cytisus scoparius*), English ivy (*Hedera helix*), Common periwinkle (*Vinca minor*), Lamium/Yellow archangel (*Lamium galeobdolon*), Policeman's helmet (*Impatiens glandulifera*), Common tansy (*Tanacetum vulgare*), English holly (*Ilex aquifolium*), Japanese knotweed (*Fallopia japonica*), and Cherry laurel (*Prunus laurocerasus*). Many of the knotweed pockets appear to have been treated historically or to be currently undergoing chemical treatment by the City of Surrey. There is one patch of an emerging species of concern called Japanese butterbur (*Petasites japonicus*) just east of Elgin rd.

Invasive species should be managed to protect natural biodiversity and prevent further spread and encroachment to and from adjacent areas. These should be treated using the current best management practices for each species. Manual removal is recommended wherever possible in order to minimize the introduction of chemical herbicides into sensitive environmental areas. Some species, such as Japanese knotweed, do not respond to manual control methods and chemical control methods such as foliar Glyphosate application should be considered. Large areas of Reed Canary grass can be dug up using an excavator or overplanted with large stock black cottonwood and red alder; increasing canopy cover has been found to be one of the most effective methods to shade out reed canary grass over time. English ivy should be manually removed from the base of all trees, with roots severed at breast height. Exact treatment and control methods are dependent on site conditions and the species encountered and may require adapted and site-specific control plans.

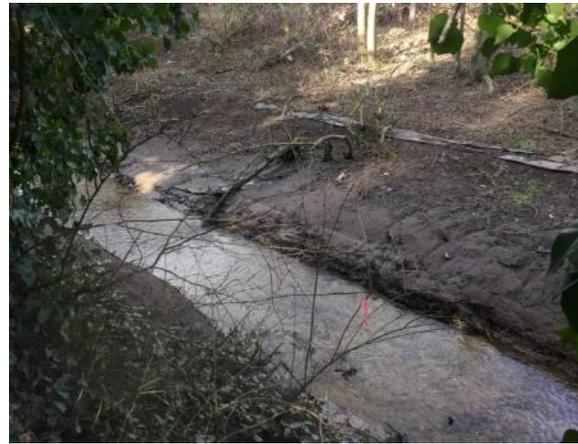
Elgin Creek turns briefly west at the north end of the site. Vegetation here is minimal and soils are exposed.

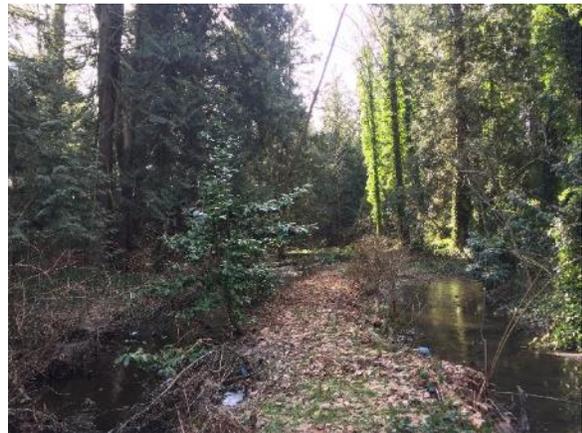
Elgin Creek and southern edge of property. Thick English ivy is found on several of the trees.

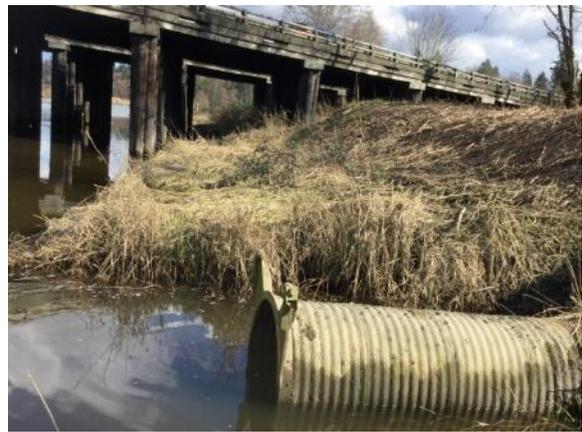
Culvert where Anderson Creek flows into Nicomekl River. This has recently been replaced.

Anderson Creek presently flows through a culvert before draining into Nicomekl River. Culverts can create natural barriers to fish passage. It is recommended that the culvert is removed and the connection between Anderson and Nicomekl is naturalized. This will improve fish access to Anderson Creek and provide additional freshwater habitat. This would assist in meeting one of the goals of the Nicomekl park, which is to ensure continued fish passage into Elgin, Barbara, and Anderson Creeks. This culvert was recently replaced with one that is free flowing. The City requires a culvert or bridge in this area for the recreation trail that goes across it.

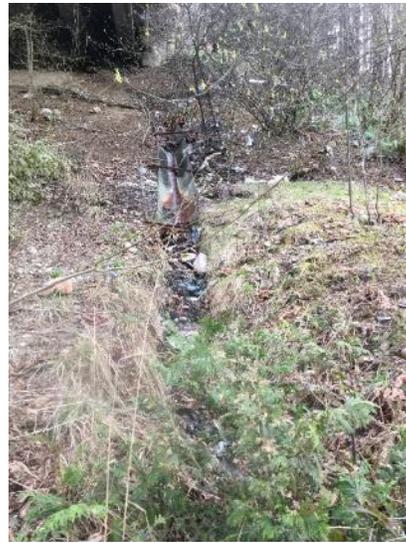
Constructed ditch, partially consisting of rusty metal half pipe.

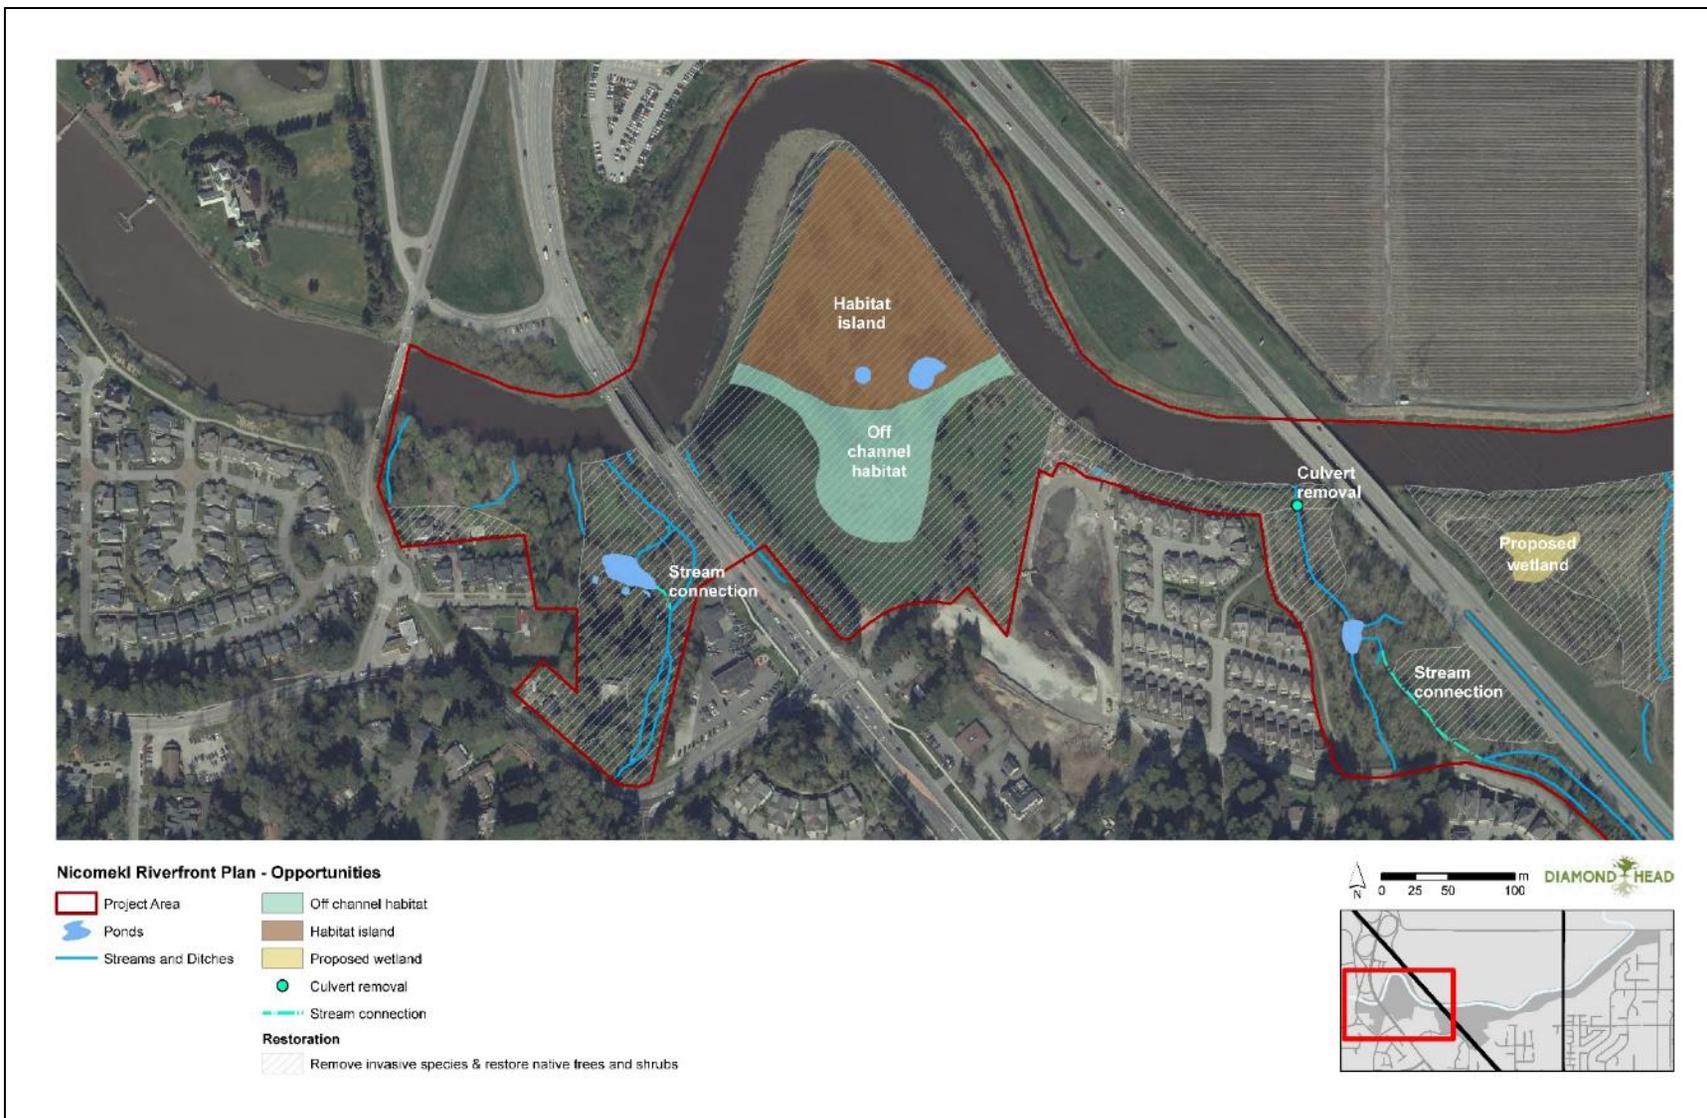
Figure 15: Opportunities for habitat enhancement on the west end of the site.

This park provides a unique and significant opportunity to protect a highly diverse natural area. This area is large in size, is continuous and connected to adjacent natural or semi natural areas, and provides a wide range of habitat features. There are some opportunities to enhance these areas, restore previous disturbance, and protect them from the influences of human development. The following sections include a number of recommendations that should be considered during the design phase of the park. More detail will be provided in the later stages of planning.

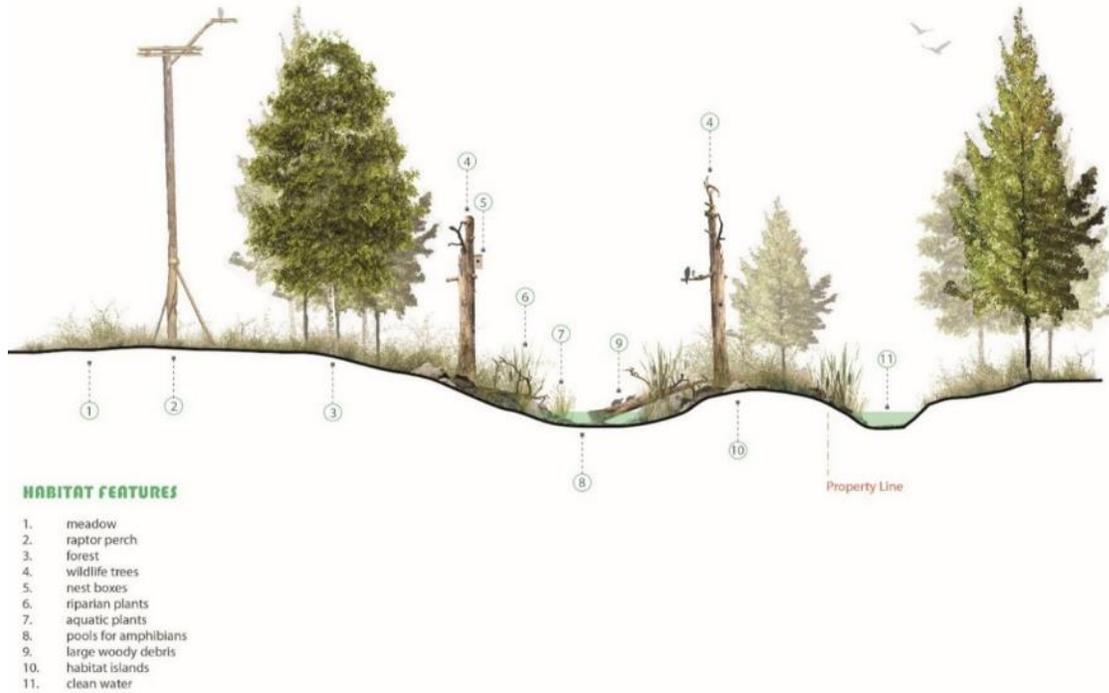
Figure 18: Habitat Features to be Incorporated into the Environmental Program.

Areas that have previously been disturbed or are dominated by invasive species provide a limited diversity of habitat features. Creation of additional artificial and natural habitat features wherever possible will improve overall biodiversity in the park. Habitat enhancement recommendations are discussed below and conceptually illustrated in Figure 18.

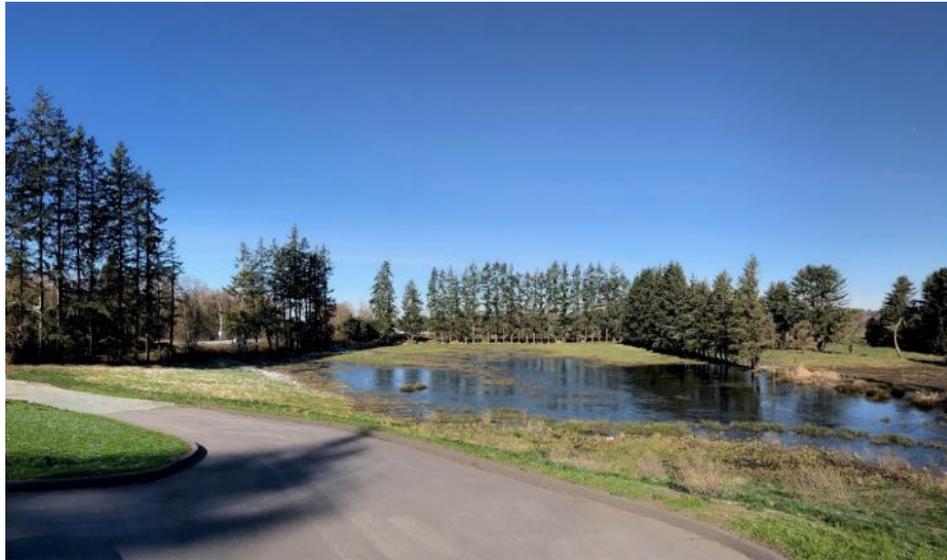
An off-channel pond could be constructed in the naturally flooding area in the golf course site.

The influence of tides and the extent of estuarine habitat areas is limited by the Sea dam and dykes. This lower reach of the river is critical for adult and juvenile salmon for forage, cover from prey and to provide a zone for adaptation to the transition from salt to fresh water during migration. The creation of protected intertidal or wetland/pond complexes in the lower reaches of the river would greatly benefit a diversity of wildlife species. The lowland areas that are disturbed or dominated by invasive species provide an excellent opportunity to create some permanently wetter ponds and wetland features.

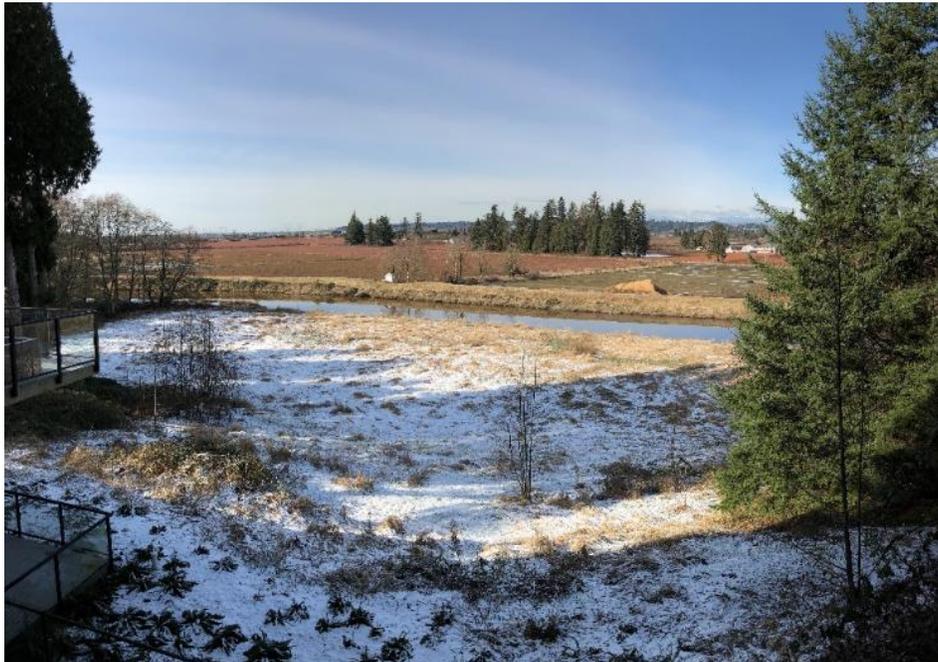
Large reed canary fields provide an opportunity to create off channel ponds or wetlands

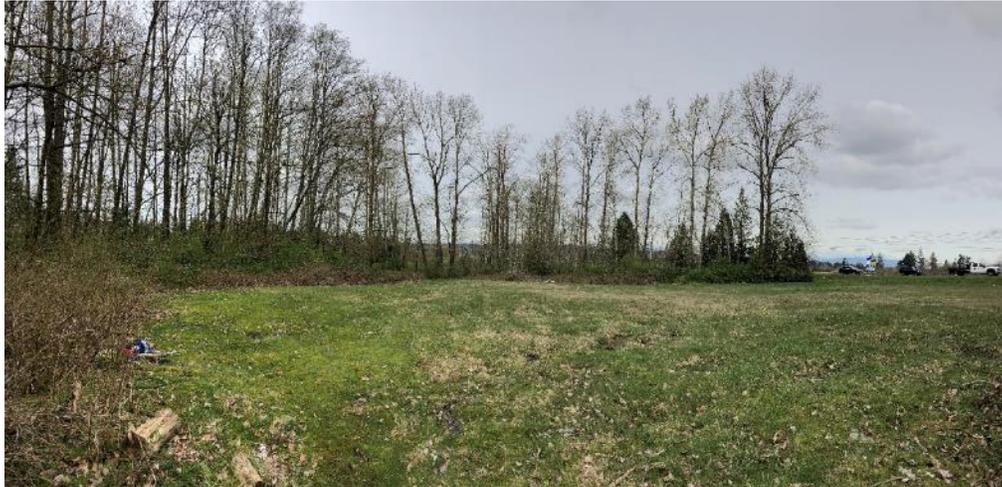
Turf field adjacent to Highway 99 could be used to daylight the upper Anderson creek

There are two constructed streams that run south along the west side of Highway 99 into a culvert which drains into Anderson creek. There is a large turf field between Anderson creek and these creeks that could be used to connect these reaches. This land is owned by the Ministry of Transportation, not the City of Surrey and is outside the scope of this project.

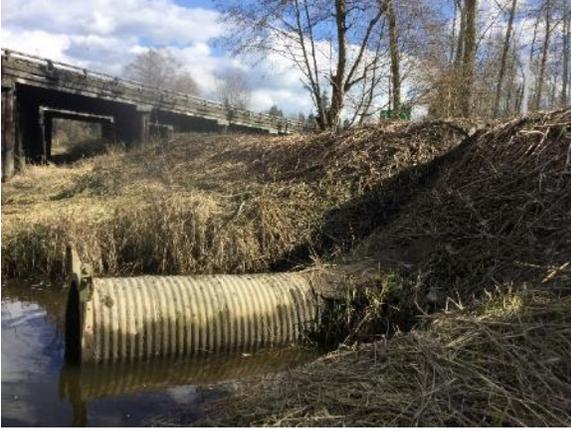
Culvert from Anderson creek. This has recently been replaced with one that is free flowing.
