# City of Surrey PLANNING & DEVELOPMENT REPORT File: 7912-0080-00

Planning Report Date: November 5, 2012

# BROOKSDALE ESTATE

19353 16<sup>th</sup> Avenue, Surrey Conservation plan

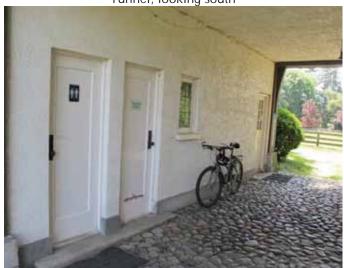
Tunnel interior

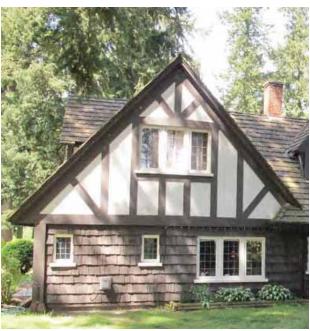
East elevation gable end: cornerboard, bargeboards and projected sills

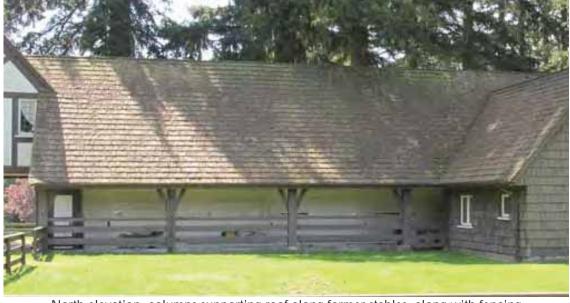
North elevation: columns supporting roof along former stables, along with fencing

# Conservation Recommendation: Preservation and Rehabilitation

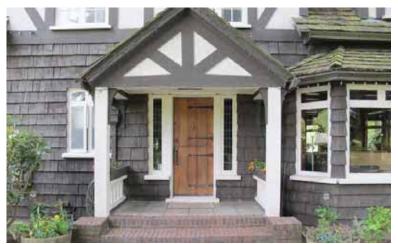
Main entryway of the Main House at Brooksdale Estate

- The south elevation entryway should be preserved, including the original door and sidelights, which should be repaired as necessary.
- The east elevation entryway is not original to the building and can be restored to echo the appearance of the main entryway to the main house. If executed, the restoration of the entryway should include an historically appropriate front-gabled roof, columns and balustrades, similar to those on the main entryway of the main house, pictured below. Solid wood should be used, as Hardie Board or combed or textured lumber are not acceptable materials.

Preserve the historic door and patio area at the northeastern entryway.
