# **Final Report**

Fleetwood Greenway North Creek Integrated Stormwater Management Plan

KWL Project No. 471.288 June 2016

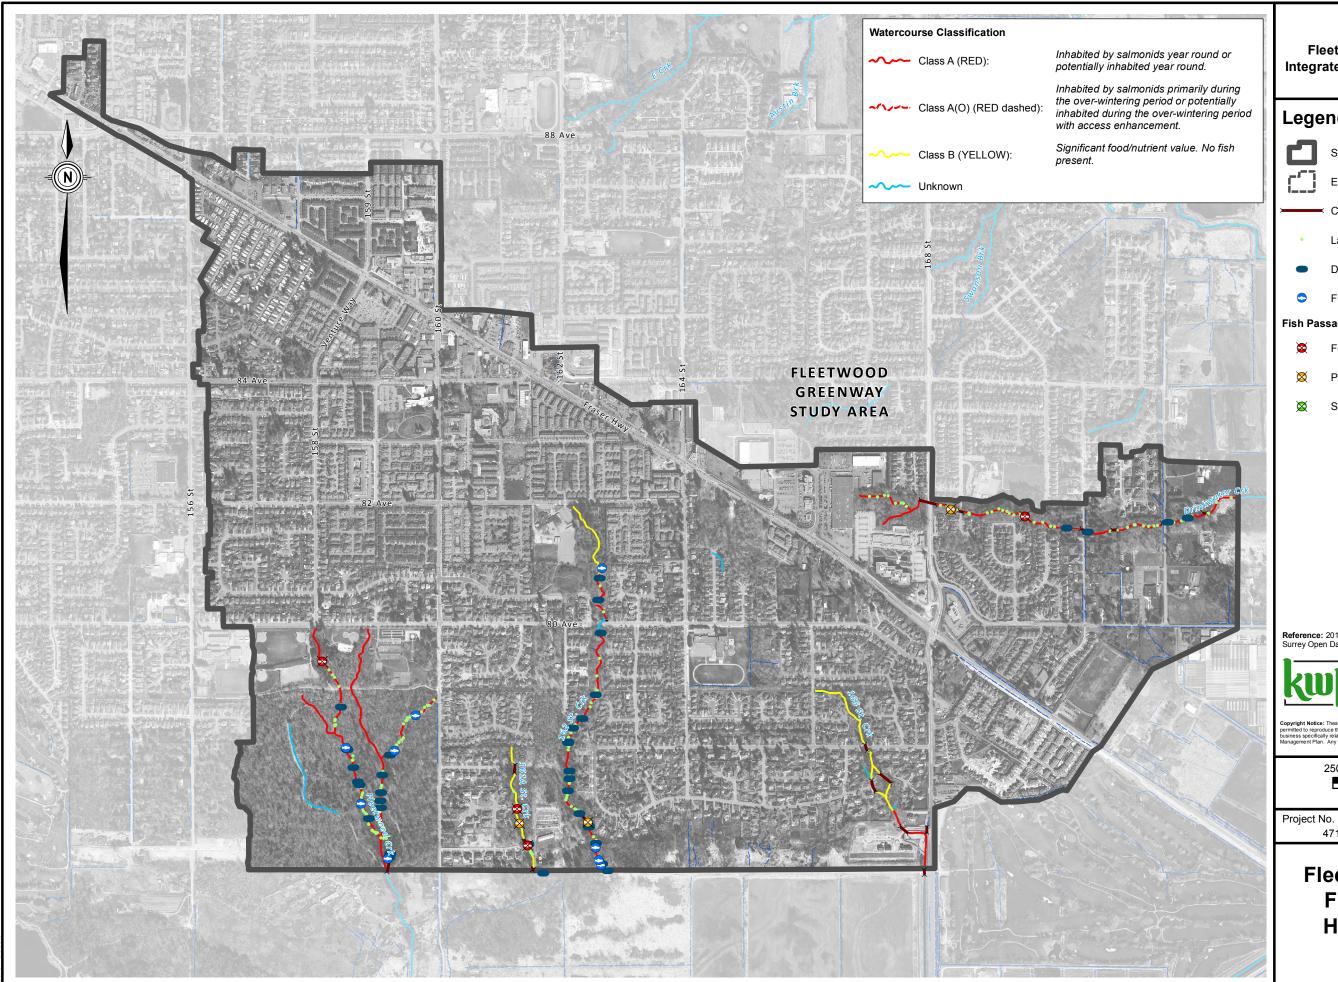
Figure 4-3

**Fleetwood Greenway Fish and Aquatic Habitat Inventory**

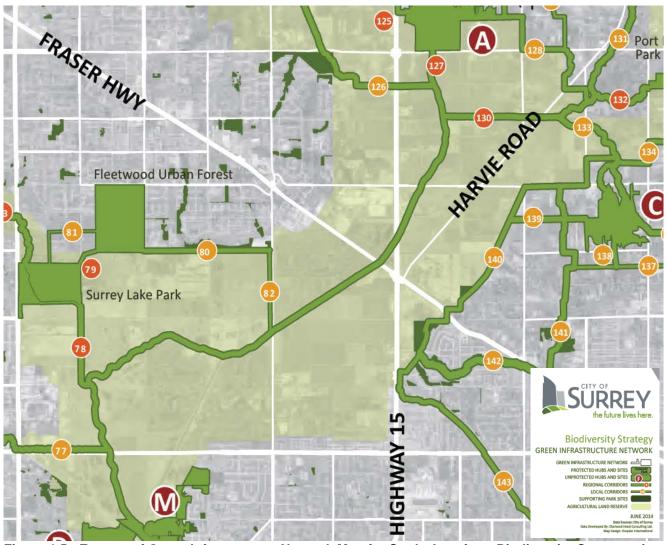
Figure 4-5: Excerpt of Green Infrastructure Network Map for Study Area from Biodiversity Conservation Strategy (from City of Surrey 2014)

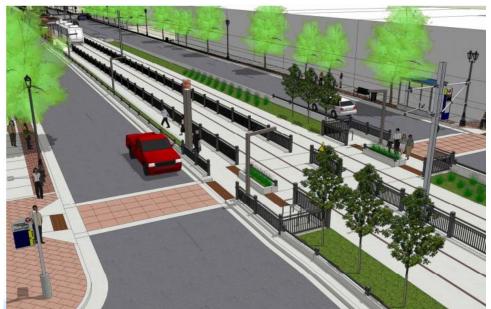
Conceptual Image of Proposed Central Corridor Project, Minneapolis-St. Paul, Minnesota<sup>2</sup>

Figure 7-1 and 7-2 show the location of potential regional water quality treatment facilities as part of environmental enhancements as the primary goal is environmental protection. The proposed locations could be structural treatment units (oil/grit separators), but there may also be opportunities to incorporate biofiltration BMPs in the re-development of the Fraser Highway corridor to treat the proposed catchment runoff. The re-development of the road corridor is a unique opportunity to mitigate and improve the environmental impact of the road along with the proposed incorporation of light rail in the corridor. Other cities including Portland, Oregon, and Minneapolis-St. Paul, Minnesota, have taken a similar opportunity to incorporate stormwater BMPs with light rail and road re-development projects.

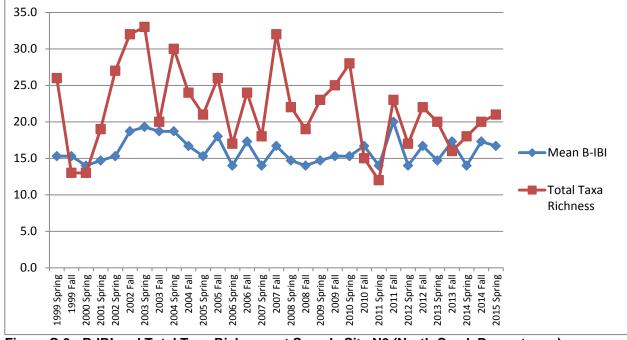
Figure C-3: B-IBI and Total Taxa Richness at Sample Site N2 (North Creek Downstream)

- Mean B-IBI values at Station N1 increased significantly from 1999 to 2015 (Figure 4-1). In contrast, mean B-IBI value at North Creek Station N2 has declined slightly since 1999 although the change is not statistically significant (Figure 4-1).

- At both stations, taxa richness was lower before 2001, peaked between 2002 and 2004, and then declined (Figure 4-1). This peak in taxa richness was statistically significant at Station N1, but not at Station N2. Observed patterns were likely due to the rapid establishment of new tolerant taxa concurrent with a somewhat slower loss of sensitive taxa, which is typical in urbanizing streams.

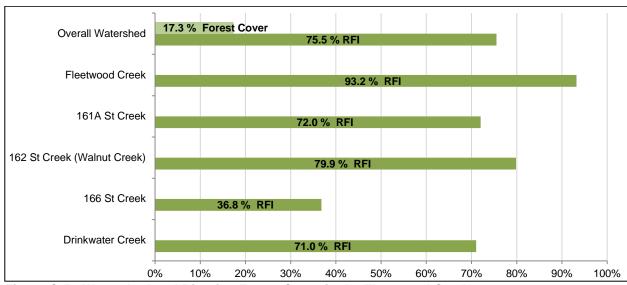
Figure C-5: Watershed and Riparian Forest Cover in the Fleetwood Catchment

Key findings for the Fleetwood catchment (Figure 4-2; Table 4-2):

- A total of 17.3% (88.4 ha) of the Fleetwood catchment is forested. The largest patch of forest, 38 ha or 43% of total forest cover in the catchment, is found in Fleetwood Urban Park.
- Riparian forest cover in the watershed remains high at 75.5%, in line with the recommended guidelines. Four of the five creeks in the catchment have greater than 70% riparian forest cover (Photo 4-1)

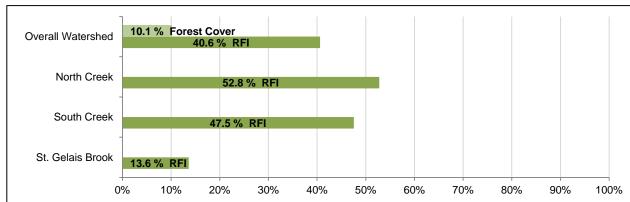
Figure C-6: Watershed and Riparian Forest Cover in the North Creek Catchment

Key findings for the North Creek catchment (Figure 4-2; Table 4-2):

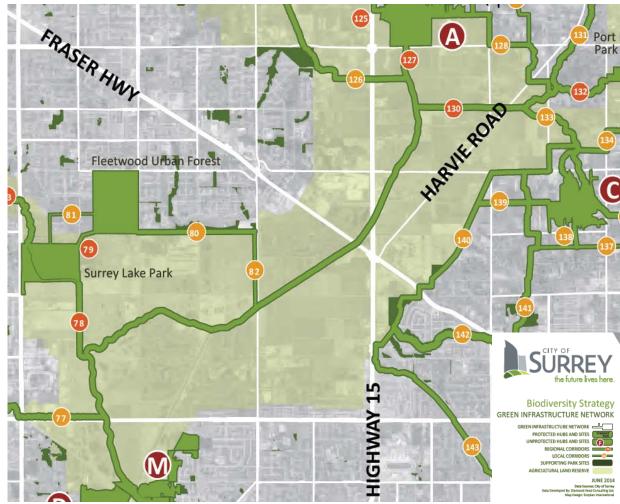
Figure C-8: Excerpt of Green Infrastructure Network Map for Study Area from Biodiversity Conservation Strategy (from City of Surrey 2014)

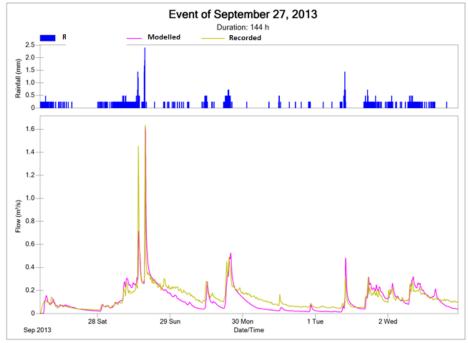
Image D-1: Dry Event Calibration (September 2013)

The September 27, 2013 storm was used as the dry event calibration, utilizing rainfall data from the 68 Avenue at 176 Street rain gauge. This storm was a 2-year 15- and 30-minute event compared to the Surrey Kwantlen Park IDF. After calibration, the modelled peak flow was 1% lower than the observed peak flow, while the volume of modelled flow was approximately 15% higher than observed. The dry event calibration is presented in Image D-1.

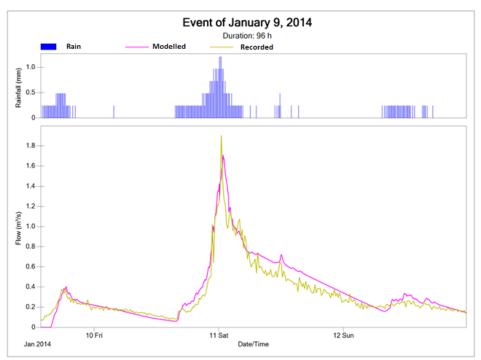
Image D-2: Wet Event Calibration (January 2014)

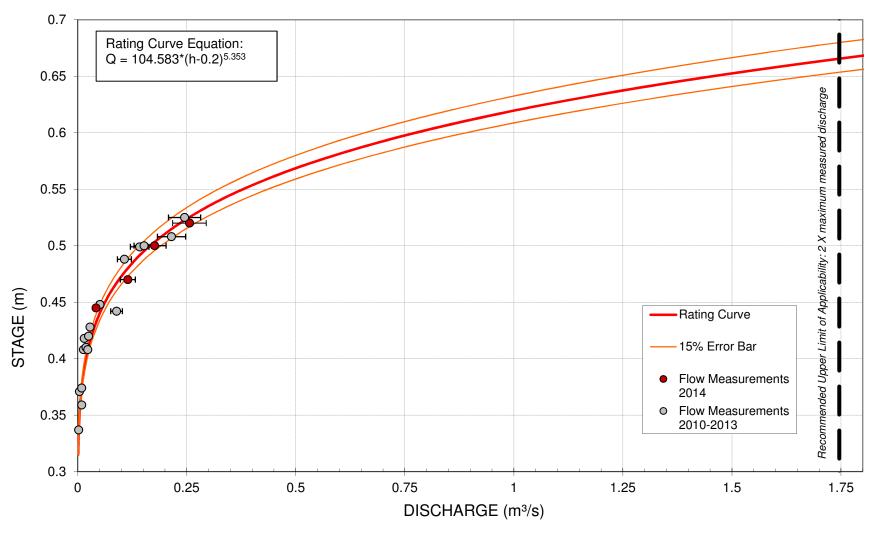
Figure D-2: 2013-2014 North Creek at Fraser Highway Stage-Discharge (Curve is unchanged from 2010)

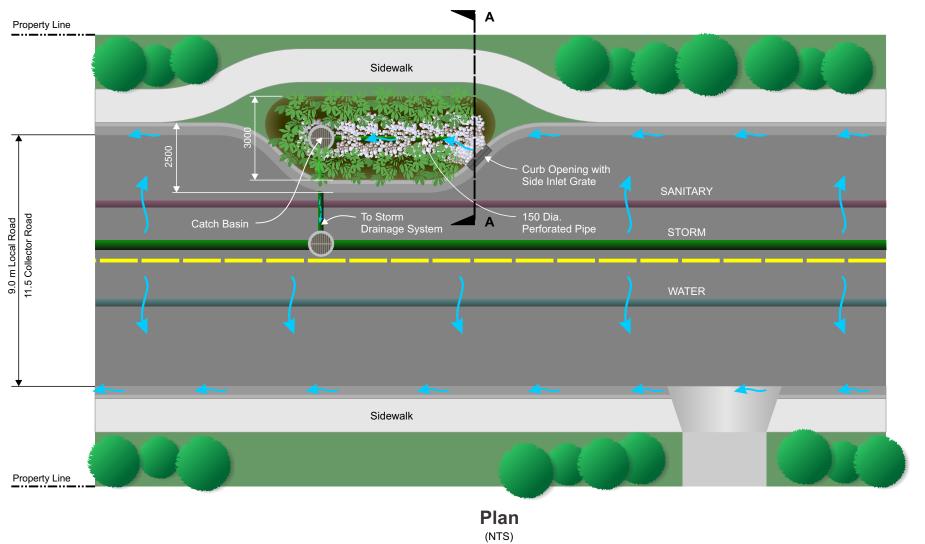
Typical Bump Out Raingarden at Intersection

#### Storm Drainage System Inlet 200 mm 3000 (Typ.) 500 above Bioretention Invert Standard Curb and Gutter with Organic Mulch Sidewalk Pavement Opening at Inlet Swale Granular 2 (Max.) Subgrade 1 (Max.) 1 (Max.) Growing Maximum Groundwater Medium Layer **Table Elevation** Drain Rock Reservoir Wrapped in Geotextile To Storm 150 Dia. Drainage System Perforated Pipe

**Section A-A**

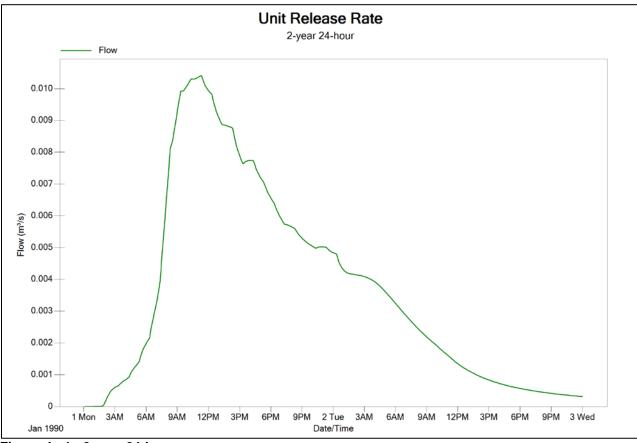
Figure J - 1: 2-year 24-hour

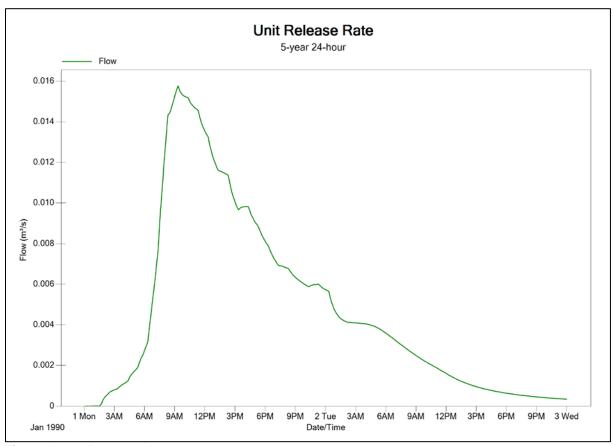
Figure J - 2: 5-year 24-hour

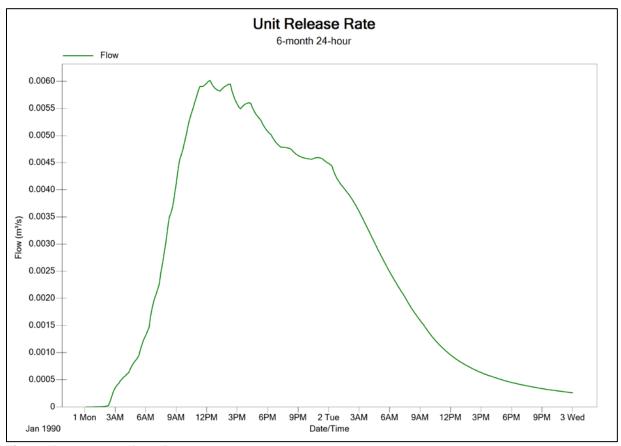
Figure J - 3: 6-month 24-hour
