City of Surrey
PLANNING & DEVELOPMENT REPORT

File: 7914-0288-00

- **Heritage Revitalization Agreement**

To permit a coach house and additions to the Cobblestones property.

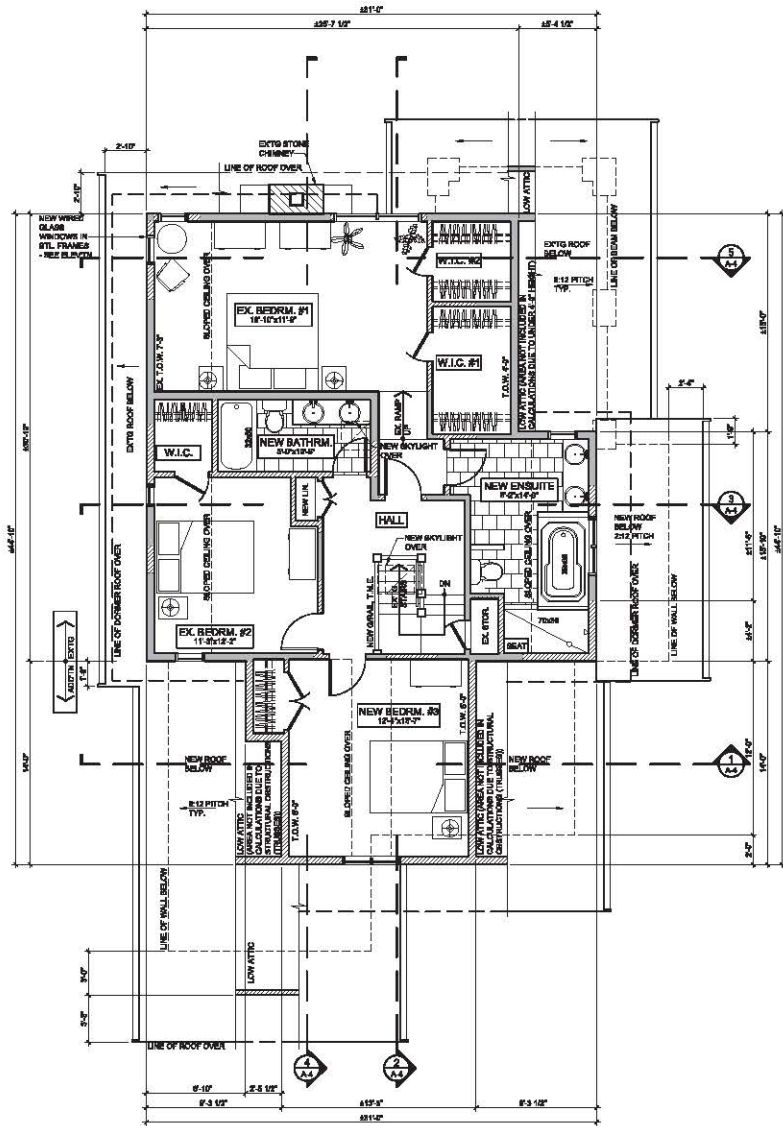
2 UPPER FLOOR PLAN
SCALE: 1/4" = 1'-0"

AREA SUMMARY	MAIN FLOOR	UPPER FLOOR
EXTER.	1366.0 SF	416.0 SF
ACFTYNE	198.0 SF	288.0 SF
SUBSTRYNE	216.0 SF (OVER PORCHES)	177.0 SF
INSUL.	1708.0 SF	
BLDG. TOTAL	2870.0 SF

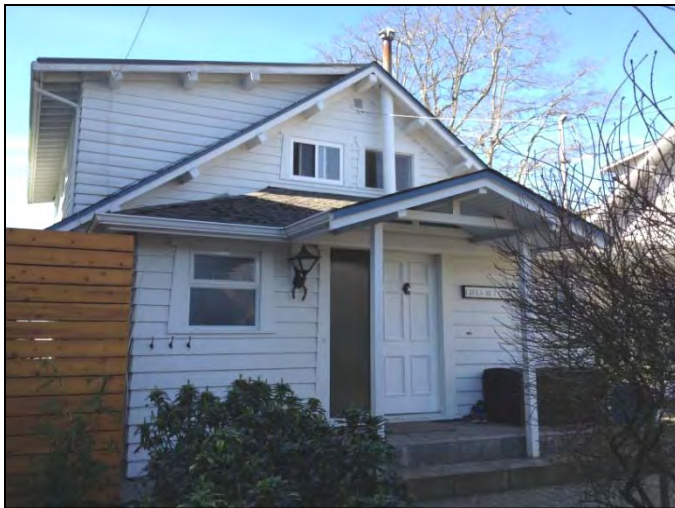
Photo 9: Rear of house showing 1963 additions.

Aforementioned 1963 renovations added three extensions: a full-width, one-storey rear addition; upper floor south, large shed dormer addition, and; upper floor north, small gable dormer addition. This work also enclosed the covered front porch, replaced much of the original wood siding and trims, and replaced all windows with enlarged, direct-glazed (no sash) windows, including corner window groups.

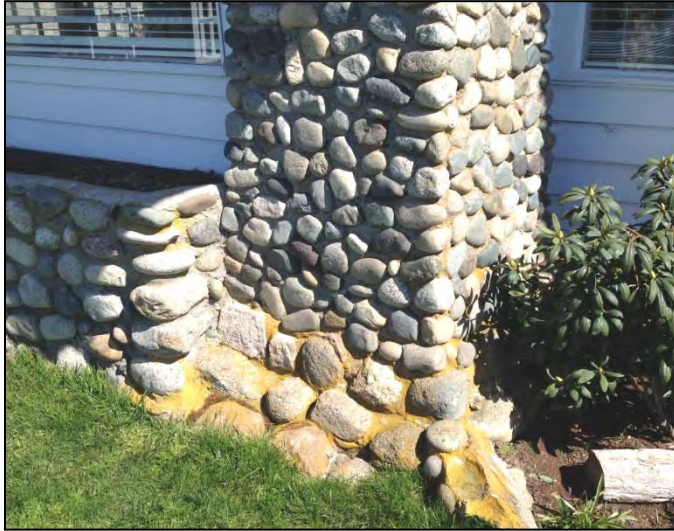
Photo 10: Detail of base of stone pier. Note later planter on left.

The exterior features distinctive river rock, or cobblestone, masonry piers at the front porch, massive chimney in the centre of the front facade and at the base of the original walls. The interior side of the chimney is also exposed cobblestones.

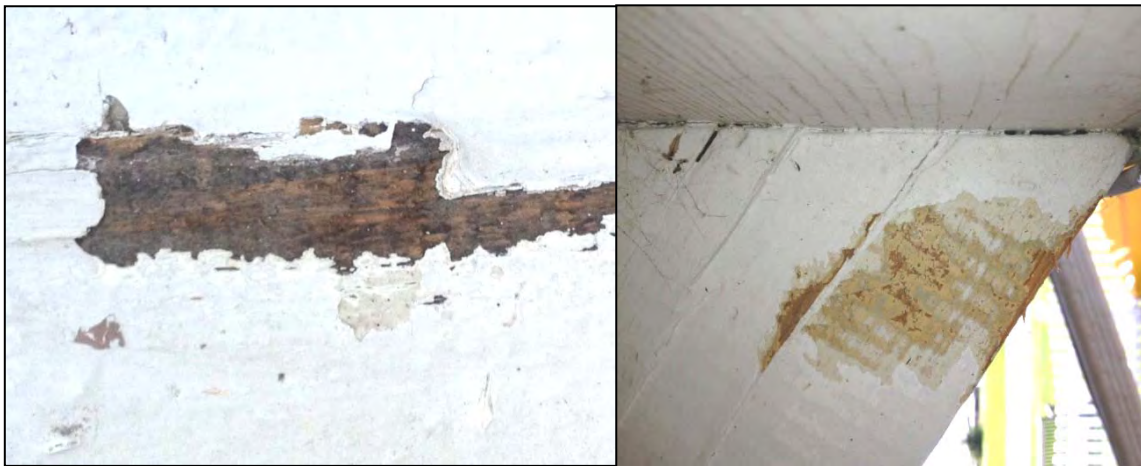
Photo 11: Original dark brown siding (left) & deep tan trimwork (right).

Later colour layers are consistently (from lowest/earliest): light taupe, ivory, dark blue (trim), off white, pale grey (trim). This reflects changing colour tastes during the mid-century rise of modernist design trends, culminating in the 1960s-70s all-white colour scheme.

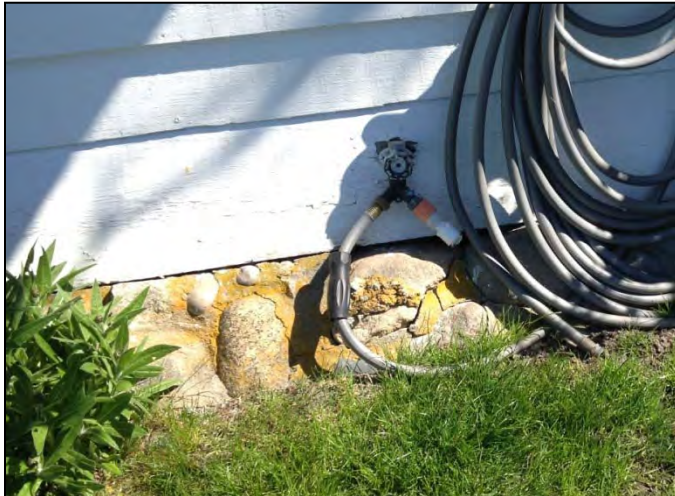
Photo 13: Original stone foundation. Note typical lichen growth.

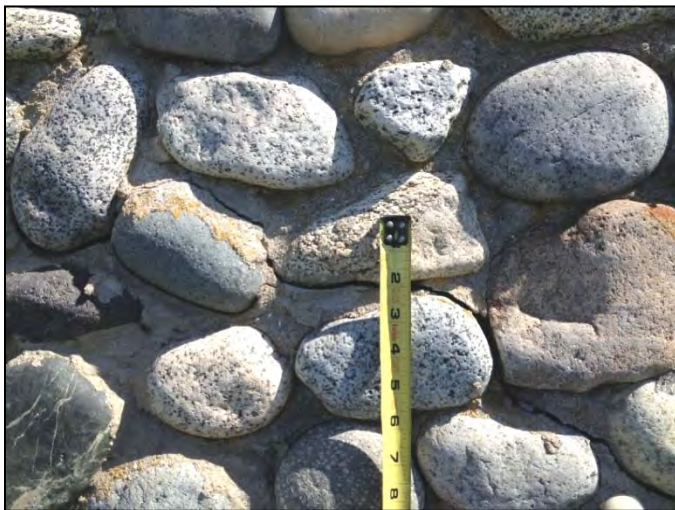
Photo 14: Typ. cracking of later mortar repairs.

Mortar cracking is likely the result of minor building and/or chimney settlement and differential seasonal, eg. free/thaw, cycling. The original, and likely later repair mortars, used dense, high cement-based mortar (Types-M or S) instead of more flexible high lime mortar (Type-N or O). Being such a massive chimney, this cracking is considered minor.

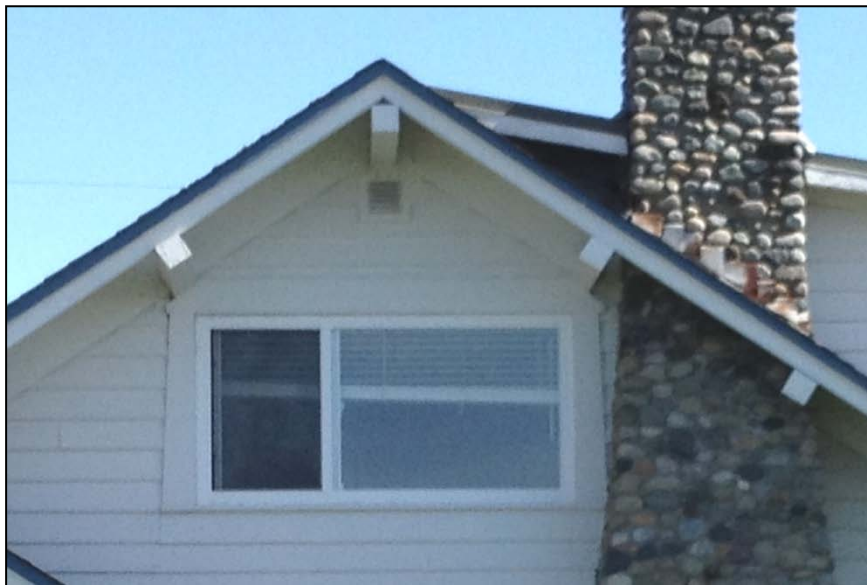
Photo 15: West gable end. Note poor condition chimney step flashing, exposed ends of roof purlins, window trim design & vinyl-framed window in an altered opening.

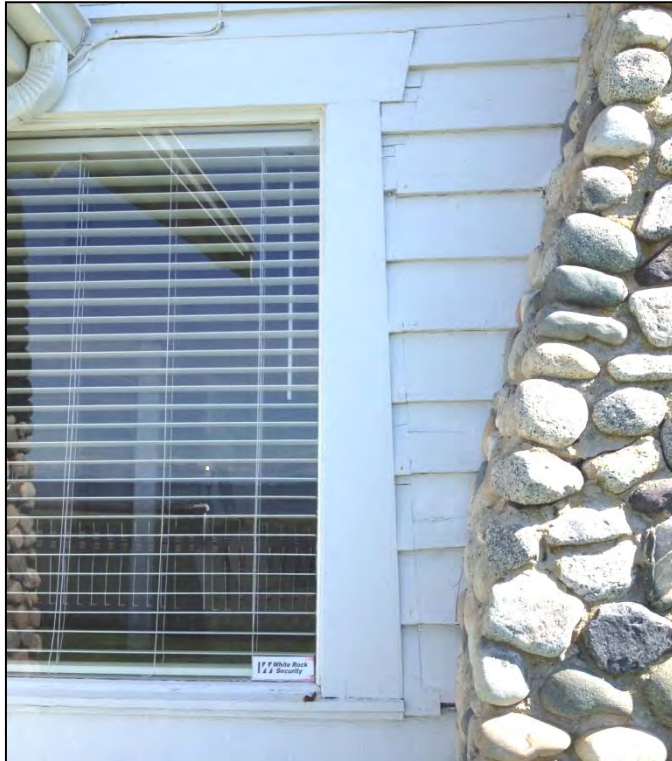
Photo 16: Window detail showing original trim design repeated for altered opening for contemporary direct-glazed window. Note line of original trims.

Original windows have been entirely replaced with modern, direct-glazed, wood windows, likely in the 1963 renovation campaign. Having received regular repainting, these windows are in *good* condition. Some upper floor windows are modern white vinyl-framed units. There is no visible metal head flashing over windows, lack of which may have lead to water ingress into walls over time.

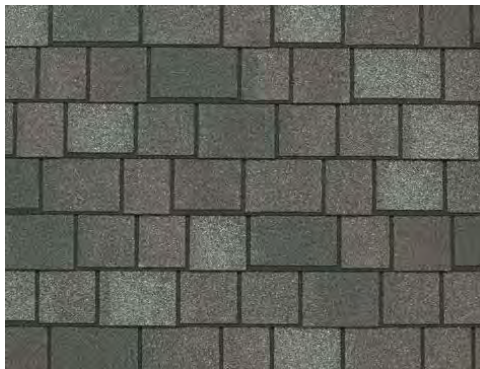
▪ Photo 17: IKO shingles.

IKO Royal Estate, Colour: Mountain Slate, or alternate accepted by heritage consultant. Note this shingle has a restrained, traditional "shingle" appearance.

- Due to the extent of new roof additions, and condition of existing roofing, remove all existing roof and provide new roofing complete with complete underlay, and eave protection per Code and RCABC Best Practices.
- Use continuous ridge attic venting not plastic/metal vents in field of roof.
- Though original house had cedar shingle roofing, asphalt shingle roofing is supportable. Low 2:12 pitch of 1963 dormer and new shed dormer does not meet minimum Code slope for cedar shingles; the shingles would not shed water properly.
- Asphalt shingles to be:

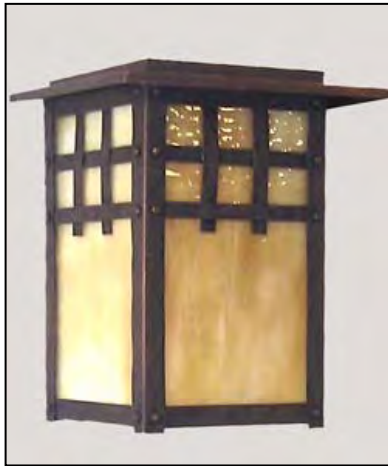
Waterglass Studio, The Craftsman, Model: 904I, Glass Colour: Amber Opal, or alternate accepted by heritage consultant.

Photo 18: Proposed light fixture.

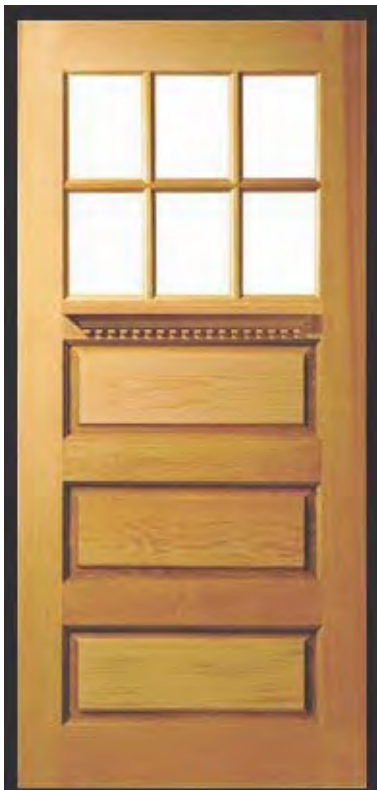
Photo 20: Proposed door. Note shelf to be Type-E (no dentils) & glazing to have no grid.

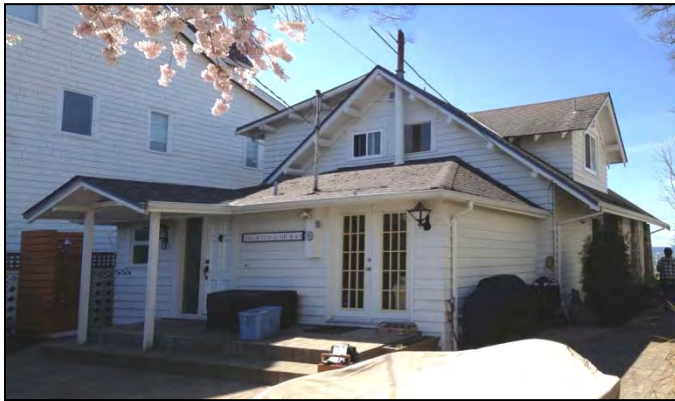
Photo 21: View from north east, note 1963 additions.

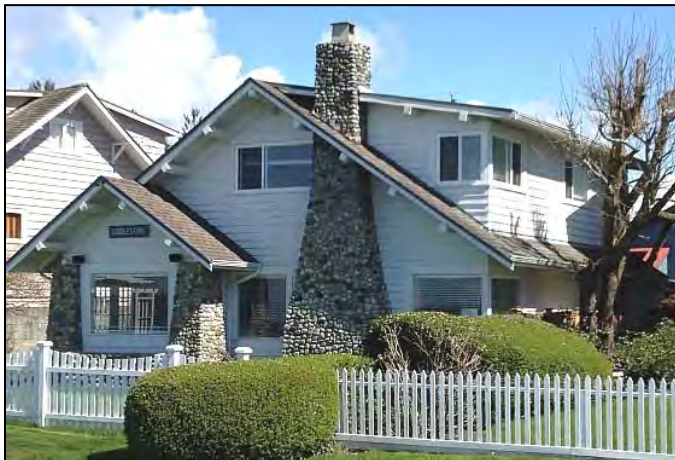
Photo 22: View from south west, note enclosed front porch.

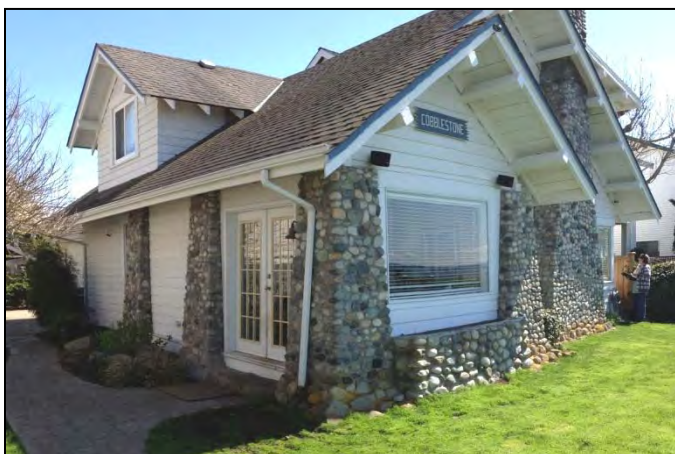
Photo 23: Detailed view enclosed porch, note 1963 gable dormer.

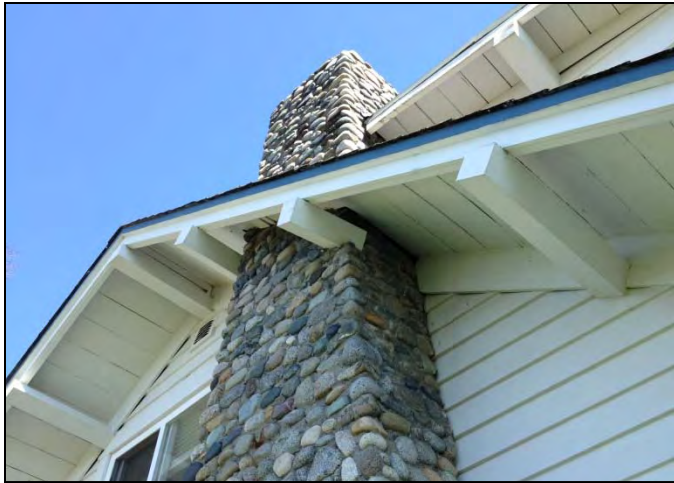
Photo 24: Detail view chimney & roof overhang, note overhang of 1963 dormer.

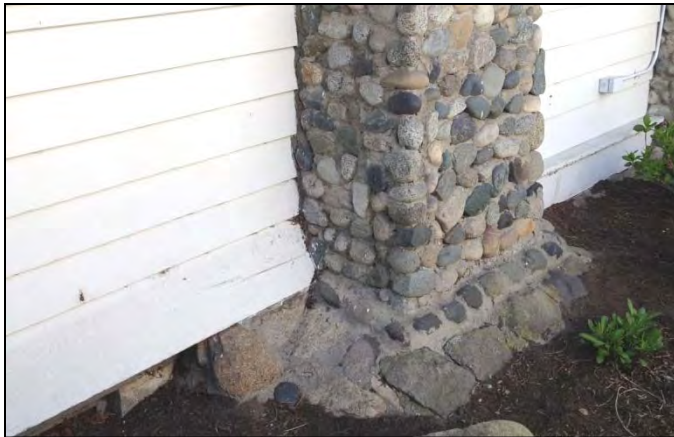
Photo 25: Typ. base of cobblestone pier, note wide flared bottom siding board.

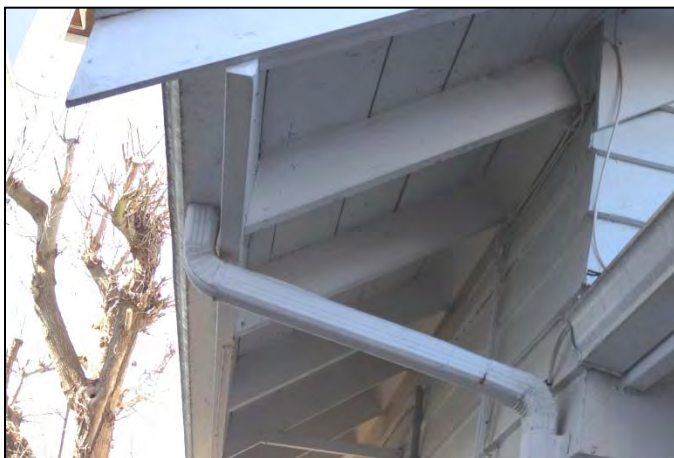
Photo 26: Typ. roof eave, note exposed rafter tails.
